Schools Profiles Reports – Saint Lucia

Technical Assistance for Increasing Resilience of the Education System to Climate Change in Saint Lucia and Antigua & Barbuda

Document permissions:	Confidential - Client and its funding agencies
Project number:	20501
Project name	Increasing Resilience of the Education System to Climate Change in Antigua and Barbuda
Report Title:	School Profile Report – Saint Lucia
Report number	20501.110-01
Version number:	V01Draft
Client:	United Nations Industrial Development Organization

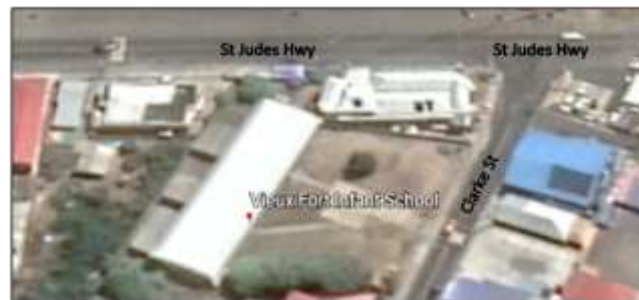
Vieux Fort Infant School

Facility Name:	Vieux Fort Infant	Risk Category:	RCIII
Type of School:	Infant	Occupancy Group:	Group A: Public Buildings
School Address:	Clarke Street, Vieux Fort	No. of Occupants:	197
Latitude:	60°57'09.69" N	Year Built:	Unknown
Longitude:	13°43'52.06" W	Year(s) Renovated:	2015, 2020
Use:	School	Original Design Code:	Unknown
Building Condition Assessment Date:	September 4, 2020	Fire Safety Assessment Dates:	November 25, 2020 November 25, 2020
School Description:	No. of Buildings:	4	
	Shape of Buildings:	Rectangular	
	School Layout:	There are 3 single storey buildings and one two-storey building. One single storey building houses a classroom, another houses a kitchen and one is currently used for storage. The other building houses classrooms, toilets, a sick bay, library, computer lab, staff room, stage and principal's office.	
	Overall Condition Rating:	Good - 4	
Environmental and Social Factors	Community Type:	Urban

Adjacent Land Uses:	Transportation, Commercial, Institutional	
	Occupancy Group A and B Buildings within 1 km:	Restaurants, Religious Buildings, Teaching Facilities	
Climate Vulnerability	Landslides	No or low susceptibility	The school is situated on low lying lands, far from elevated lands
	Hurricanes	Moderate to high	The school is situated in a fairly open area and exposed to easterly winds
	Flooding	Moderate to high susceptibility	The school is south of the Airport and a distance from the old alignment of the Vieux Fort River
	Drought	No or low susceptibility	Did not report drought to be a concern
	Sea-Level Rise	No or low susceptibility	The school is built on flat lands which are relatively close to the sea
Preliminary Cost Estimate of Interventions (USD)		\$ 681 063.00

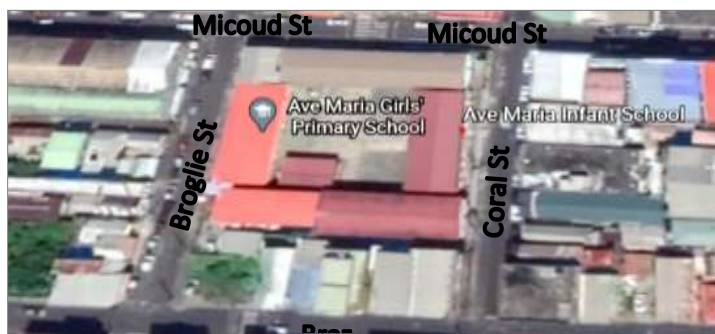
Ave Maria Infant School

Facility Name:	Ave Maria Infant		Risk Category:	RCIV
Type of School:	Infant		Occupancy Group:	Group A: Public Buildings
School Address:	Corner of Coral & Micoud Street, Castries		No. of Occupants:	402
Latitude:	14°00'31.73" N		Year Built:	1901
Longitude:	60°59'19.39" W		Year(s) Renovated:	2001, within last 10 years
Use:	School & Emergency Shelter		Original Design Code:	Unknown
Building Condition Assessment Date:	September 9, 2020		Fire Safety Assessment Dates:	December 29, 2020
				December 29, 2020
School Description:	No. of Buildings:		2	
	Shape of Buildings:		Two rectangular buildings forming L-shape	
	School Layout:		Each building has two floors which house classrooms. The first floor houses a stage, storage room and principal's office. The ground floor houses washrooms, a library, canteen and staff resource and storage rooms.	
	Overall Condition Rating:		Good - 4	
Environmental and Social Factors:	Community Type:		Urban

Adjacent Land Uses:		Commercial, Institutional, Transportation	
	Occupancy Group A and B Buildings within 1 km:		City and Town Halls, Public Libraries, Religious Buildings, Teaching Facilities, Restaurants, Court Houses, Auditoria, Permanent Exhibition Buildings, Passenger Assembly Buildings, Public Health Centres and Clinics	
Climate Vulnerability:	Landslides	No or low susceptibility	The school is situated on flat land and not near the base of a hill	
	Hurricanes	Moderate susceptibility	The school is in a fairly open area and surrounded by buildings which act as wind barriers	
	Flooding	High susceptibility	The school is located in an area which is known to flood from heavy rains	
	Drought	No or low susceptibility	The school is located in an area which faces few water issues	
	Sea-Level Rise	Moderate susceptibility	The school location floods easily and is in relatively close proximity to the sea

Preliminary Cost Estimate of Interventions (USD)			\$ 464,103.00

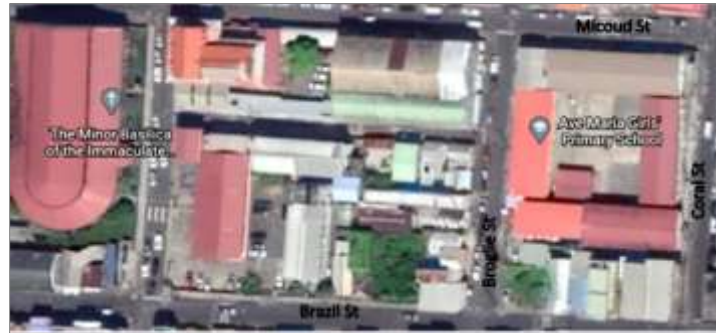
Ave Maria Primary School

Facility Name:	Ave Maria Primary		Risk Category:	RCIV
Type of School:	Primary		Occupancy Group:	Group A: Public Buildings
School Address:	Corner of Broglie & Brazil Street, Castries		No. of Occupants:	529
Latitude:	14°00'31.73" N		Year Built:	1901
Longitude:	60°59'19.39" W		Year(s) Renovated:	Within last 8 years
Use:	School & Emergency Shelter		Original Design Code:	Unknown
Building Condition Assessment Date:	September 9, 2020		Fire Safety	December 8, 2020
			Assessment Dates:	December 8, 2020
School Description:	No. of Buildings:	3		
	Shape of Buildings:	Two rectangular buildings forming an L-shape and a stand-alone rectangular building		
	School Layout:	The L-shaped building has two floors which house classrooms. The ground floor houses a sick bay, office and home economics room. The rectangular building houses a canteen.		
	Overall Condition Rating:	Good - 4		
Environmental and Social Factors:	Community Type:	Urban

Adjacent Land Uses:	Commercial, Institutional, Transportation		
	Occupancy Group A and B Buildings within 1 km:	City and Town Halls, Public Libraries, Religious Buildings, Teaching Facilities, Restaurants, Court Houses, Auditoria, Permanent Exhibition Buildings, Passenger Assembly Buildings, Public Health Centres and Clinics		
Climate Vulnerability:	Landslides	No or low susceptibility	The school is situated on flat land and not near the base of a hill	
	Hurricanes	Moderate susceptibility	The school is in a fairly open area and surrounded by buildings which act as wind barriers	
	Flooding	High susceptibility	The school is located in an area which is known to flood from heavy rains	
	Drought	No or low susceptibility	The school is located in an area which faces few water issues	
	Sea-Level Rise	Moderate susceptibility	The school location floods easily and is in relatively close proximity to the sea

Preliminary Cost Estimate of Interventions (USD)			\$ 326,405.00

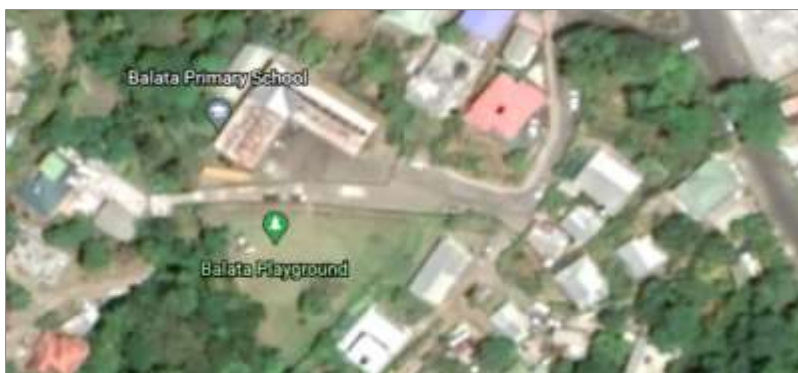
Balata Combined School

Facility Name:	Balata Combined	Risk Category:	RCIV
Type of School:	Primary	Occupancy Group:	Group A: Public Buildings
School Address:	Balata, Castries	No. of Occupants:	274
Latitude:	14°00'45.43" N	Year Built:	1978, 1989, 2003
Longitude:	60°57'13.83" W	Year(s) Renovated:	2019
Use:	School & Emergency Shelter	Original Design Code:	Unknown
Building Condition Assessment Date:	August 27, 2020	Fire Safety Assessment Dates:	December 21, 2020
			December 21, 2020
School Description:	No. of Buildings:	3	
	Shape of Buildings:	L-shaped and rectangular buildings	
	School Layout:	One building has two floors and the other has only one. The two storey building houses classrooms, toilets, a kitchen, staff room and principal's office. The single storey houses a library.	
	Overall Condition Rating:	Poor - 2	
Environmental and Social Factors:	Community Type:	Suburban	
	Adjacent Land Uses:	Residential, Recreation, Transportation, Institutional

Occupancy Group A and B Buildings within 1 km:	Assembly Halls, Restaurants, Religious Buildings	
Climate Vulnerability:	Landslides	Moderate susceptibility	The school is on flat land and a rubble masonry wall is present where there is a slightly higher elevation near the school
	Hurricanes	Low to moderate susceptibility	The school is inland in a fairly open area with trees
	Flooding	Moderate susceptibility	A river is in close proximity to the school
	Drought	Low to moderate susceptibility	The school is located in an area which faces few water issues
	Sea-Level Rise	No or low susceptibility	The school is situated inland and above sea level
Preliminary Cost Estimate of Interventions (USD)		\$ 444,919.00

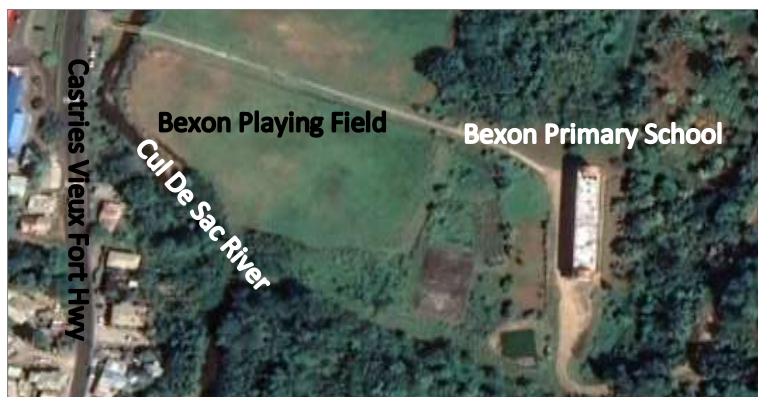
Bexon Primary School

Facility Name:	Bexon Primary		Risk Category:	RCIV
Type of School:	Primary		Occupancy Group:	Group A: Public Buildings
School Address:	Bexon, Castries		No. of Occupants:	152
Latitude:	13°57'08.70" N		Year Built:	1996
Longitude:	60°58'30.92" W		Year(s) Renovated:	After 2007 earthquake
Use:	School		Original Design Code:	Unknown
Building Condition Assessment Date:	September 14, 2020		Fire Safety Assessment Dates:	September 14, 2020
				January 6, 2021
School Description:	No. of Buildings:		1	
	Shape of Buildings:		Rectangular	
	School Layout:		The building has three floors which house classrooms, washrooms, storerooms, panel rooms, a science lab, janitor room, canteen, principal's office and staff room.	
	Overall Condition Rating:		Fair/Average - 3	
Environmental and Social Factors:	Community Type:		Suburban	
	Adjacent Land Uses:		Residential, Agricultural, Recreational, Institutional	
	Occupancy Group A and B Buildings within 1 km:		Restaurants, Religious Buildings, Teaching Facilities

Climate Vulnerability:	Landslides	Moderate susceptibility	The school is situated on flat lands but at the base of a hill located on the east	
	Hurricanes	No or low susceptibility	The school is in a fairly open area which easily floods when there are heavy rains	
	Flooding	High susceptibility	The school is located in a flood plain near very close to a river	
	Drought	No or low susceptibility	The school is located in an area which faces few water issues	
	Sea-Level Rise	No or low susceptibility	The school is located inland and not close to the sea	
Preliminary Cost Estimate of Interventions (USD)			\$ 587,343.00

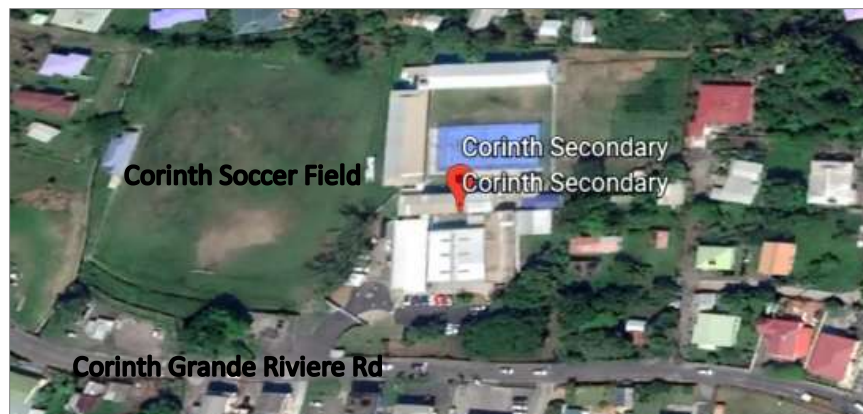
Corinth Secondary School

Facility Name:	Corinth Secondary	Risk Category:	RCIV
Type of School:	Secondary	Occupancy Group:	Group A: Public Buildings
School Address:	Corinth, Gros Islet	No. of Occupants:	765
Latitude:	14°02'46.54" N	Year Built:	1982, 2015-2016
Longitude:	60°57'57.47" W	Year(s) Renovated:	Unknown
Use:	School & Emergency Shelter	Original Design Code:	Unknown
Building Condition Assessment Date:	September 16, 2020	Fire Safety	December 21, 2020
		Assessment Dates:	December 21, 2021
School Description:	No. of Buildings:	8	
	Shape of Buildings:	Rectangular buildings forming a U-shape and L-shape and rectangular buildings	
	School Layout:	All buildings except two, have two floors. All buildings house classrooms except two which house the canteen and one which houses the resource room. Two buildings house special education classrooms. One building houses the general counsel room and another has the staff room. The administrative rooms and two labs are housed in one other building.

Overall Condition Rating:	Good - 4	
Environmental and Social Factors:	Community Type:	Suburban	
	Adjacent Land Uses:	Residential, Recreation, Transportation, Commercial	
	Occupancy Group A and B Buildings within 1 km:	Restaurants, Religious Buildings	
Climate Vulnerability:	Landslides	No or low susceptibility	The school is situated on flat lands and not at the base of a hill
	Hurricanes	Moderate susceptibility	The school is located in an open country area known to have drainage issues
	Flooding	Moderate susceptibility	The school is located in a low-lying area near a river
	Drought	No or low susceptibility	The school is located in an area which faces no water issues
	Sea-Level Rise	No or low susceptibility	The school is located inland in open country and not close to the sea
Preliminary Cost Estimate of Interventions (USD)		\$ 1,175,016.00

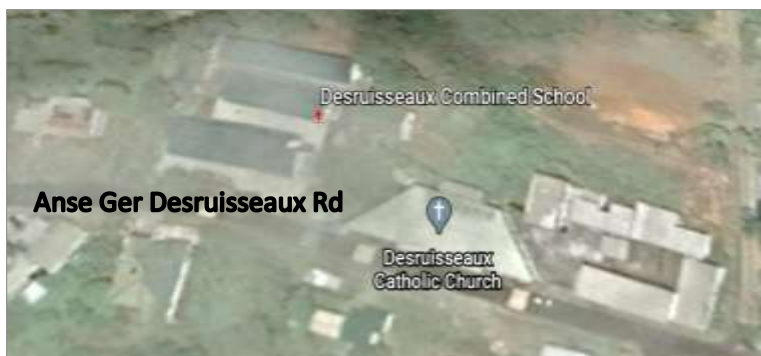
Desruisseaux Combined School

Facility Name:	Desruisseaux Combined		Risk Category:	RCIV
Type of School:	Primary		Occupancy Group:	Group A: Public Buildings
School Address:	Blanchard, Desruisseaux, Micoud		No. of Occupants:	250
Latitude:	13°47'53.56" N		Year Built:	Unknown
Longitude:	60°56'03.39" W		Year(s) Renovated:	2020
Use:	School & Emergency Shelter		Original Design Code:	Unknown
Building Condition Assessment Date:	September 11, 2020		Fire Safety Assessment Date:	November 23, 2020
			Fire Safety Assessment Date:	November 23, 2020
School Description:	No. of Buildings:		6	
	Shape of Buildings:		Rectangular buildings	
	School Layout:		There are 4 single storey buildings and two buildings with two floors. Two of the single storey buildings house only toilets and another house the IT Lab and conference room. The last single storey building houses the principal's office, staff room, kitchen, and home economics room. The two double storey buildings house classrooms one of which has a sick bay, storage room, a library and stage.

Overall Condition Rating:		Poor - 2	
Environmental and Social Factors:	Community Type:		Rural	
	Adjacent Land Uses:		Residential, Agricultural, Recreation, Transportation, Institutional	
	Occupancy Group A and B Buildings within 1 km:		Restaurants, Religious Buildings	
Climate Vulnerability:	Landslides	No or low susceptibility	The land on which the school is situated is gently sloping and there are no nearby observable landslide risks	
	Hurricanes	Moderate to high susceptibility	The school ground is located in a fairly open country environment	
	Flooding	No to low susceptibility	There is no river in close proximity to the school	
	Drought	Low to moderate susceptibility	The school is in an area which experiences water issues	
	Sea-Level Rise	No or low susceptibility	The school is located inland away from the sea and on a hill	
Preliminary Cost Estimate of Interventions (USD)			\$ 1,554,059.00

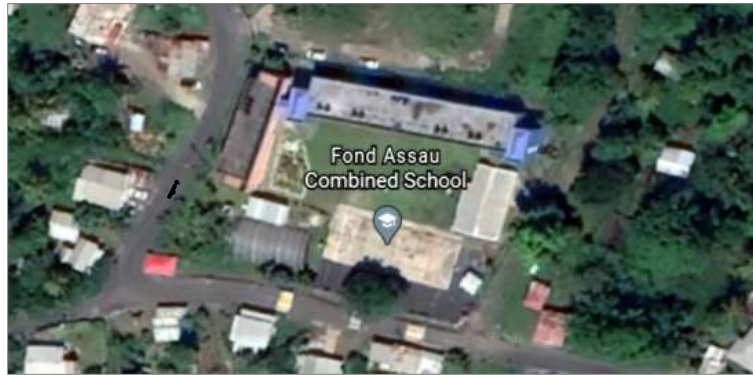
Fond Assau Combined School

Facility Name:	Fond Assau Combined		Risk Category:	RCIV
Type of School:	Primary		Occupancy Group:	Group A: Public Buildings
School Address:	Fond Assau, Babonneau, Castries		No. of Occupants:	142
Latitude:	13°59'47.27" N		Year Built:	2006, 2015
Longitude:	60°56'10.83" W		Year(s) Renovated:	Unknown
Use:	School & Emergency Shelter		Original Design Code:	Unknown
Building Condition Assessment Date:	September 4, 2020		Fire Safety Assessment Dates:	December 21, 2020
				December 21, 2020
School Description:	No. of Buildings:		3	
	Shape of Buildings:		Rectangular	
	School Layout:		Two buildings have three storeys and there is one single storey building. The two three storey buildings house classrooms, toilets, and administrative offices. The single storey building houses a kitchen and a resource/recreational room.	
	Overall Condition Rating:		Good - 4	
Environmental and Social Factors:	Community Type:		Suburban

Adjacent Land Uses:		Residential, Agricultural, Transportation	
	Occupancy Group A and B Buildings within 1 km:		Assembly Halls, Restaurants, Religious Buildings, Teaching Facilities	
Climate Vulnerability:	Landslides	No or low susceptibility	School is situated on gently sloping land with no identifiable landslide risks	
	Hurricanes	Moderate to high susceptibility	School is inland within an agricultural zone in a fairly open area on the upper slopes of a narrow valley	
	Flooding	No or low susceptibility	The school is not in close proximity to a river	
	Drought	Moderate susceptibility	School is situated in an area which has no previous history of being affected by drought	
	Sea-Level Rise	No or low susceptibility	The school is located inland away from the sea	
Preliminary Cost Estimate of Interventions (USD)			\$ 747,069.00

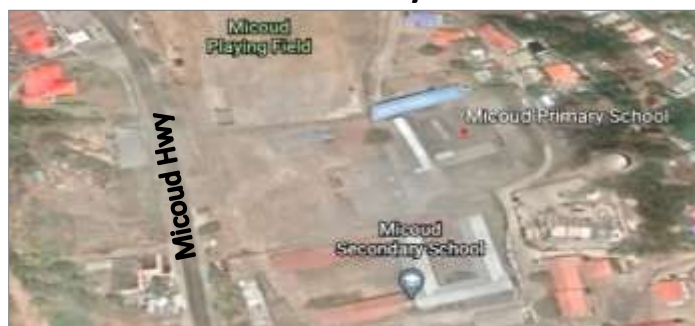
Micoud Primary School

Facility Name:	Micoud Primary	Risk Category:	RCIV
Type of School:	Primary	Occupancy Group:	Group A: Public Buildings
School Address:	Micoud	No. of Occupants:	424
Latitude:	13°49'09.95" N	Year Built:	1975
Longitude:	60°54'00.71" W	Year(s) Renovated:	2018
Use:	School & Emergency Shelter	Original Design Code:	Unknown
Building Condition Assessment Date:	September 9, 2020	Fire Safety Assessment Dates:	November 23, 2020
			November 23, 2020
School Description:	No. of Buildings:	5	
	Shape of Buildings:	Rectangular buildings	
	School Layout:	There are 3 single storey buildings, one with two floors and one with 3 floors. One building serves as the administration building. Another building houses toilets and a canteen. Two buildings house only classrooms one of which has toilets. The other building has special education rooms and classrooms.	
	Overall Condition Rating:	Fair/Average - 3	
Environmental and Social Factors:	Community Type:	Urban

Adjacent Land Uses:	Residential, Recreation, Transportation, Commercial, Institutional	
	Occupancy Group A and B Buildings within 1 km:	Dance Halls, Restaurants, Religious Buildings, Teaching Facilities, Public Health Centres and Clinics	
Climate Vulnerability:	Landslides	Moderate susceptibility	The land on which the school is situated is gently sloping and there are no nearby observable landslide risks.
	Hurricanes	Moderate to high susceptibility	The school ground is in a relatively open area above the low elevation in the vicinity.
	Flooding	No or low susceptibility	There is no river in close proximity to the school
	Drought	Low to moderate susceptibility	The school is in an area which experiences major water issues.
	Sea-Level Rise	No to low susceptibility	The school is located inland away from the sea and on a hill
Preliminary Cost Estimate of Interventions (USD)		\$ 743,868.00

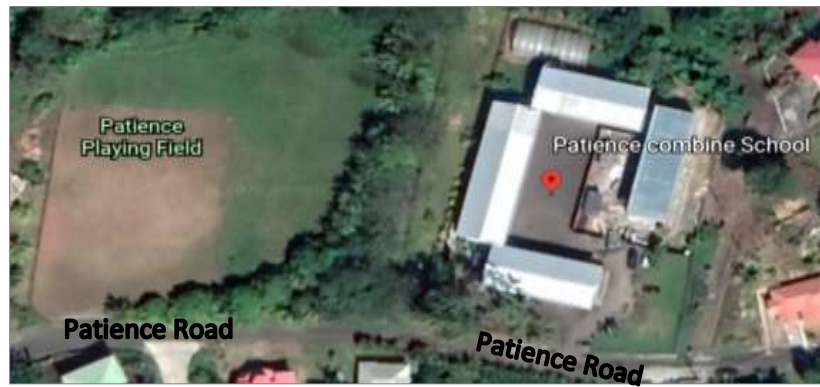
Patience Combined School

Facility Name:	Patience Combined		Risk Category:	RCIV
Type of School:	Primary		Occupancy Group:	Group A: Public Buildings
School Address:	Patience, Micoud		No. of Occupants:	289
Latitude:	13°51'03.64" N		Year Built:	1990, 2020
Longitude:	60°54'27.74" W		Year(s) Renovated:	2019
Use:	School & Emergency Shelter		Original Design Code:	Unknown
Building Condition Assessment Date:	September 9, 2020		Fire Safety Assessment Date:	November 23, 2020
				November 23, 2020
School Description:	No. of Buildings:		4	
	Shape of Buildings:		Rectangular buildings joined to make a U-shape	
	School Layout:		All buildings have two floors and house classrooms. One building houses the principal's office, home economics, staff and sick rooms. Another houses the IT lab and toilets.	
	Overall Condition Rating:		Good - 4	
Environmental and Social Factors:	Community Type:		Rural	
	Adjacent Land Uses:		Residential, Recreational, Transportation, Agricultural

Occupancy group A and B Buildings within 1 km:		Restaurants	
Climate Vulnerability:	Landslides	Moderate susceptibility	The school is situated on the edge of a hill which was benched for school placement	
	Hurricanes	Moderate to high susceptibility	The school is located inland near trees which act as wind barriers but may pose as a hazard	
	Flooding	No or low susceptibility	School is not in close proximity to a river	
	Drought	Moderate susceptibility	The school is in an area which experiences few water issues	
	Sea-Level Rise	No or low susceptibility	The school is located inland away from the sea	
Preliminary Cost Estimate of Interventions (USD)			\$ 682,370.00

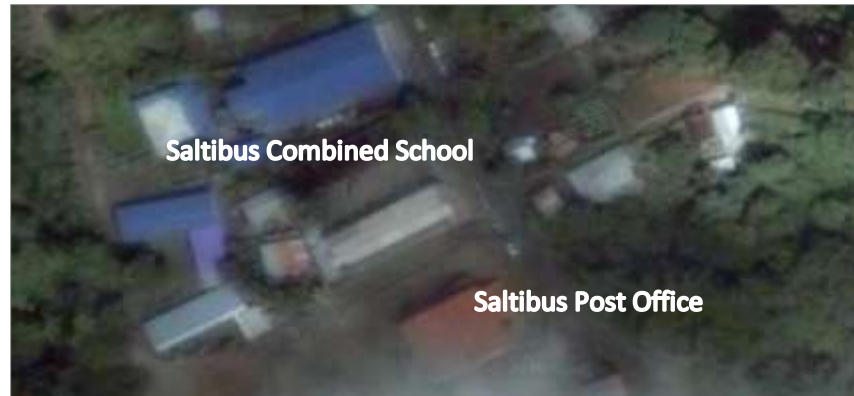
Saltibus Combined School

Facility Name:	Saltibus Combined		Risk Category:	RCIV
Type of School:	Primary		Occupancy Group:	Group A: Public Buildings
School Address:	Saltibus, Choiseul		No. of Occupants:	126
Latitude:	61°00'47.44" N		Year Built:	Unknown
Longitude:	13°48'16.68" W		Year(s) Renovated:	Unknown
Use:	School & Emergency Shelter		Original Design Code:	Unknown
Building Condition Assessment Date:	September 14, 2020		Fire Safety Assessment Dates:	November 25, 2020
				November 25, 2020
School Description:	No. of Buildings:		5	
	Shape of Buildings:		Two rectangular buildings joined to form an L-shape and rectangular	
	School Layout:		There are four single storey buildings and one two storey building. Two of the single storey buildings house the infant school which have classrooms, a music room and a janitor's room. Another single storey building houses toilets and the last one houses a classroom, library, principal's office and IT lab. The two storey buildings houses classrooms, a stage, storage room, kitchen, canteen and sick room.

Overall Condition Rating:		Good - 4	
Environmental and Social Factors:	Community Type:		Rural	
	Adjacent Land Use:		Residential, Agricultural, Recreation, Transportation, Institutional	
	Occupancy Group A and B Buildings within 1 km:		Community Centre, Religious Buildings	
Climate Vulnerability:	Landslides	High susceptibility	The school is situated on relatively flat lands	
	Hurricanes	Moderate to high susceptibility	The place where the school is situated on high land in a fairly open area susceptible to heavy rainfall	
	Flooding	No or low susceptibility	The school is not located in close proximity to a river	
	Drought	Moderate to high susceptibility	The school is located in an area which faces water issues	
	Sea-Level Rise	No or low susceptibility	The school is inland at a much higher elevation than the sea	
Preliminary Cost Estimate of Interventions (USD)			\$ 594,476.00

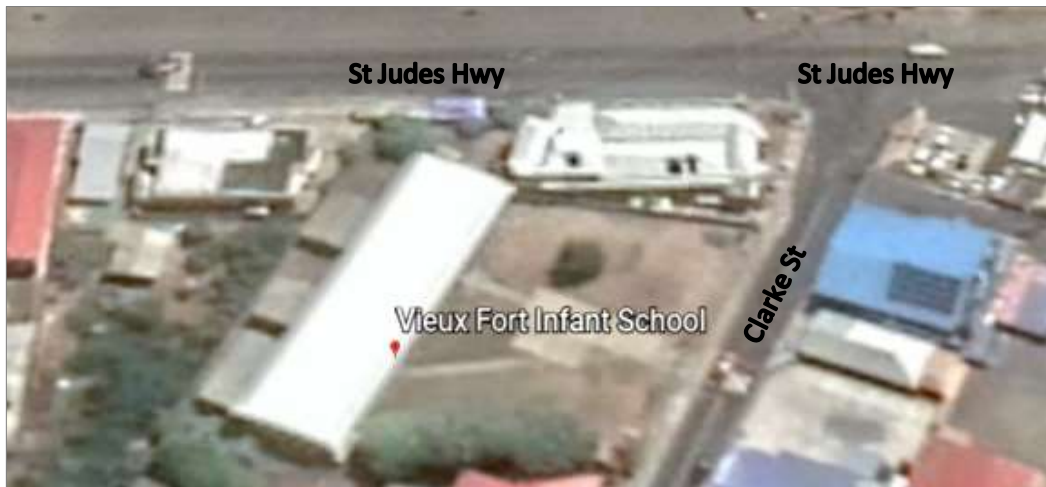
Vieux Fort Infant School

Facility Name:	Vieux Fort Infant		Risk Category:	RCIII
Type of School:	Infant		Occupancy Group:	Group A: Public Buildings
School Address:	Clarke Street, Vieux Fort		No. of Occupants:	197
Latitude:	60°57'09.69" N		Year Built:	Unknown
Longitude:	13°43'52.06" W		Year(s) Renovated:	2015, 2020
Use:	School		Original Design Code:	Unknown
Building Condition Assessment Date:	September 4, 2020		Fire Safety Assessment Dates:	November 25, 2020
				November 25, 2020
School Description:	No. of Buildings:	4		
	Shape of Buildings:	Rectangular		
	School Layout:	There are three single storey buildings and one two-storey building. One single storey building houses a classroom, another houses a kitchen and one is currently used for storage. The other building houses classrooms, toilets, a sick bay, library, computer lab, staff room, stage and principal's office.		
	Overall Condition Rating:	Good - 4		
Environmental and Social Factors:	Community Type:	Urban

Adjacent Land Uses:	Transportation, Commercial, Institutional		
	Occupancy Group A and B Buildings within 1 km:	Restaurants, Religious Buildings, Teaching Facilities		
Climate Vulnerability:	Landslides	No or low susceptibility	The school is situated on low lying lands, far from elevated lands	
	Hurricanes	Moderate to high	The school is situated in a fairly open area and exposed to easterly winds	
	Flooding	Moderate to high susceptibility	The school is south of the Airport and a distance from the old alignment of the Vieux Fort River	
	Drought	No or low susceptibility	Did not report drought to be a concern	
	Sea-Level Rise	No or low susceptibility	The school is built on flat lands which are relatively close to the sea	
Preliminary Cost Estimate of Interventions (USD)			\$ 681,063.00

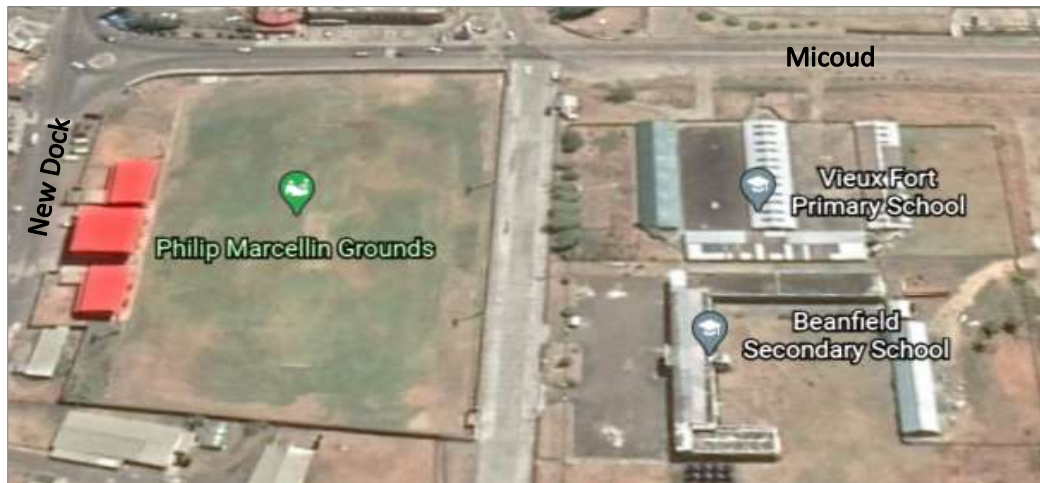
Vieux Fort Primary School

Facility Name:	Vieux Fort Primary	Risk Category:	RCIV
Type of School:	Primary	Occupancy Group:	Group A: Public Buildings
School Address:	Beanfield, Vieux Fort	No. of Occupants:	226
Latitude:	60°56'58.77" N	Year Built:	Between 1984 - 1985
Longitude:	13°43'45.47" W	Year(s) Renovated:	2019, 2018, 2016, 2015, 2008
Use:	School & Emergency Shelter (Blocks A, D, C)	Original Design Code:	Unknown
Building Condition Assessment Date:	September 4, 2020	Fire Safety Assessment Dates:	November 25, 2020 November 25, 2020
School Description:	No. of Buildings:	4	
	Shape of Buildings:	Rectangular	
	School Layout:	Two buildings house only classrooms, one building houses special education rooms, toilets and electrical room and another building houses the assembly hall and administrative offices.	
	Overall Condition Rating:	Poor - 2	
Environmental and Social Factors:	Community Type:	Urban	
	Adjacent Land Uses:	Recreation, Transportation, Commercial, Institutional

Occupancy Group A and B Buildings within 1 km:	Passenger Assembly Buildings, Restaurants, Religious Buildings, Teaching Facilities	
Climate Vulnerability:	Landslides	No or low susceptibility	The school is situated on flat lands and not near the base of a hill
	Hurricanes	Moderate to high susceptibility	The school is on flat land with few surrounding wind barriers
	Flooding	High susceptibility	The school is located in close proximity to a river
	Drought	Moderate susceptibility	The school is located in an area which faces water issues
	Sea-Level Rise	High susceptibility	The school is built on flat lands in close proximity to the sea
Preliminary Cost Estimate of Interventions (USD)		\$ 1,173,189.00
