Detailed Work Packages and Standard Structural Repair and Retrofit Drawings

Technical Assistance for Resilience to Climate Variability in the Building Sector of Antigua and Barbuda

Project No: 18106

Detailed Work Packages Consisting, Site Plans, Standard Retrofit Drawings and Engineering Cost Estimates for 34 Buildings

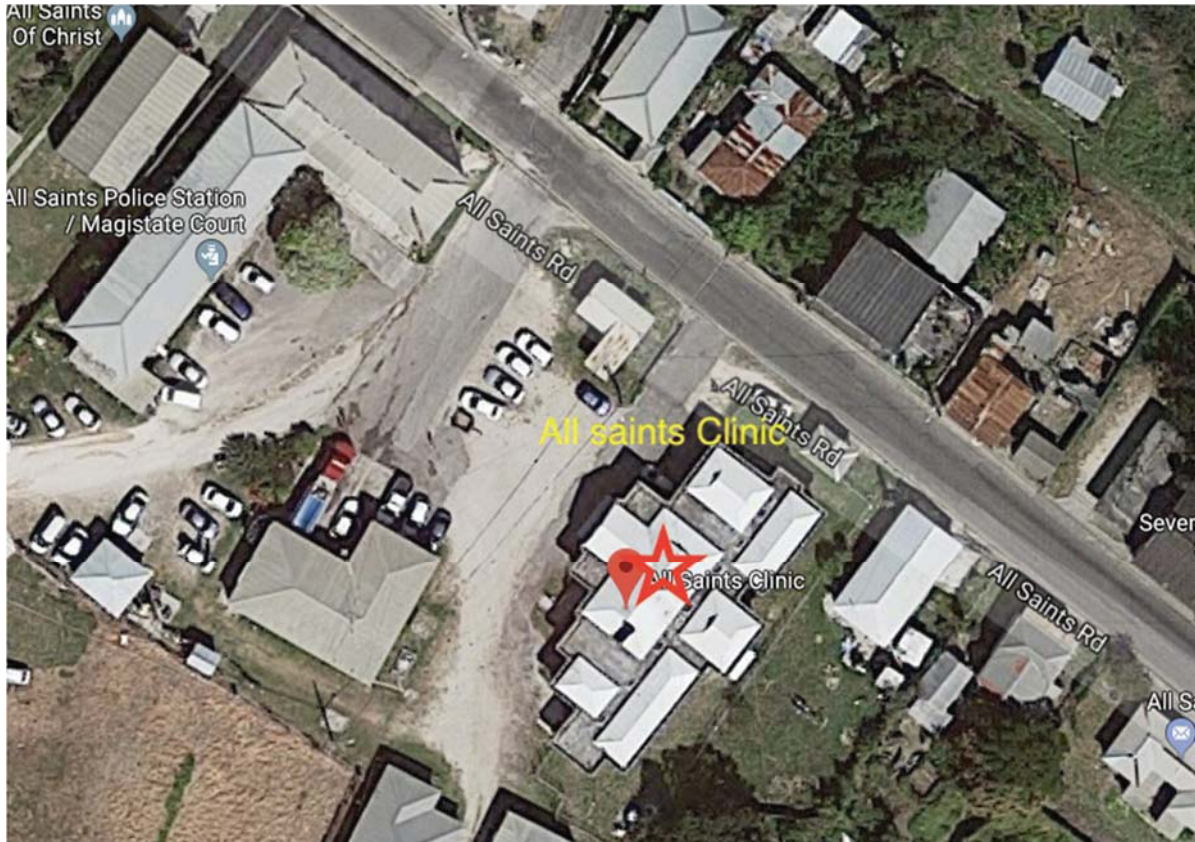
Facility Name:	All Saints Clinic	Year built:	
Building Name:	All Saints Clinic	Year(s) remodeled:	
Building Address:	All Saints	Original Design Code:	O ECS Building Code
Latitude:	17.0643909	Area (m2):	446
Longitude:	61.795558	Length (m):	35
Use:	Medical	Width (m):	20
Risk Category:	II	No. of storeys:	1
Occupancy Group:	Group A	Storey height (m):	10
No. of occupants:	30	Total height (m):	13
Roof shape:	Hip	Walls	Concrete Blocks
Roofing:	Metal Sheetting	Structural system	Concrete Frame
Overall Condition	Average		
Comments	Inspection suggested that the building is in good condition. The main issue appears to be the parking area which is minimal, shared with other buildings and is unpaved

Task No.	Interventions/Improvements	Unit	Quantity	Unit Rate (USD)	Total (USD)
ASC-01	Condition of construction materials - repair as detailed in drawings Repair small cracks with a high strength epoxy grout	sum	1	2,500	2,500
ASC-02	Structural Integrity of Roofs Retrofit roof with collars at top third of roof height Strengthening overhangs at gable end walls	lm m ²	300 32	16 31	4,800 978
ASC-03	Exterior Doors, Exits and Entrances Protecting existing door with an impact-resistant covering Install threshold to prevent ingress of water Fasten door frames into concrete surrounds with bolts or screws	nr nr nr	6 6 6	1,000 100 30	6,000 600 180
ASC-04	Windows and shutters Replace existing windows with standard operable or fixed windows and install shutters with Miami Dade NOA	m ²	10	1,270	12,700
ASC-05	Other Elements of the Building Envelope Repair cracks > 6 mm using a welded mesh	sum	1	3,500	3,500
ASC-06	Safety of roofing Inspect roof and then Install hurricane straps at the eaves/ring beams and ridge to rafter connections Fixing roof sheathing with minimum 75 mm screws into rafters and ridges Decreasing spacing of fasteners, particularly at eaves, hips, ridge & edges of gable roofs	nr nr nr	210 600 420	5 1 1	1,050 600 420

ASC-07	Parapets and other outside Elements (railings, ornaments) Repair cracks > 6 mm using a welded mesh	sum	1	2,500	2,500
ASC-08	Internal walls - concrete masonry units finishd with mortar plastering Reconstruct wall where cracks are greater than 6 mm Repair small cracks with epoxy grout Replace entire wall with new ring beam	sum sum m2	1 1 60	2,500 1,500 202	2,500 1,500 12,120
ASC-09	False or Suspended Ceilings Replace and retrofit up to 50% of ceiling	m ²	223	40	8,920
ASC-10	Condition and safety of floor coverings Allow for repairs to defective areas of the floor finish - allow for 10% of floor area	m ²	45	88	3,960
ASC-11	Water Reserves Install potable water storage tanks to accommodate a 5-day supply	Litres	6,750	0.75	5,063
ASC-12	Alternate water supply to regular water supply Install rainwater tanks with capacity equivalent to 30% of building consumption - include potable water backup connection Re-plumbing of building to facilitate dual water use - potable and non-potable Installation of pump or upgrade of existing	Litres sum nr	2,025 1 1	0.75 7,500 2,500	1,519 7,500 2,500

ASC-13	Water Distribution System Supply and install 80 Gall solar water heaters on roof Source, repair chronic pipe leaks and retrofit plumbing Install low volume water fixtures	nr sum nr	1 1 6	2,500 2,500 800	2,500 2,500 4,800
	To Collection				91,209

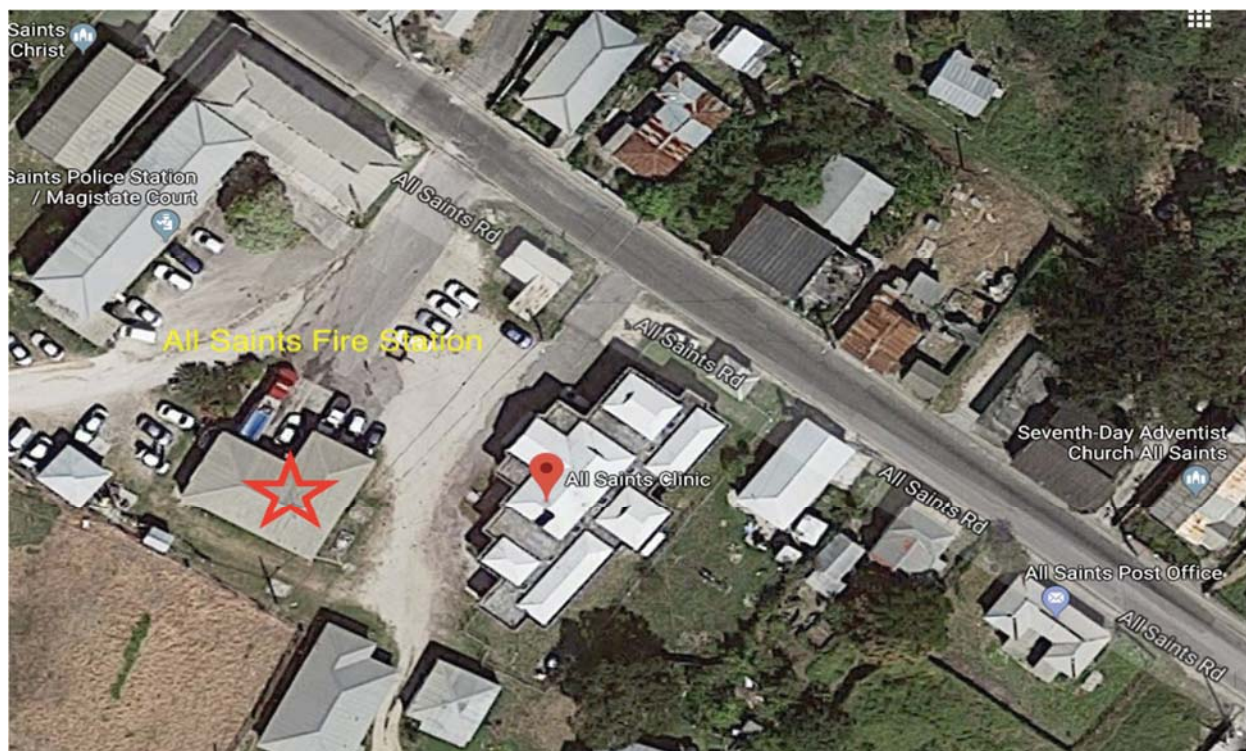
Facility Name:	All Saints Fire Station	Year built:	
Building Name:	All Saints Fire Station	Year(s) remodeled:	
Building Address:	All Saints	Original Design Code:	OECS Building Code
Latitude:	17.0643993	Area (m2):	200
Longitude:	61.7963752	Length (m):	10
Use:	Military	Width (m):	20
Risk Category:	III	No. of storeys:	1
Occupancy Group:	Group A	Storey height (m):	3
No. of occupants:	15	Total height (m):	5
Roof shape:	Hip	Walls	Concrete Blocks
Roofing:	Metal sheeting	Structural system	Concrete Frame
Overall Condition	Average		
Comments	Although rated in average condition, works on this building are absolutely necessary as the overall score was only 56%

Task No.	Interventions/Improvements	Unit	Quantity	Unit Rate (USD)	Total (USD)
ASFS-01	Condition of the building - as per Engineer's drawings and specifications				
	Reconstruct slab on grade by cutting out damaged section and replacing with engineered section	m ²	30	135	4,050
	Increase capacity of columns	nr	5	300	1,500
	Increase capacity of beams	lm	15	300	4,500
	Increasing flexural and shear strength by adding reinforcing bars and stirrups	sum	1	2,500	2,500
	Repair beams spalling and honeycombing as detailed	lm	6	150	900
ASFS-02	Condition of construction materials - repair as detailed in drawings				
	Repair small cracks with a high strength epoxy grout	sum	1	2,500	2,500
	Repair cracks > 6 mm using a welded mesh and non-shrink grout	sum	1	5,000	5,000
ASFS-03	Structural Redundancy - as per typical detail and specifications				
	Introduce new columns so as to improve redundancy of structure - location and design to be provided by Engineer	lm	20	495	9,900

ASFS-04	Safety of Foundations - as per Engineer's details and specifications				
	Reconstruct of severely damaged foundation walls, strip and spread footings	m ²	10	116	1,160
	Underpin subsided foundations				
	Improve the drainage of the area to prevent saturation of foundation soil - alignment identified on site and drainage plans	sum	1	1,000	1,000
	Introducing new load bearing members to the foundations to relieve the already overloaded members.	m ²	10	232	2,320
ASFS-05	Structural Integrity of Roofs				
	Retrofit roof with collars at top third of roof height	lm	300	16	4,800
	Strengthening overhangs at gable end walls	m ²	37	31	1,131
ASFS-06	Exterior Doors, Exits and Entrances				
	Protecting existing door with an impact-resistant covering	nr	4	1,000	4,000
	Fasten door frames into concrete surrounds with bolts or screws	nr	4	60	240
	Install threshold to prevent ingress of water	nr	4	100	400
ASFS-07	Windows and shutters

Replace existing windows with standard operable or fixed windows and install shutters with Miami Dade NOA	m ²	13	1,270	16,510
ASFS-08	Other Elements of the Building Envelope				
	Repair cracks > 6 mm using a welded mesh	sum	1	1,500	1,500
	Replace entire existing masonry wall with the inclusion of a ring beam	m ²	50	202	10,100
ASFS-09	Safety of roofing				
	Inspect roof and then Install hurricane straps at the eaves/ring beams and ridge to rafter connections	nr	210	5	1,050
	Fixing roof sheathing with minimum 75 mm screws into rafters and ridges	nr	600	1	600
	Decreasing spacing of fasteners, particularly at eaves, hips, ridge & edges of gable roofs	nr	420	1	420
ASFS-10	Parapets and other outside Elements (railings, ornaments)				
	Repair cracks > 6 mm using a welded mesh	sum	1	2,500	2,500
	Reconstruct wall where cracks are greater than 6 mm	m ²	50	202	10,100
	To Collection				88,681

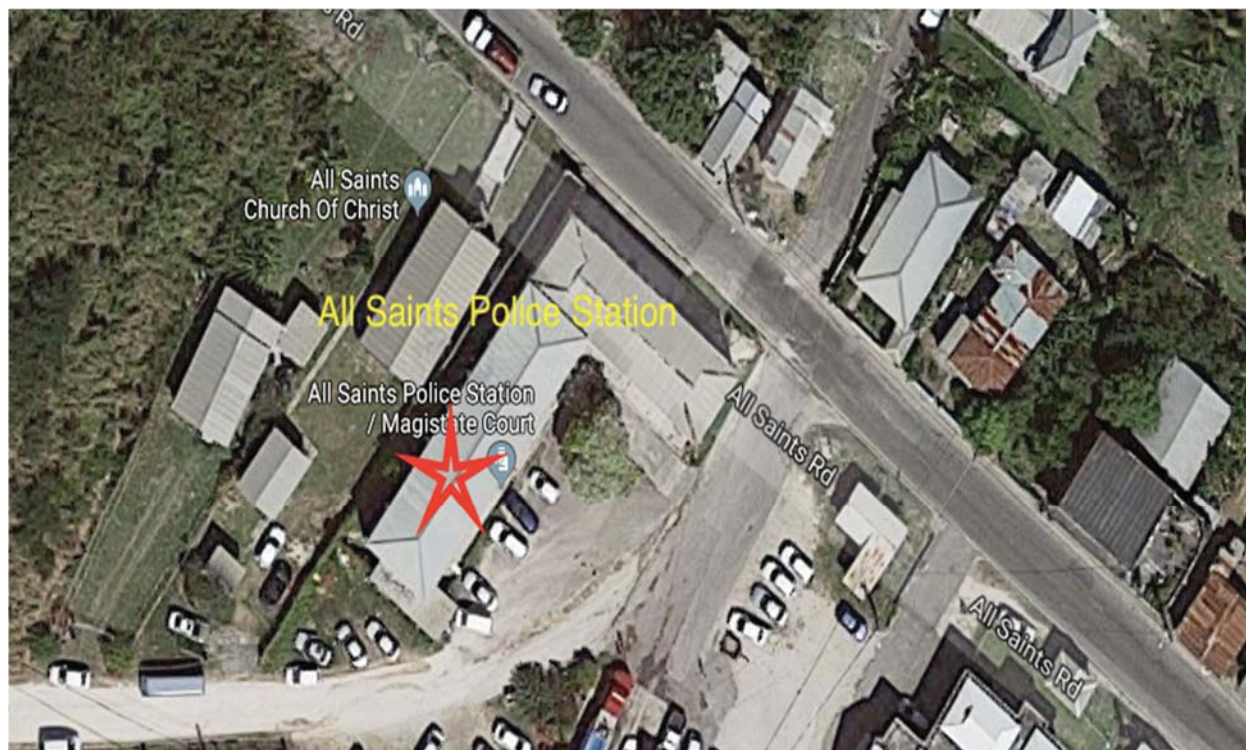
Facility Name:	All Saints Police Station	Year built:	
Building Name:	All Saints Police Station/ Magistrate's Court	Year(s) remodeled:	
Building Address:	All Saints	Original Design Code:	OECS Building Code
Latitude:	17.0644635	Area (m2):	760
Longitude:	61.7957966	Length (m):	15
Use:	Military	Width (m):	39
Risk Category:	IV	No. of storeys:	2
Occupancy Group:	Group A	Storey height (m):	10
No. of occupants:	25	Total height (m):	13
Roof shape:	Hip and Valley	Walls	Concrete Blocks
Roofing:	Metal Sheetting	Structural system	Concrete Frame
Overall Condition	Low		
Comments	Although the police station occupies part of one building with the Magistrate's Court, both sections are included. The section of the Police Station which is in a southwest alignment is in a very poor condition

Task No.	Interventions/Improvements	Unit	Quantity	Unit Rate (USD)	Total (USD)
ASPS-01	Condition of the building - as per Engineer's drawings and specifications				
	Reconstruct slab on grade by cutting out damaged section and replacing with engineered section	m ²	114	135	15,390
	Increase capacity of columns	nr	5	300	1,500
	Increase capacity of beams	lm	15	300	4,500
	Increasing flexural and shear strength by adding reinforcing bars and stirrups	sum	1	2,500	2,500
	Repair beams spalling and honeycombing as detailed	lm	6	150	900
ASPS-02	Condition of construction materials - repair as detailed in drawings				
	Repair small cracks with a high strength epoxy grout	sum	1	2,500	2,500
	Repair cracks > 6 mm using a welded mesh	sum	1	5,000	5,000
ASPS-03	Structural Redundancy - as per typical detail and specifications				
	Introduce new columns so as to improve redundancy of structure - location and design to be provided by Engineer	lm	20	495	9,900

ASPS-04	Safety of Foundations - as per Engineer's details and specifications				
	Reconstruction of severely damaged foundation walls, strip and spread footings	m ²	10	116	1,160
	Improving the drainage of the area to prevent saturation of foundation soil	sum	1	1,000	1,000
	Introducing new load bearing members to the foundations to relieve the already overloaded members.	m ²	10	232	2,320
ASPS-05	Structural Integrity of Roofs				
	Retrofit roof with collars at top third of roof height	lm	300	16	4,800
	Strengthening overhangs at gable end walls	m ²	37	31	1,131
ASPS-06	Exterior Doors, Exits and Entrances				
	Protecting existing door with an impact-resistant covering	nr	4	1,000	4,000
	Fasten door frames into concrete surrounds with bolts or screws	nr	4	60	240
	Install threshold to prevent ingress of water	nr	4	100	400
ASPS-07	Windows and shutters				
	Replace existing windows with standard operable or fixed windows and install shutters with Miami Dade NOA	m ²	80	1,270	101,600

ASPS-08	Other Elements of the Building Envelope				
	Repair cracks > 6 mm using a welded mesh	sum	1	1,500	1,500
	Replace entire existing masonry wall with the inclusion of a ring beam	m ²	50	202	10,100
ASPS-09	Safety of roofing				
	Inspect roof and then Install hurricane straps at the eaves/ring beams and ridge to rafter connections	nr	210	5	1,050
	Fixing roof sheathing with minimum 75 mm screws into rafters and ridges	nr	600	1	600
	Decreasing spacing of fasteners, particularly at eaves, hips, ridge & edges of gable roofs	nr	420	1	420
ASPS-10	Parapets and other outside Elements (railings, ornaments)				
	Repair cracks > 6 mm using a welded mesh	sum	1	2,500	2,500
	Reconstruct wall where cracks are greater than 6 mm	m ²	50	202	10,100
ASPS-11	Internal walls - concrete masonry units finishd with mortar plastering				
	Reconstruct wall where cracks are greater than 6 mm	sum	1	2,500	2,500
	Repair small cracks with epoxy grout	sum	1	1,500	1,500

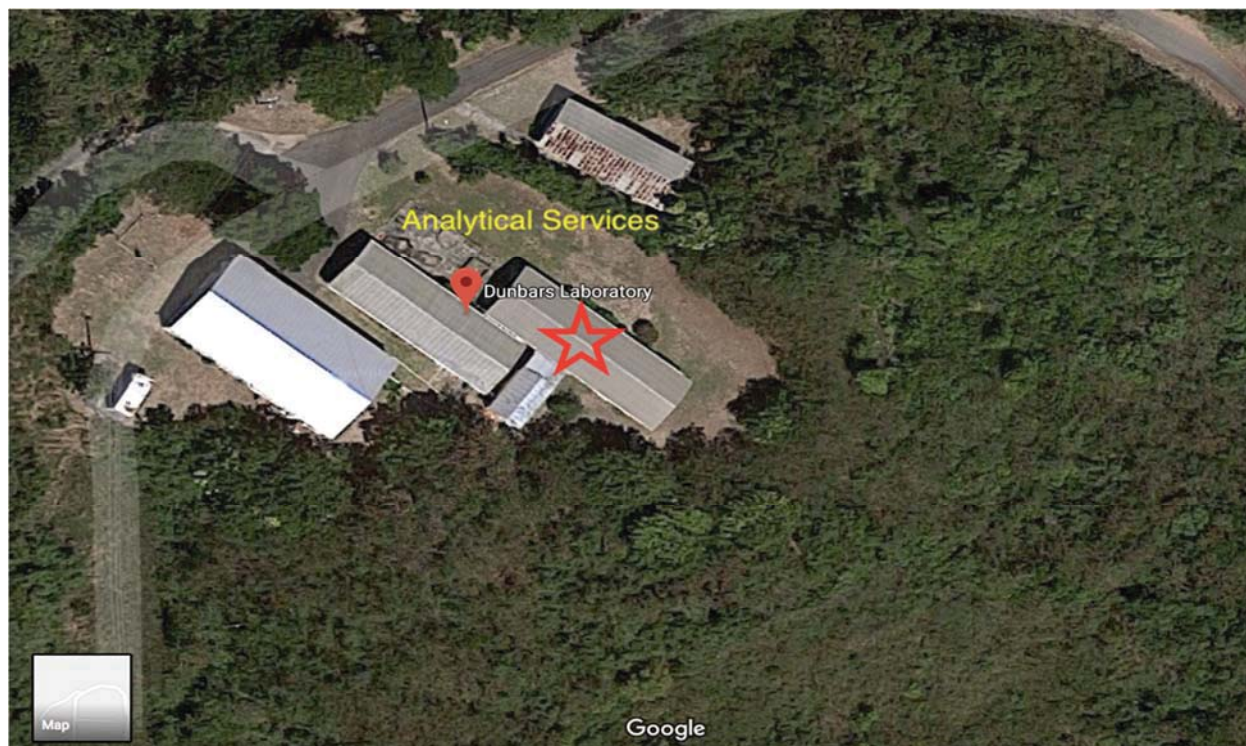
Facility Name:	Analytical Services 1	Year built:	
Building Name:	Agro Processing Building	Year(s) remodeled:	
Building Address:	Friar's Hill Road	Original Design Code:	
Latitude:	17.1486338	Area (m2):	320
Longitude:	61.8315398	Length (m):	10
Use:	Medical	Width (m):	8
Risk Category:	II	No. of storeys:	2
Occupancy Group:	Group A	Storey height (m):	10
No. of occupants:	12	Total height (m):	13
Roof shape:	Gable	Walls	Concrete Blocks
Roofing:	Metal Sheeting	Structural system	Concrete Frame
Overall Condition	Average		
Comments	This building is considered only marginally average with a score of 53%

Task No.	Interventions/Improvements	Unit	Quantity	Unit Rate (USD)	Total (USD)
AS-01	Structural Integrity of Roofs Replace entire roof with trusses and roof angle of 25 degrees	m ²	320	200	64,000
AS-02	Exterior Doors, Exits and Entrances Protecting existing door with an impact-resistant covering Install threshold to prevent ingress of water Install one impact resistant door with minimum opening of 2.0 metres	nr nr nr	2 2 1	1,000 100 2,500	2,000 200 2,500
AS-03	Windows and shutters Replace existing windows with standard operable or fixed windows and install shutters with Miami Dade NOA	m ²	11	1,270	13,970
AS-04	Other Elements of the Building Envelope Repair cracks > 6 mm using a welded mesh Replace entire wall with new ring beam	sum m ²	1 50	1,500 202	1,500 10,100
AS-05	Internal walls - concrete masonry units finishd with mortar plastering Reconstruct wall where cracks are greater than 6 mm Repair small cracks with epoxy grout Replace entire existing masonry wall with the inclusion of a ring beam	sum sum m ²	1 1 60	2,500 1,500 202	2,500 1,500 12,120

AS-06	False or Suspended Ceilings Replace and retrofit entire ceiling	m ²	320	80	25,600
AS-07	Safety of stairways and Ramps Repair and retrofit up to 50% of the staircase	flights	1	5,000	5,000
AS-08	Condition and safety of floor coverings Allow for repairs to defective areas of the floor finish - allow for 20% of floor area	m ²	64	88	5,632
AS-09	Water Reserves Install potable water storage tanks to accommodate a 5-day supply - allowance for 12 occupants plus 4,500 litres for operations of the laboratory	Litres	9,900	0.75	7,425
AS-10	Alternate water supply to regular water supply Install rainwater tanks with capacity equivalent to 30% of building consumption - include potable water backup connection Re-plumbing of building to facilitate dual water use - potable and non-potable Installation of pump or upgrade of existing	Litres sum nr	2,970 1 1	0.75 7,500 2,500	2,228 7,500 2,500
AS-11	Water Distribution System Supply and install 80 Gall solar water heaters on roof Source, repair chronic pipe leaks and retrofit plumbing Install low volume water fixtures	nr sum nr	1 1 4	2,500 2,500 800	2,500 2,500 3,200

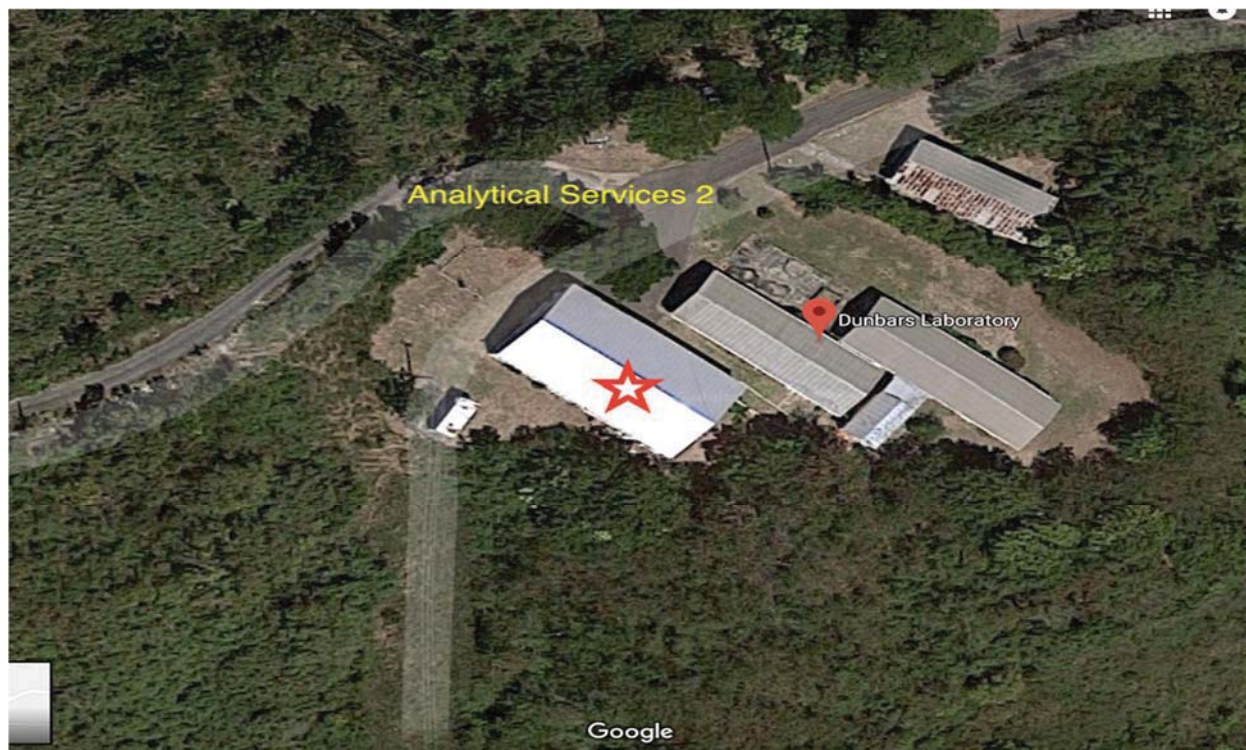
Facility Name:	Analytical Services 2	Year built:	
Building Name:	Laboratory Building	Year(s) remodeled:	
Building Address:	Friar's Hill Road	Original Design Code:	
Latitude:	17.1486337	Area (m2):	680
Longitude:	61.8315422	Length (m):	25
Use:	Medical	Width (m):	12
Risk Category:	II	No. of storeys:	2
Occupancy Group:	Group A	Storey height (m):	10
No. of occupants:	12	Total height (m):	13
Roof shape:	Gable	Walls	Concrete Blocks
Roofing:	Metal Sheetting	Structural system	Concrete Frame
Overall Condition	Average		
Comments	This building is considered only marginally average with a score of 53%

Task No.	Interventions/Improvements	Unit	Quantity	Unit Rate (USD)	Total (USD)
AS2-01	Condition of construction materials - repair as detailed in drawings Repair small cracks with a high strength epoxy grout	sum	1	2,500	2,500
AS2-02	Structural Integrity of Roofs Replace entire roof with trusses and roof angle of 25 degrees	m ²	680	200	136,000
AS2-03	Exterior Doors, Exits and Entrances Protecting existing doors with an impact-resistant covering Install threshold to prevent ingress of water	nr nr	2 2	1,000 100	2,000 200
AS2-04	Windows and shutters Replace existing windows with standard operable or fixed windows and install shutters with Miami Dade NOA	m ²	20	1,270	25,400
AS2-05	Other Elements of the Building Envelope Repair cracks > 6 mm using a welded mesh	sum	1	1,500	1,500
AS2-06	Parapets and other outside Elements (railings, ornaments) Repair small cracks with epoxy grout	sum	1	1,500	1,500
AS2-07	Internal walls - concrete masonry units finishd with mortar plastering Reconstruct wall where cracks are greater than 6 mm Repair small cracks with epoxy grout Replace entire wall with new ring beam	sum sum m ²	1 1 60	2,500 1,500 202	2,500 1,500 12,120

AS2-08	False or Suspended Ceilings Replace and retrofit entire ceiling	m ²	680	80	54,400
AS2-09	Safety of stairways and Ramps Reconstruct up to 50% of the staircase	flights	2	2,500	5,000
AS2-10	Condition and safety of floor coverings Allow for repairs to defective areas of the floor finish - allow for 20% of floor area	m ²	136	88	11,968
AS2-11	Water Reserves Install potable water storage tanks to accommodate a 5-day supply - allowance for 50 occupants	Litres	5,400	1	4,050
AS2-12	Alternate water supply to regular water supply Install rainwater tanks with capacity equivalent to 30% of building consumption - include potable water backup connection Re-plumbing of building to facilitate dual water use - potable and non-potable Installation of pump or upgrade of existing	Litres sum nr	1,620 1 1	1 7,500 2,500	1,215 7,500 2,500
AS2-13	Wastewater System Empty and improve site septic units and filtration systems	sum	1	2,500	2,500

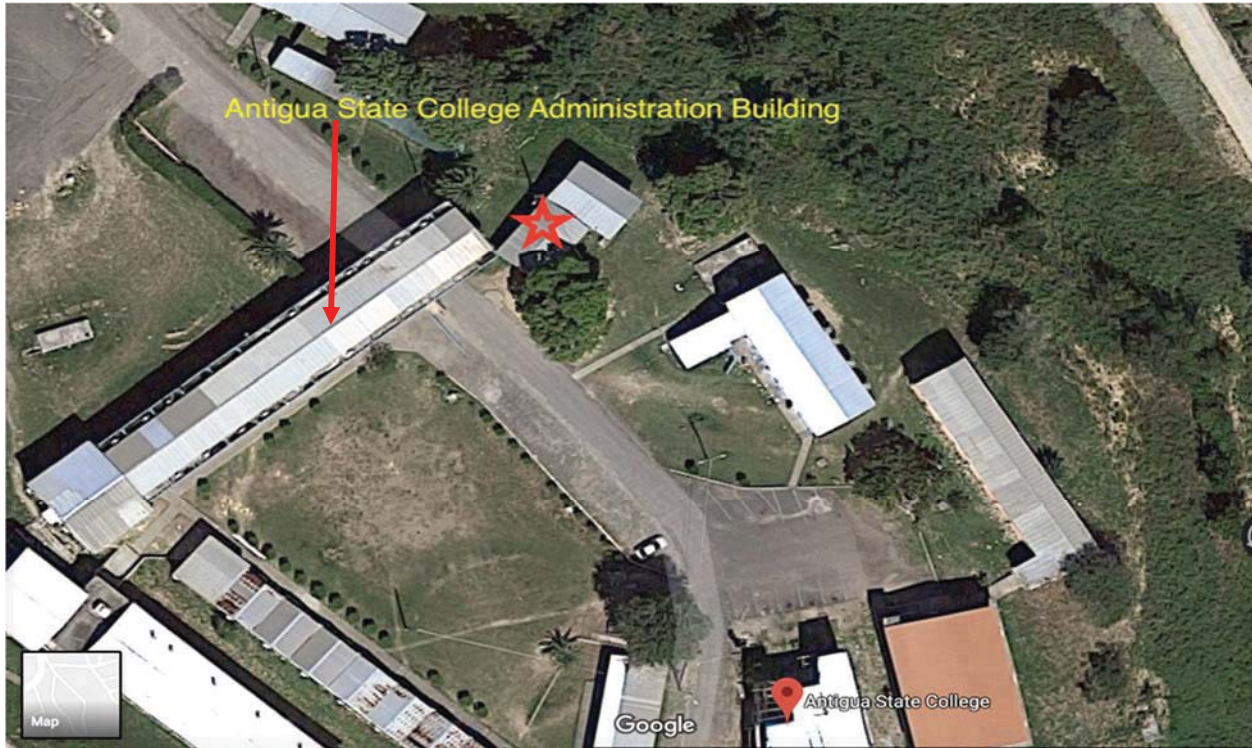
Facility Name:	Antigua State College 1	Year built:	
Building Name:	Administration Building	Year(s) remodeled:	
Building Address:	Valley Road	Original Design Code:	
Latitude:	17.10019	Area (m2):	660
Longitude:	61.83966	Length (m):	66
Use:	Educational	Width (m):	10
Risk Category:	III	No. of storeys:	2
Occupancy Group:	Group A	Storey height (m):	4
No. of occupants:	500	Total height (m):	8
Roof shape:	Gable	Walls	Wooden
Roofing:	Metal Sheeting	Structural system	Wooden Frame on concrete column
Overall Condition	Average		
Comments	Marginally average with a score of 58%. Condition suggest that works are required in the immediate to short term

Task No.	Interventions/Improvements	Unit	Quantity	Unit Rate (USD)	Total (USD)
ASC1-01	Condition of the building - as per Engineer's drawings and specifications				
	Introduce new columns so as to improve redundancy of structure	lm	20	495	9,900
	Stiffening of an existing floor and tying it into the walls	sum	1	5,000	5,000
	Increase capacity of columns	nr	10	300	3,000
	Increase capacity of beams	lm	20	300	6,000
	Introduce new collector beams to improve capacity of floor	lm	20	495	9,900
	Increasing flexural and shear strength by adding reinforcing bars and stirrups	sum	1	2,500	2,500
	Repair beams spalling and honeycombing as detailed	lm	20	150	3,000
	Repair slab soffits for spalling and honeycombing	m ²	75	320	24,000
ASC1-02	Safety of Foundations - as per Engineer's details and specifications				
	Underpin subsided foundation	lm	100	90	9,000
ASC1-03	Structural Integrity of Roofs				
	Replace entire roof with trusses and roof angle of 25 degrees	m ²	660	200	132,000

ASC1-04	Exterior Doors, Exits and Entrances				
	Protecting existing door with an impact-resistant covering	nr	3	1,000	3,000
	Install threshold to prevent ingress of water	nr	3	100	300
ASC1-05	Windows and shutters				
	Replace existing windows with standard operable or fixed windows and install shutters with Miami Dade NOA	m ²	45	1,270	57,150
ASC1-06	Other Elements of the Building Envelope				
	Repair cracks > 6 mm using a welded mesh	sum	1	2,500	2,500
	Replace entire existing masonry wall with the inclusion of a ring beam	sum	1	5,000	5,000
ASC1-07	Internal walls - concrete masonry units finishd with mortar plastering				
	Replace entire wall with new ring beam on both floors	m ²	104	203	21,081
ASC1-08	False or Suspended Ceilings				
	Replace and retrofit entire ceiling	m ²	1,320	31	40,920
ASC1-09	Safety of stairways and Ramps				
	Reconstruct up to 50% of the staircase	sum	1	5,000	5,000
ASC1-10	Condition and safety of floor coverings

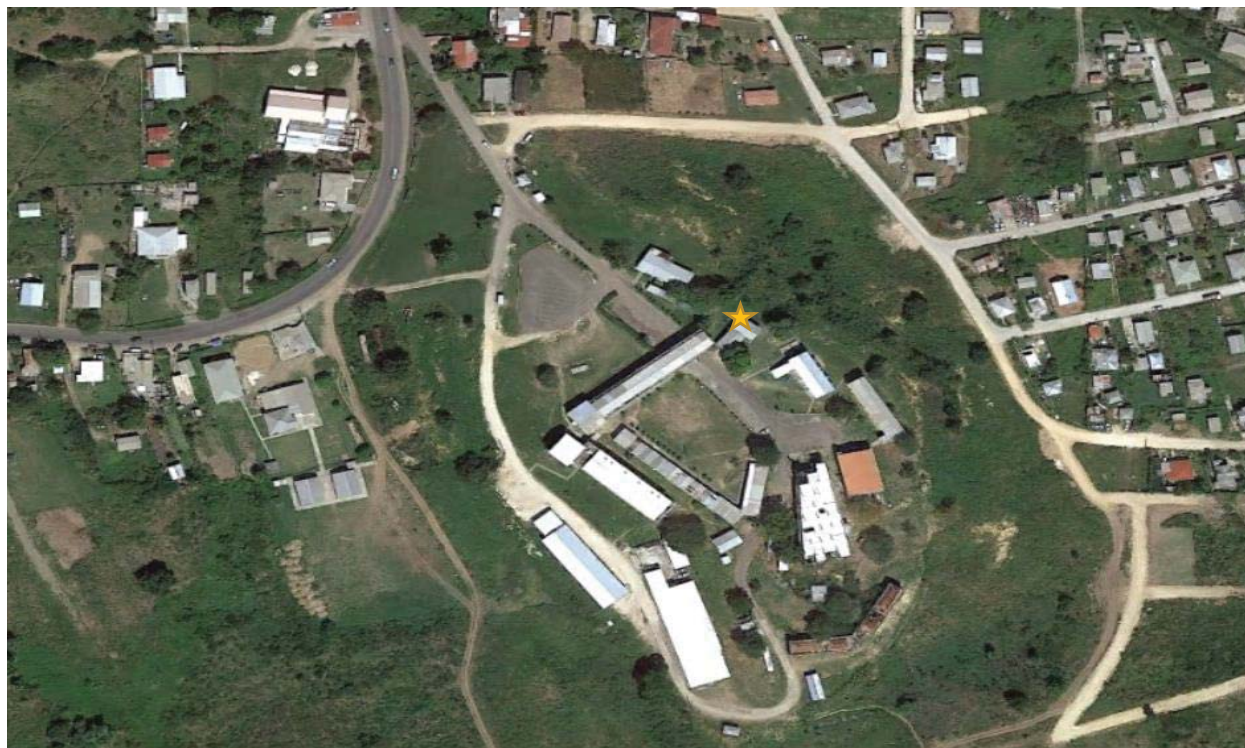
Facility Name:	Antigua State College 2	Year built:	
Building Name:	Staff Room	Year(s) remodeled:	
Building Address:	Valley Road	Original Design Code:	
Latitude:	17.10036	Area (m2):	189
Longitude:	61.83935	Length (m): 21	21
Use:	Educational	Width (m): 9	9
Risk Category:	III	No. of storeys	1
Occupancy Group:	Group A	Storey height (m):	6
No. of occupants:	500	Total height (m):	8
Roof shape:	Gable	Walls	Timber
Roofing:	Metal Sheetting	Structural system	Timber
Overall Condition	Low		
Comments	This is a timber is an all timber building supported on block work piers and reinforced concrete column as the foundation. Structurally, the building appears inadequate and due to the level of retrofit required, reconstruction is being recommended

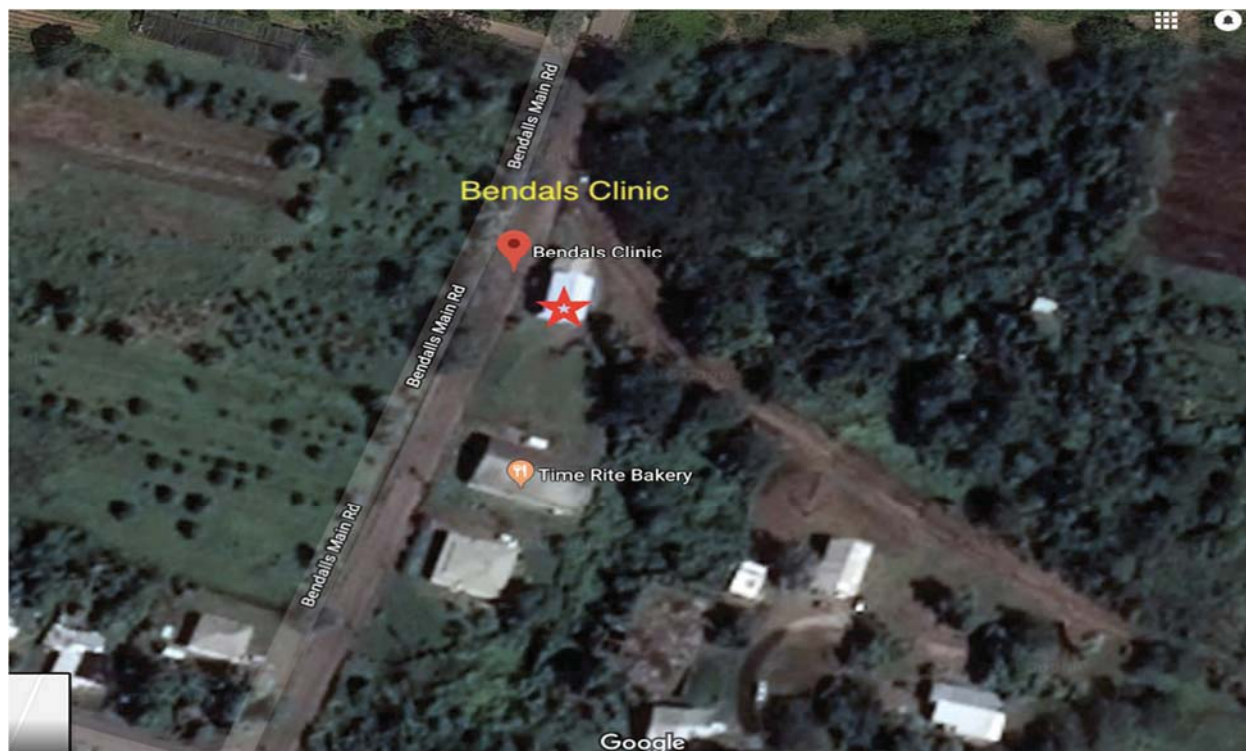
Facility Name:	Bendals Clinic	Year built:	
Building Name:	Bendals Clinic	Year(s) remodeled:	
Building Address:	St John's, American road	Original Design Code:	OECS Building Code
Latitude:	17.1118254	Area (m2):	142
Longitude:	61.8318272	Length (m):	17.4
Use:	Government	Width (m):	8.2
Risk Category:	IV	No. of storeys:	2
Occupancy Group:	Group D	Storey height (m):	3.05
No. of occupants:	25	Total height (m):	7.9
Roof shape:	Hip	Walls	Concrete Blocks
Roofing:	Metal Sheeting	Structural system	Concrete Blocks
Overall Condition	Average		
Comments	Based on the Risk Category ascribed to the building, the retrofitting should be in the immediate term – particularly as the building only has a marginal average rating

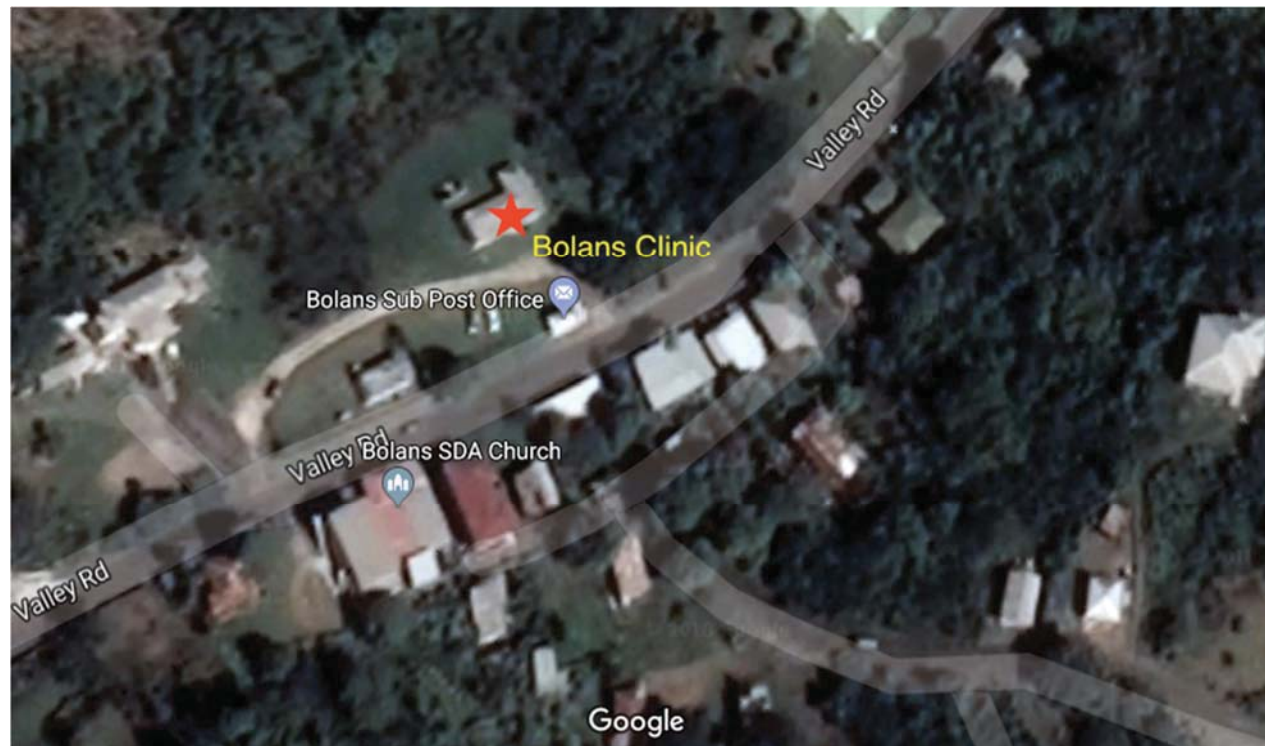
Facility Name:	Bolans Clinic	Year built:	
Building Name:	Bolans Clinic	Year(s) remodelled:	
Building Address:	Bolans Main Road	Original Design Code:	Unknown
Latitude:	17.0643005	Area (m2):	114
Longitude:	61.881495	Length (m):	15.5
Use:	Medical	Width (m):	7.4
Risk Category:	IV	No. of storeys:	Single
Occupancy Group:	Group D	Storey height (m):	2.7
No. of occupants:	35	Total height (m):	4.8
Roof shape:	Hip	Walls	Concrete Blocks
Roofing:	Metal Sheeting	Structural system	Concrete Frame
Overall Condition	Low		
Comments	Given the Risk Category and the rating of Low, retrofit needs to be in the immediate term

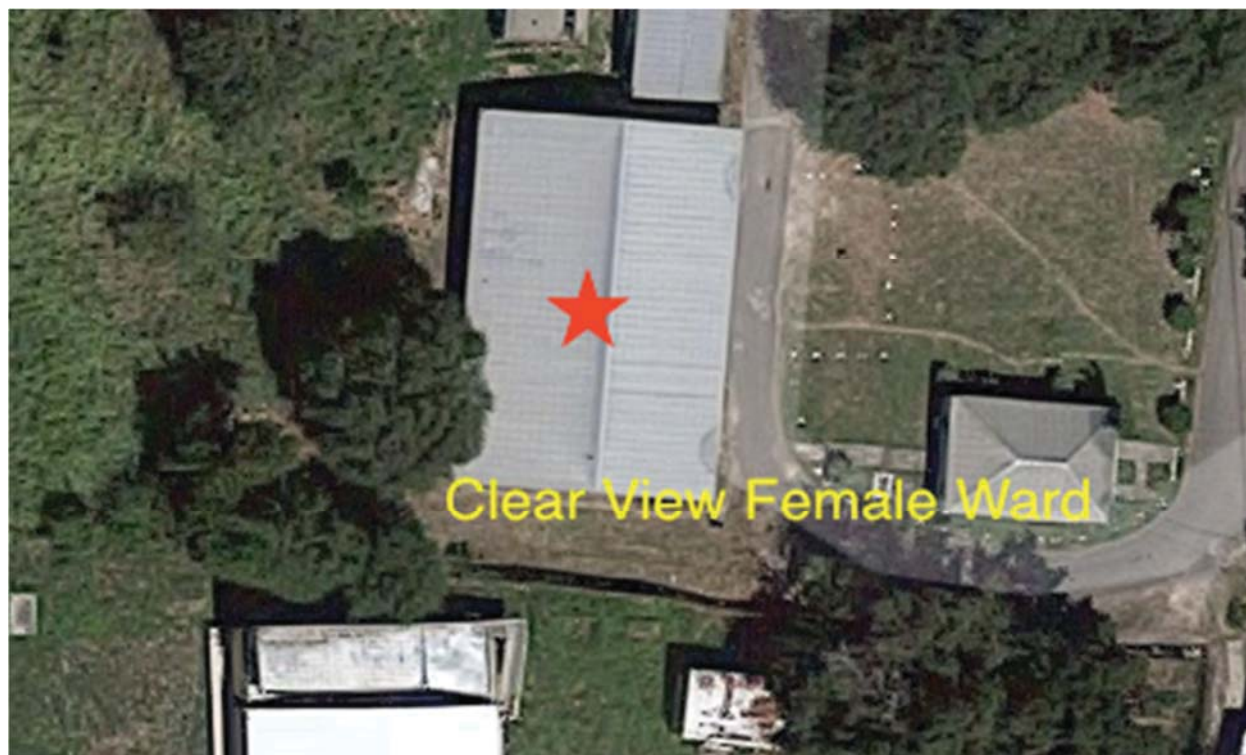
Facility Name:	Clearview Psychiatric Hospital 1	Year built:	
Building Name:	Female Ward	Year(s) remodeled:	
Building Address:	Simon Bolivar Dr	Original Design Code:	
Latitude:	17.1219315	Area (m2):	580
Longitude:	61.8276335	Length (m):	29 m
Use:	Medical	Width (m):	20 m
Risk Category:	IV	No. of storeys:	Single
Occupancy Group:	Group B	Storey height (m):	3.35 m
No. of occupants:	150	Total height (m):	4.5 m
Roof shape:	Gable	Walls	Concrete Blocks
Roofing:	Metal Sheetting	Structural system	Concrete Frame
Overall Condition	Average		
Comments	Retrofit is likely required in the immediate to short term, particularly given the Risk Category of IV

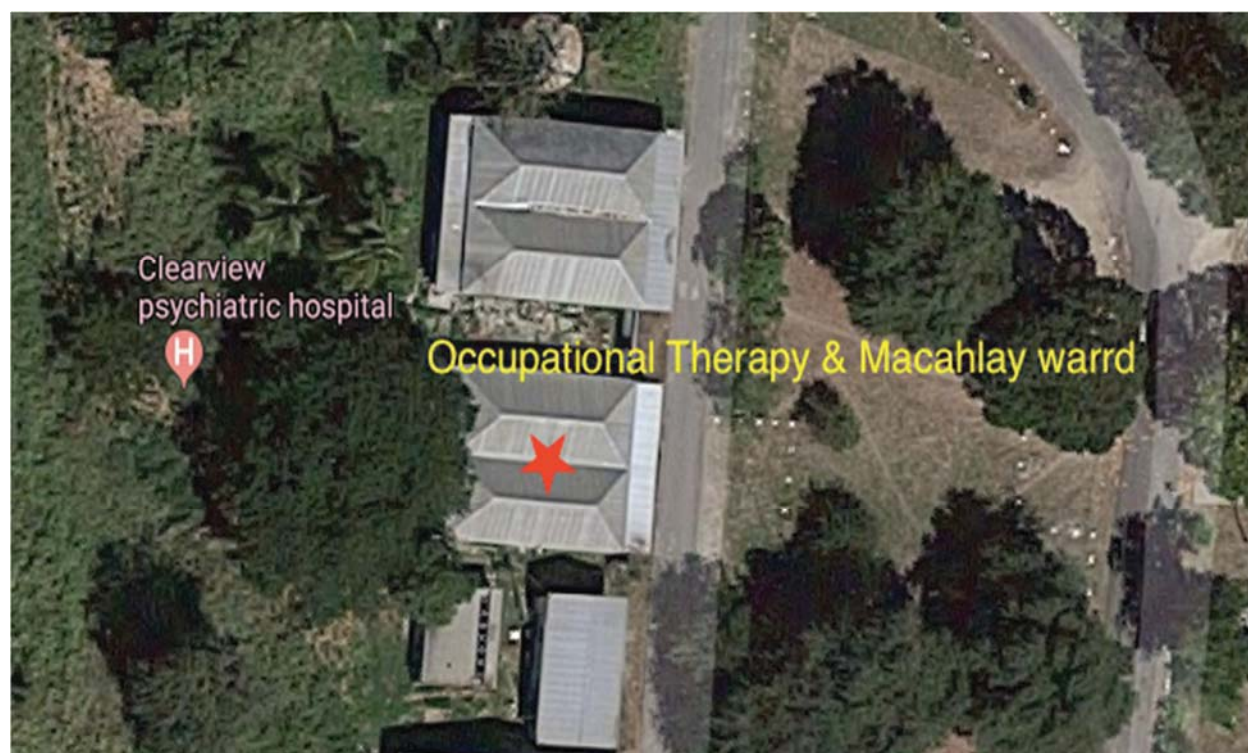
Facility Name:	Clearview Psychiatric Hospital 2	Year built:	
Building Name:	Occupational Therapy & Macahlay Ward	Year(s) remodeled:	
Building Address:	Simon Bolivar Dr	Original Design Code:	
Latitude:	17.1222141	Area (m2): 418	203
Longitude:	61.8276148	Length (m): 30	17
Use:	Medical	Width (m): 26	13
Risk Category:	IV	No. of storeys:	Single
Occupancy Group:	Group B	Storey height (m):	4
No. of occupants:	30	Total height (m):	4
Roof shape:	Hip and Valley	Walls	Concrete Blocks
Roofing:	Metal Sheeting	Structural system	Concrete Frame
Overall Condition	Average		
Comments	Retrofit is likely required in the immediate to short term, particularly given the Risk Category of IV

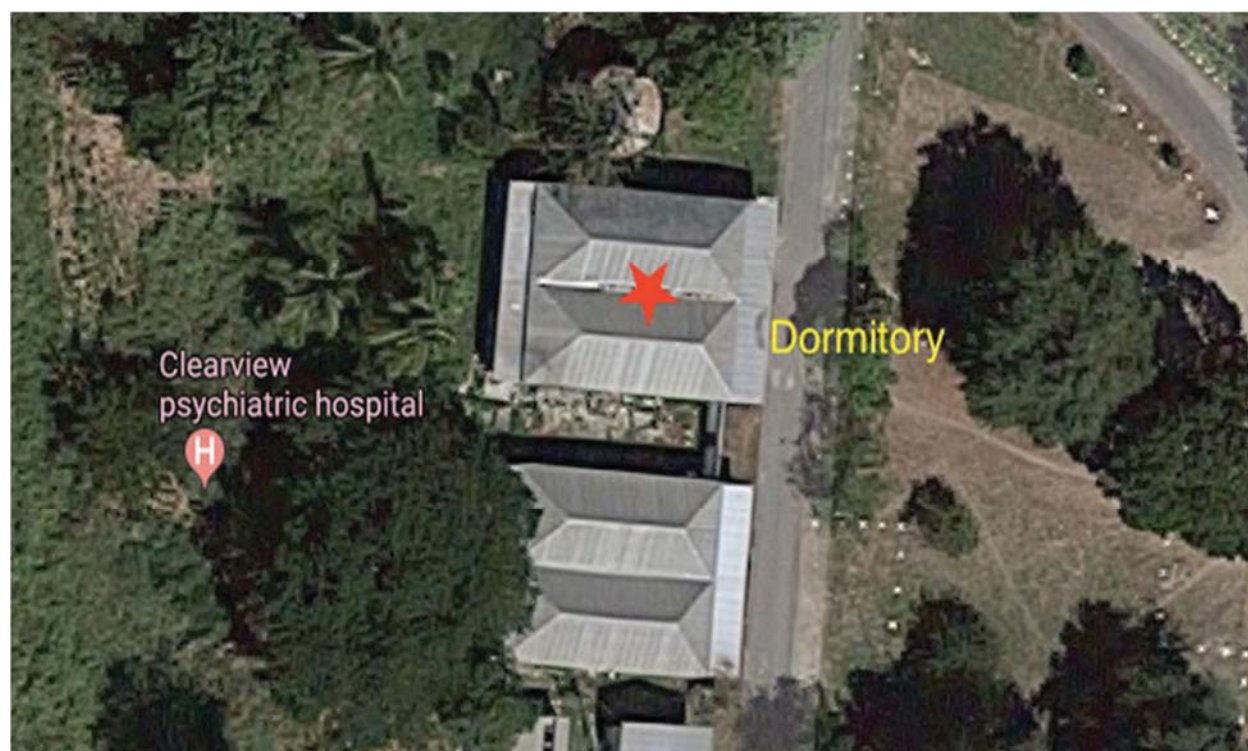
Facility Name:	Clearview Psychiatric Hospital 3	Year built:	
Building Name:	Dormitory	Year(s) remodeled:	
Building Address:	Simon Bolivar Dr	Original Design Code:	
Latitude:	17.1221714	Area (m2):	159
Longitude:	61.8275631	Length (m):	19.8
Use:	Medical	Width (m):	8
Risk Category:	IV	No. of storeys:	1
Occupancy Group:	Group B	Storey height (m):	
No. of occupants:	150	Total height (m):	4
Roof shape:	Hip and Valley	Walls	Concrete Blocks
Roofing:	Metal Sheeting	Structural system	Concrete Frame
Overall Condition	Average		
Comments	Retrofit is likely required in the immediate to short term, particularly given the Risk Category of IV

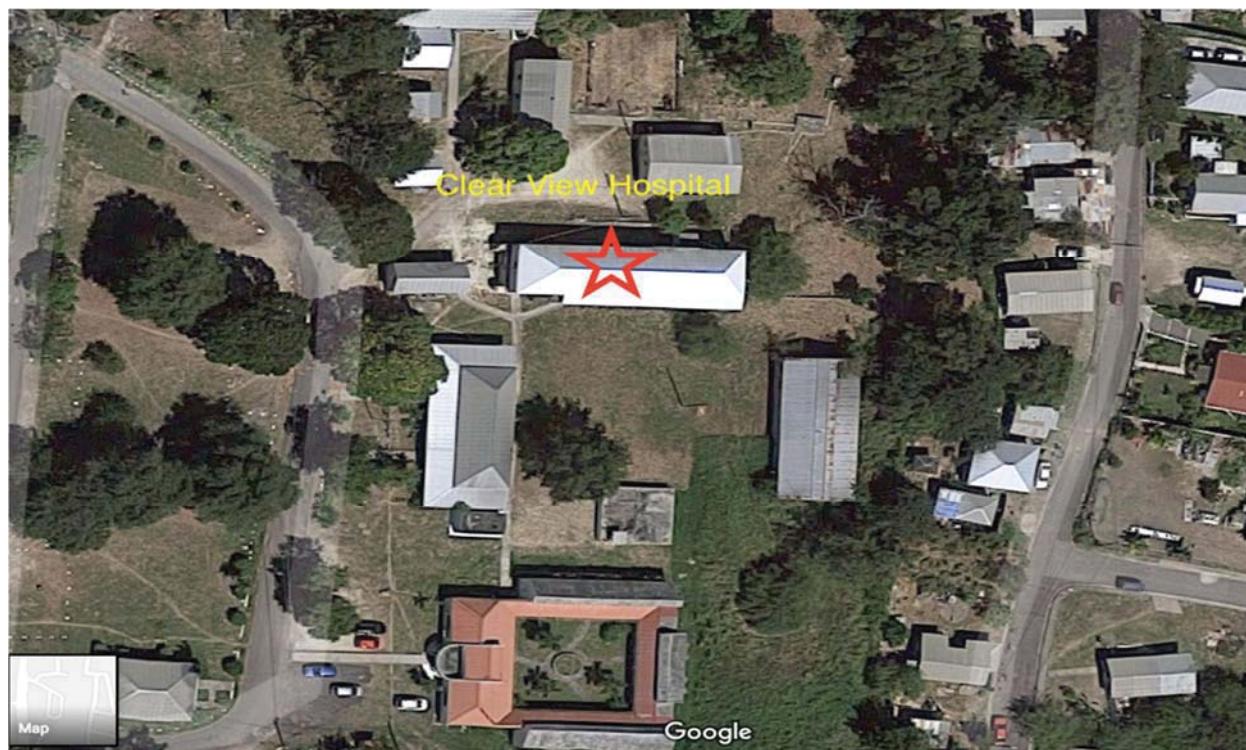
Facility Name:	Clearview Psychiatric Hospital 4	Year built:	
Building Name:	Clear View Hospital	Year(s) remodeled:	
Building Address:	Simon Bolivar Dr	Original Design Code:	
Latitude:	17.1223653	Area (m2):	270
Longitude:	61.8266947	Length (m):	32
Use:	Medical	Width (m):	9
Risk Category:	IV	No. of storeys:	Single
Occupancy Group:	Group B	Storey height (m):	3.35
No. of occupants:	150	Total height (m):	4
Roof shape:	Hip	Walls	Concrete Blocks
Roofing:	Metal Sheeting	Structural system	Concrete Frame
Overall Condition	Average		
Comments	Retrofit is likely required in the immediate to short term, particularly given the Risk Category of IV. Additionally, the rating is only a marginal average

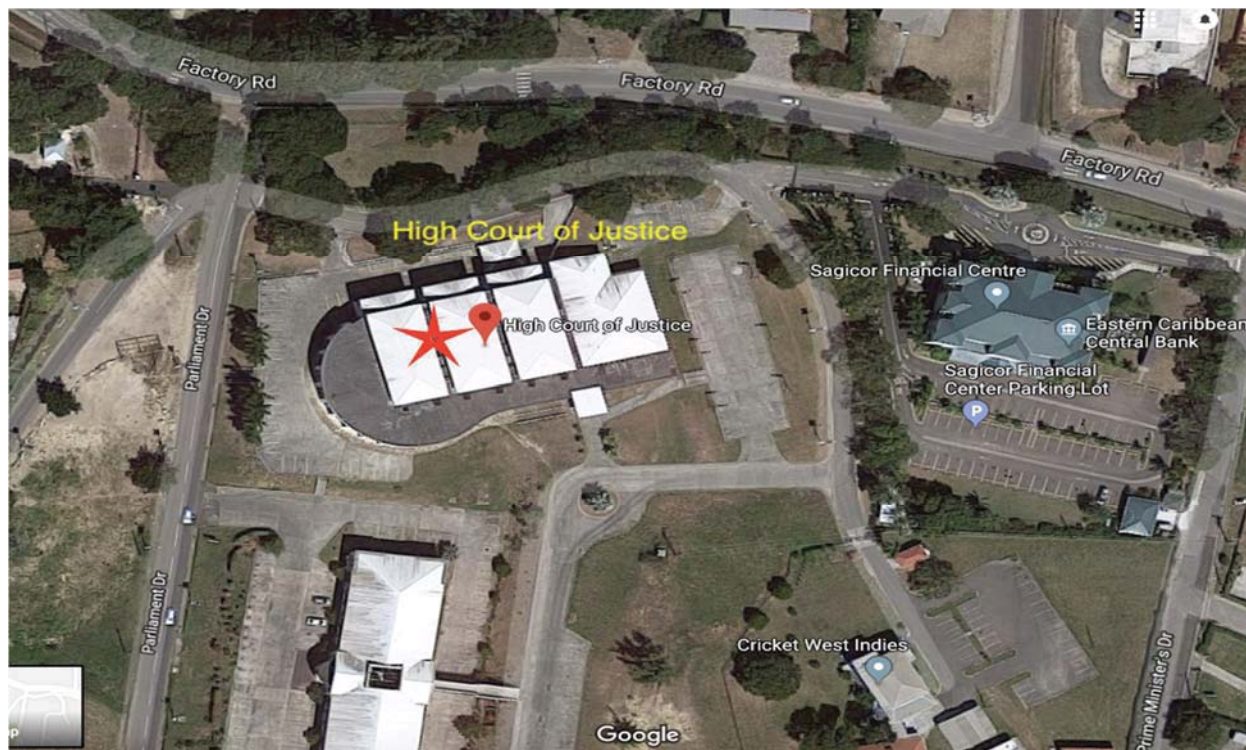
Courthouse

Facility Name:	Government Complex	Year built:	1995
Building Name:	High Court of Justice	Year(s) remodeled:	
Building Address:	Parliament Drive	Original Design Code:	OECS Building Code
Latitude:	17.120384	Area (m2):	2416.4
Longitude:	61.835148	Length (m):	72
Use:	Government	Width (m):	33.52
Risk Category:	II	No. of storeys:	3
Occupancy Group:	Group D	Storey height (m):	10'
No. of occupants:	50	Total height (m):	36'
Roof shape:	Hip and Valley	Walls	Concrete Block
Roofing:	Metal Sheetting	Structural system	Steel Frame
Overall Condition	Average		
Comments	Building is in good condition with a high average rating of 64%

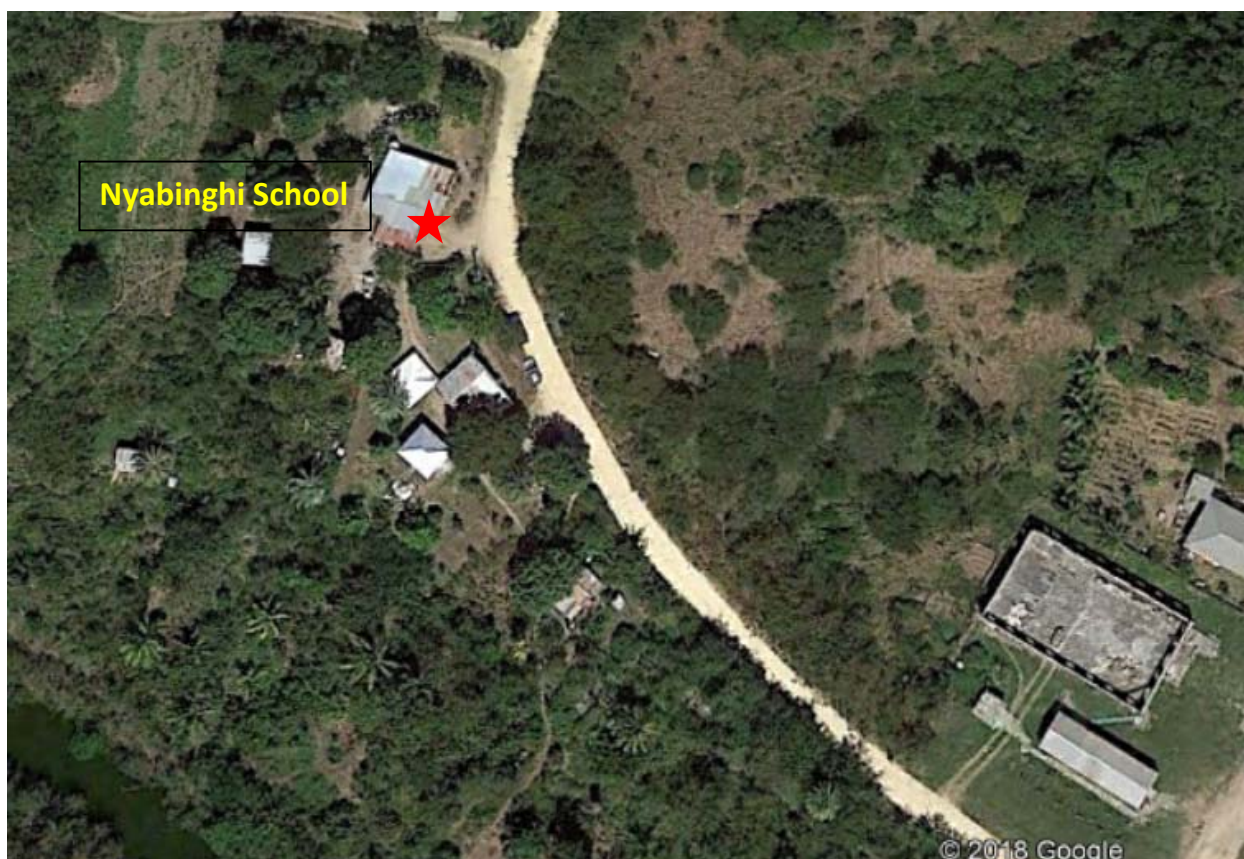
Nyabinghi School

Facility Name:	Nyabinghi Theocracy School	Year built:	
Building Name:	Living Quarters	Year(s) remodelled:	
Building Address:	Big Creek	Original Design Code:	Unknown
Latitude:	17° 5'38.43"N	Area (m2):	30
Longitude:	61°50'58.66"W	Length (m):	5.5
Use:	Educational	Width (m):	4.88
Risk Category:	II	No. of storeys:	1
Occupancy Group:	Group E	Storey height (m):	2.75
No. of occupants:	20	Total height (m):	4.5
Roof shape:	Flat Gable	Walls	Timber - Plywood
Roofing:	Metal sheets	Structural system	Timber studs
Overall Condition	Low		
Comments	Needs to be demolished and reconstructed
