CTCN City Climate Vulnerability Assessment and Identification of Ecosystem-based Adaptation Interventions, Lao PDR, January 9th to 19th

The outcome of the mission in August 2016 has provided the basis for the Response Plan, which will be carried out between January and June 2017, and the plan was initiated with an interim consultation and workshop during 9th-19th January 2017.

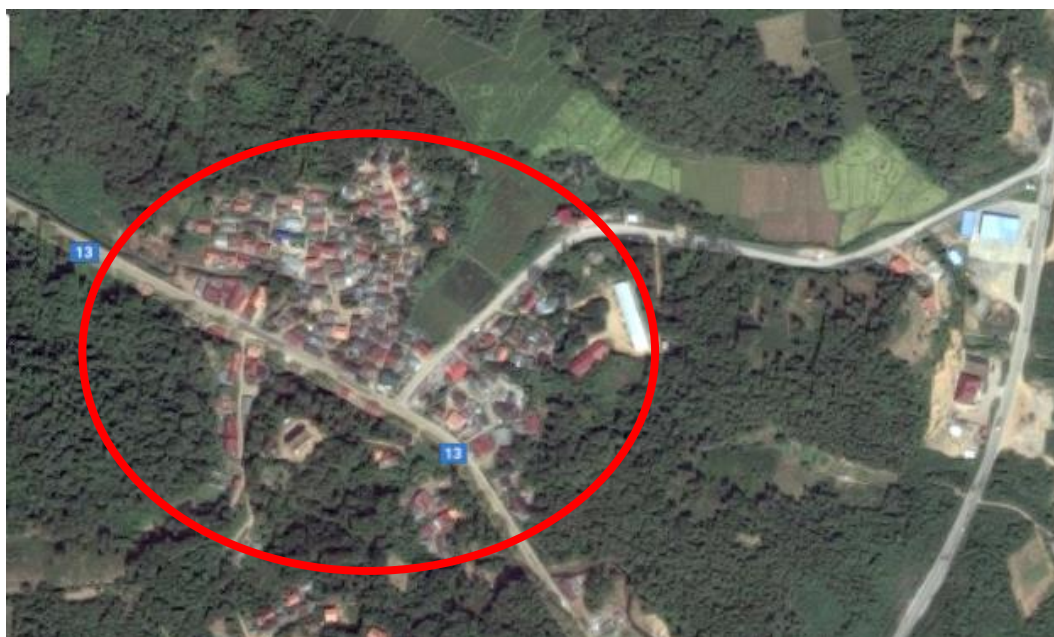
Figure 3-2 Luang Prabang Site 2.

LPB Site 2: Ban Hog New Village, approx. 8 km from LPB: The small village is situated along a stream, which 3-4 times per year floods parts of the village. The floodings are short, but intense and usually bring large amounts of soil and mud, which fills up the street and the houses adjacent to the stream. The key damages are to property along the river, whereas houses away from the stream are not damaged. There are also damages to cropland up- and downstream of the village. The stream passes a quarry upstream and a visit to the quarry showed that there is no protective walls or dikes to prevent soil and mud from the quarry to run into the river. The two culverts seen in the village were both more or less blocked with debris and sediments and were by far too small to take the flow from the stream. Therefore, the culverts are expected to act as places where the water is forced into the street, causing the problems.

The damages, besides the physical load of soil and mud were mainly on cropland, and on the water supply system in the village.

The main operational possibilities lies with having a better control with the landuse upstream and potentially assess whether riparian land upstream of the village could be used for intentional flooding, thereby using the ecosystem service provided by the riparian zone for slowing down the speed of the water and thereby take out some of the sediments before reaching the village. In addition, the run-off conditions in the quarry must be assessed to ensure that the village does not suffer from un-intended soil and mud transport from the quarry. Protective dikes and ponds may be used to reduce the soil transportation into the stream.

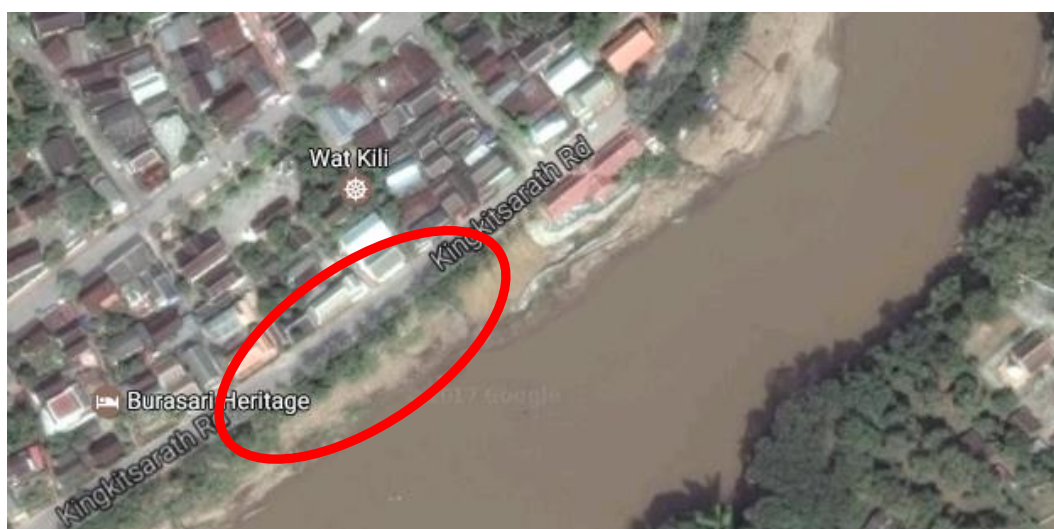
Figure 3-4 Luang Prabang Site 4.

LPB Site 4: Bank erosion along Nam Khan. A recent slide of the left bank on the eastern side of the peninsular has damaged the road and curbside and unless hard-core engineering efforts are used, the brink might eventually fall into the river. Inspection of the site showed that various un-authorized terraces and other structures incl. of wastewater- and rainwater drains have been located on the brink. It was concluded that the site would not fit into the criteria for the CTCN- project and the Green Climate Fund project either, as the bank collapse encountered has to do with constructions, brink constructions and probably also irregular release of water from the upstream dams, which may have weakened the side of the river, causing instability and accordingly a slide of the brink.

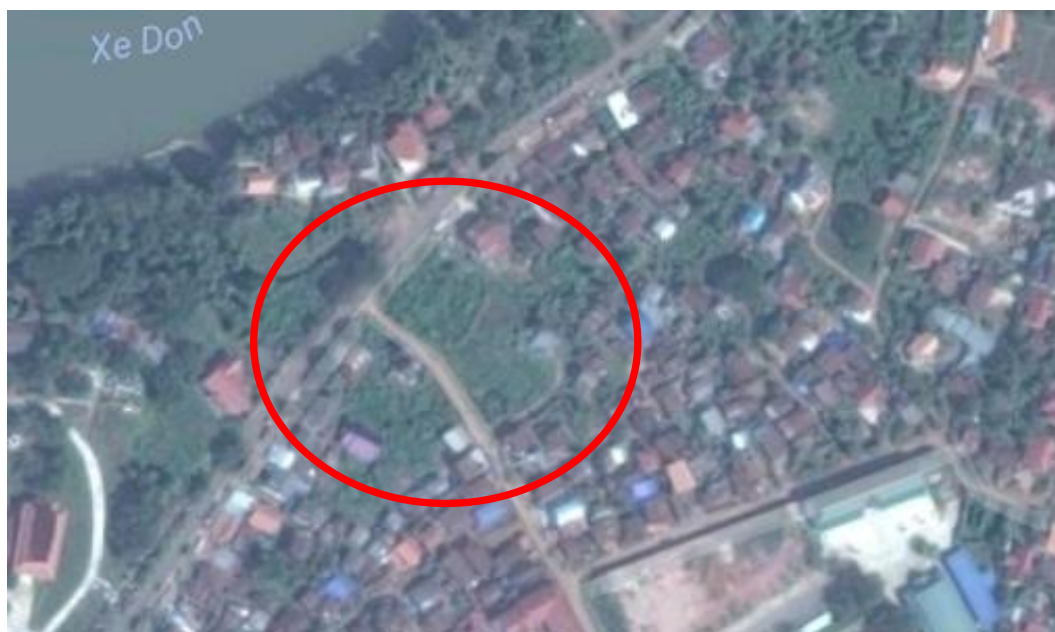
Figure 3-5 Pakxe, Site 1.

PXE Site 1: Ban He, Hoy Ya stream: The water lock established by the road has not been finalised and it cannot stop backwater from Sedone river and Mekong. However, if the lock was finished it could potentially reduce the impacts on the backland and it would then be possible to work with local ecosystem services in the area, as several areas are left open and could be used for additional storage and seepage for rainwater. These areas could also be used for cultivation when flooding is not taking place. However, it will not be possible before the water lock is finalised. The flooding takes place once a year and lasts for 2-5 weeks, depending on the water level and duration in the Mekong River. It is not known if upstream conditions (i.e., deforestation) in the Sedone catchment have contributed to increased flood risk in recent years.

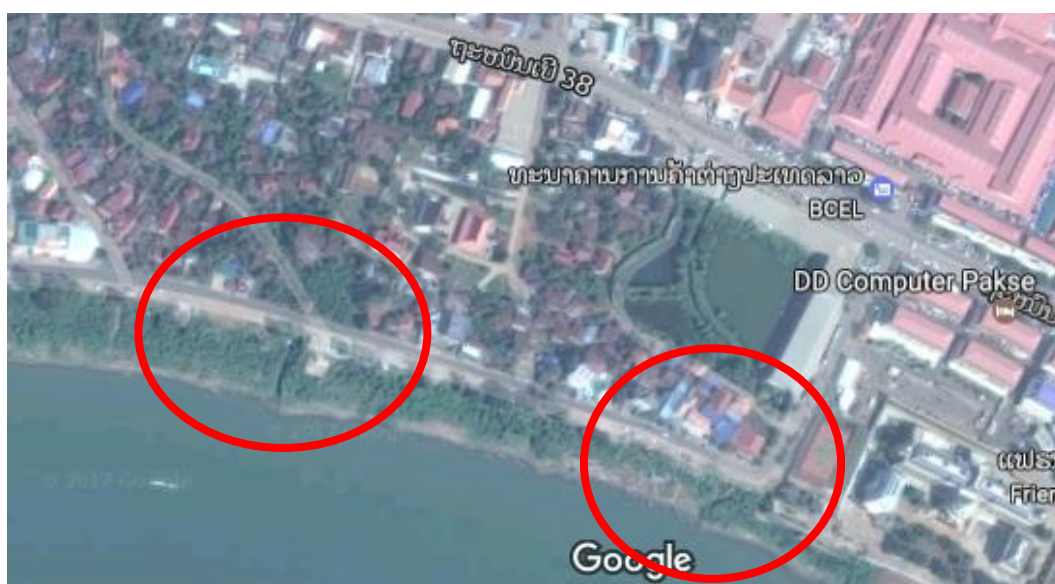
Figure 3-7 Pakxe, Site 3 and 4.

Pakxe; Site 3 and 4; Pumping stations and drainage channels. The two sites are close to each other and are built at the end of two drainage channels, feeding sewage and drainage water to the outlet. Both outlets are equipped with sluice gates, but these are not finalised and completed. The same happens for both areas; When the Mekong reaches approx. 8 meters, water will be forced into the backland and will cause flooding for all land below the water level in the Mekong. Working with ecosystem services does not seem feasible before the gates are functioning and can protect the backland. The structure to the right in the figure illustrates the drainage channel and the wastewater treatment plant. The plant is based on a string of oxidation ponds.

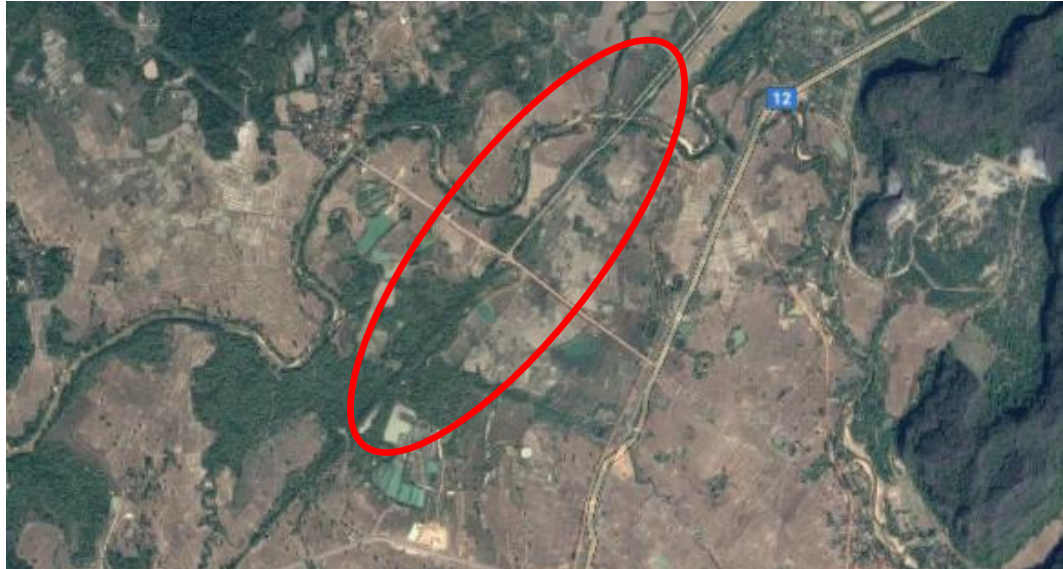
Figure 3-10 Thakhet, Sites 1 and 2

TKH Site 1 and 2: Future development area along Highway 12 towards Vietnam. The site is on both sides of the main road, but not close to the city and the plan looks at developing the area within 10-20 years. Flooding comes as flash floods from the nearby mountains, but are also influenced by water backing up into the local river, Nam Don. The sites cannot yet be considered urban or peri-urban and therefore it was decided that neither is appropriate for the assistance.

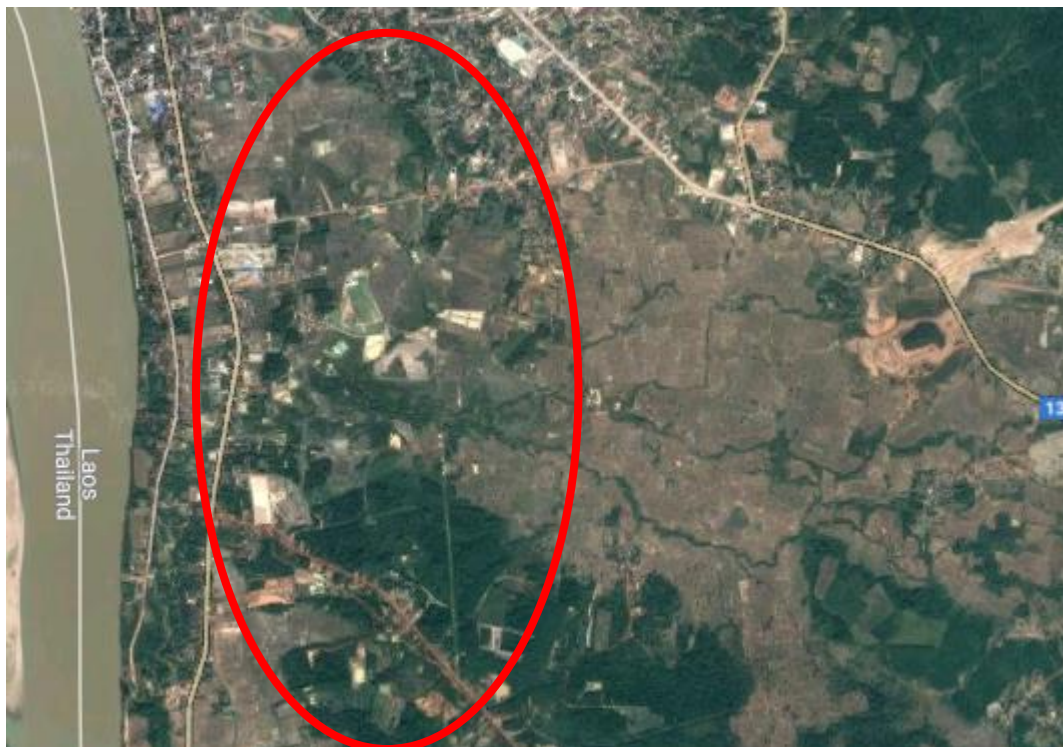
Figure 3-11 Thakhet Sites 3, 4 and 5

THK Site 3, 4 and 5. Catchment in the peri-urban area of the city, near Ban Non Bo. The upper part of the catchment is in the city and spreads out into a flood plain, used for grazing, paddy fields and fish ponds. A road crossing the flood plain acts as a barrier between the upper catchment and the lower catchment, where the lower is impacted by backwater from the Mekong. There are no water lock systems at the confluence with Mekong. The upper catchment is mainly impacted in terms of floodings caused by rainfall in the catchment and it is mainly agricultural land, which suffer from the flooding, whereas both land and houses are flooded in the lower catchment. The visit included visits to 3

sites, going from the road crossing the flood plain, seeing one site at Paximay Houang and finally the confluence with Mekong.

The upper catchment site is considered interesting because it provides opportunities to use ecosystem services in the urban part of the catchment for flood control and to provide other benefits. During the lunch the site was discussed and it was agreed that the authorities would work with the site and deliver data and information to the NDE.

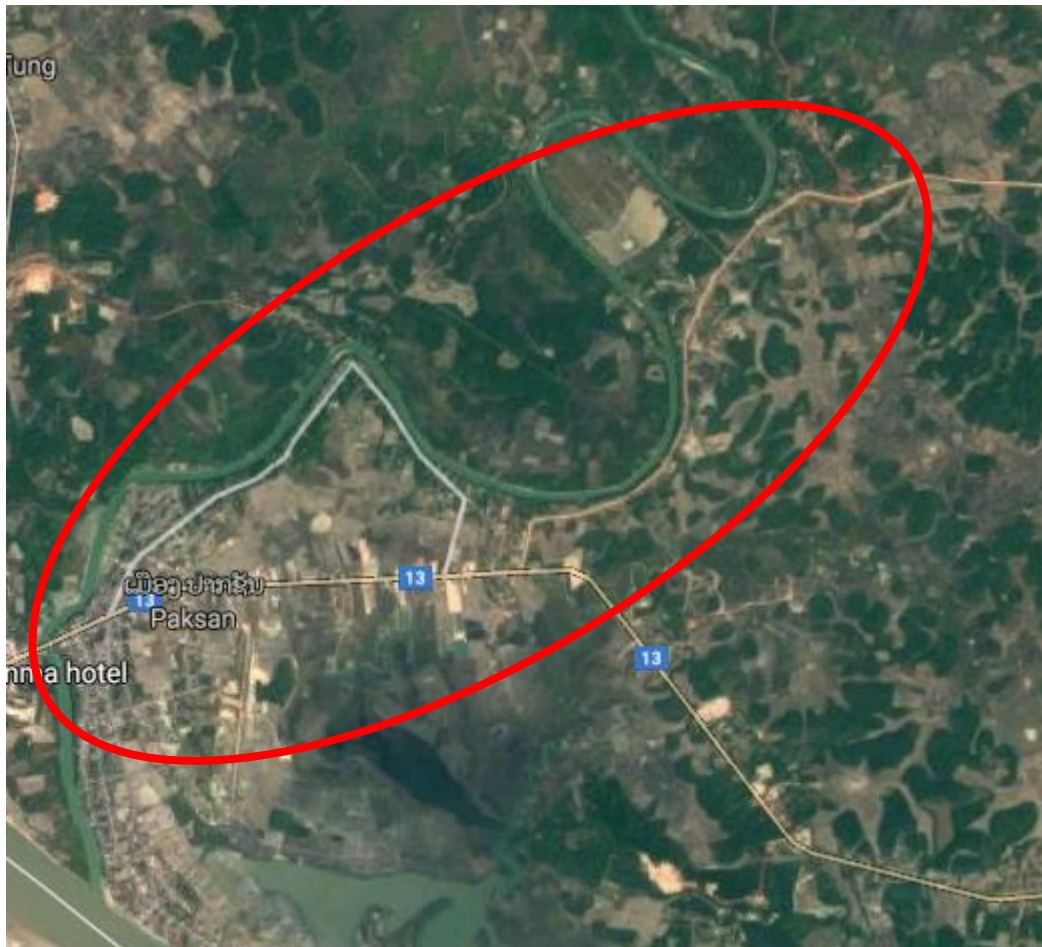
Figure 3-12 Paksan, Site 1

PKS, Site 1: Ang Houy Peung and along Nam Zan. The river is relatively large and is as all the other tributaries highly influenced by the water level in Mekong. A road leading up along the river has been improved to withstand water levels in Mekong of 15 meter, the highest recorded in recent time. Settlements on the river side of the road are flooded annually, and settlements on the other side are also sometimes flooded, but by water entering the catchment further up and coming down along the road. Despite the laws covering the building code, most houses have been built without taking the necessary precautions to avoid direct flooding in the houses. Most houses are not on polders or of the stilt-type and are accordingly flooded annually for 2-5 weeks.

PKS Site 2: Ban Tabor, upstream of Ang Houy Peung. The village next to the Nam Zan is situated on a small elevation and was only flooded severely in 2014. Speaking to the village people did not tell when the previous severe flooding took place. There were pictures of the flooding of the village in 2014, indicating a water level of 30 cm at the temple site.

The cropland around the village and the access road are flooded annually for 2-5 weeks, cutting the village off from e.g. access to the markets and the health care. The representative from Dept meteorology was asked to find data on precipitation to create an overview of the recorded flooding in 2014 was caused by extreme rain or was within the normal range.

The conclusion after seeing the sites was that the city, villages and catchment must be seen as one unit and that changes in the catchment must be analysed to see if there are links. It was suggested to investigate how far the direct impact from backwater from the Mekong reaches in Nam Zan and focus on using local landscape features for flood control upstream of this border.

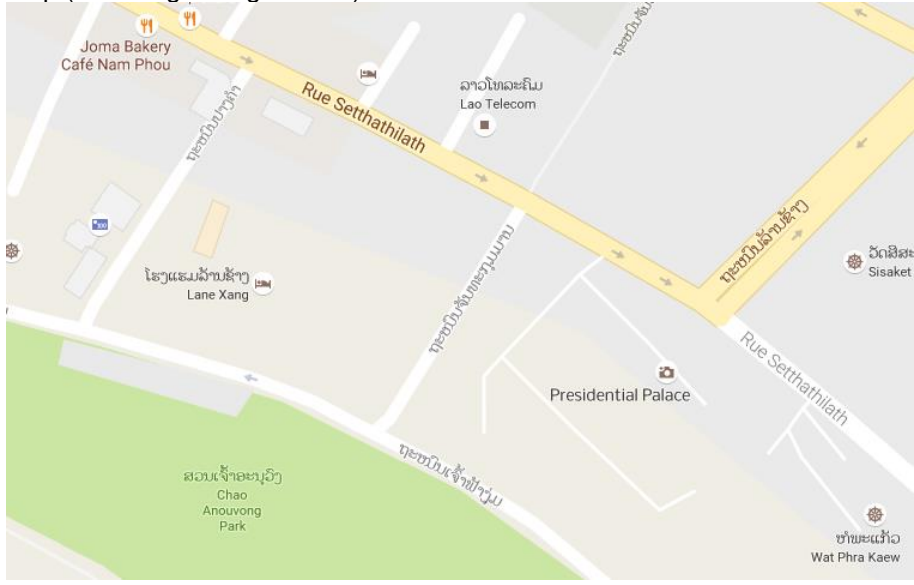
City name: Vientienne		District: Downtown	
Address: Rue Setthathilath		Number of people directly affected: 1300	
Number of other people affected: + 5000, using the street for daily transport			
Map (From e.g. Google Earth)

Frequency of flooding:	2-3 times/year	Typical duration:	1-5 days
Typical impacts:	Transport through the area is not possible during the flooding	Houses along the flooded area are damaged and people living there cannot come and go as they are used to	..
Impacts specially related to Ecosystem services	Fruit trees along the street may be damaged if the flooding takes more than 2 days	Gardens are destroyed	Snakes and smaller mammals may die
Important infrastructure elements? (Water works, transformation station, phoneline hub etc?)	The telephone connections are broken	Water supply system damaged and polluted water is entering the supply system	
Rough estimate of % impermeable area in the flooded area	70%

Type of water in the flooding: From sewers, from surface	Most of the water comes up through the sewers while the rest comes from the area around the flooded site because the flooded site is like a depression.		
Distance to green infrastructure elements (e.g. parks, gardens, sports fields, etc) and name(s)	The nearest park is along the river, about 500 meters to the south. Chao Anouvong Park
