Provision of Services Related to Enabling Readiness for Up Scaling Investments in Building Energy Efficiency for Achieving NDC Goals in Thailand

PROGRESS REPORT 5: REPORT ON CONDUCT ENERGY AUDITS ON THE FIVE BUILDING TYPES (TASK 4)

INTERNATIONAL INSTITUTE FOR ENERGY CONSERVATION - ASIA

December 2021

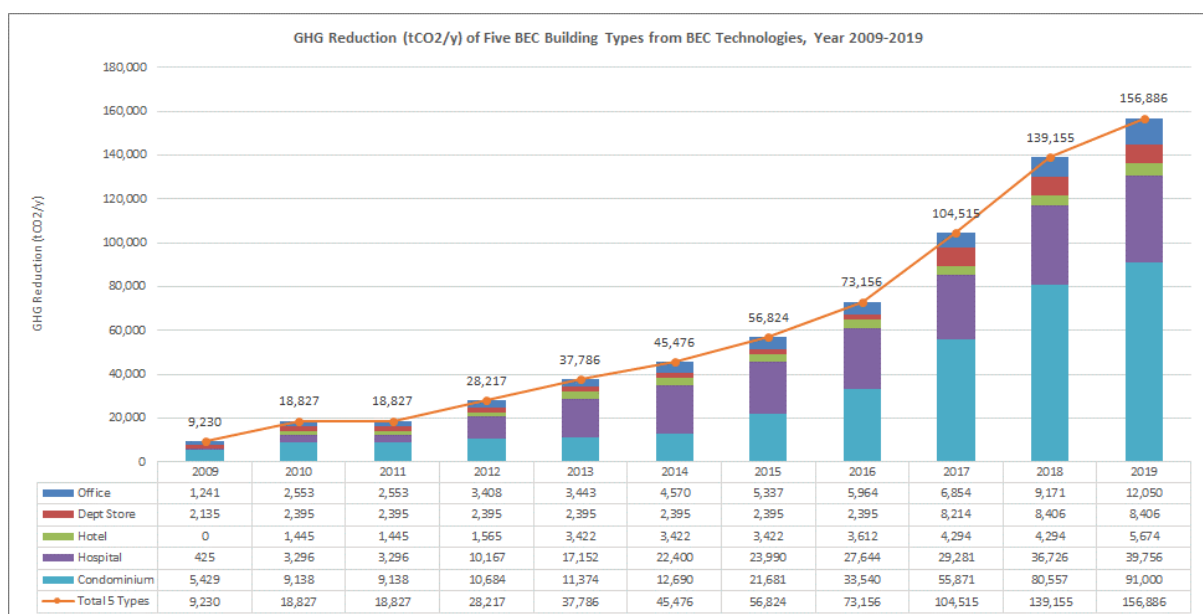
Figure: GHG emission reduction potential from implementing BEC technologies to five building types

The simulation shows GHG emission reduction potential in 2019 of 156,885 tCO₂/year from the energy saving of 249,289 MWh/year.

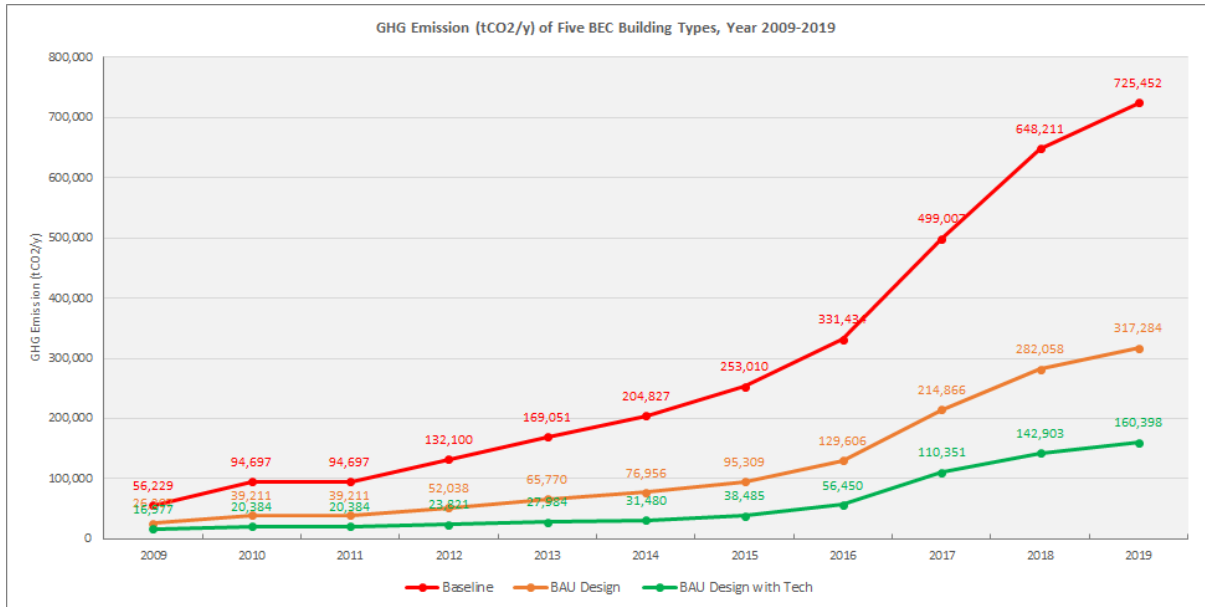
Figure 4: Benchmarking of GHG emission for three simulated scenarios

The following line graph visualizes GHG emissions for BEC reference baseline with 725,452 t CO₂/year in 2019, BAU design with 317,284 tCO₂/year and scenario with implementation of BEC technologies at 160,398 tCO₂/year.

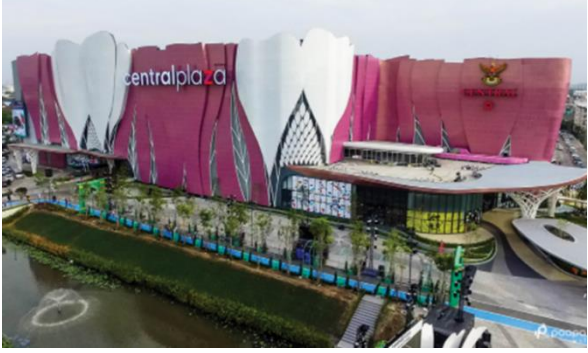
Showing building envelope comprising: <ul style="list-style-type: none"> • Opaque wall using light weight concrete with metal sheet and amplelite plate. • Windows and transparent wall using clear laminated glass 10 mm

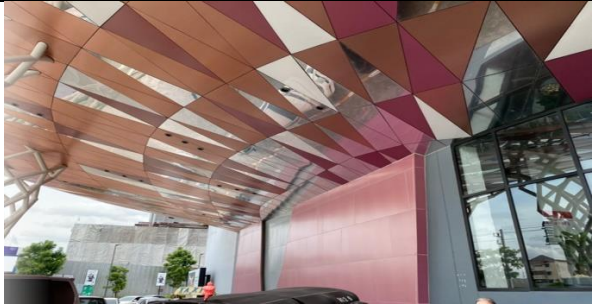
<ul style="list-style-type: none"> • Closer look of opaque wall using light weight concrete with metal sheet and amplexite plate.

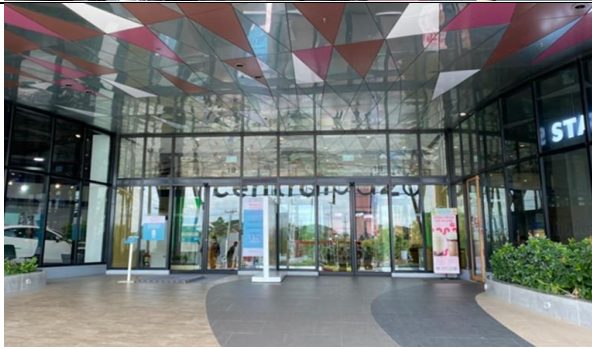
<ul style="list-style-type: none"> • Closer look of windows and transparent wall using clear laminated glass 10 mm.

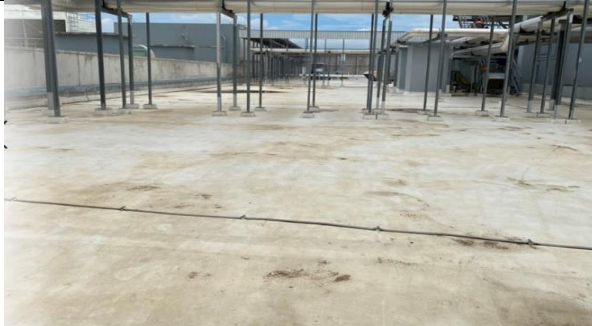
<ul style="list-style-type: none"> • Concrete roof and Insulation batts with fiber glass, no painted.

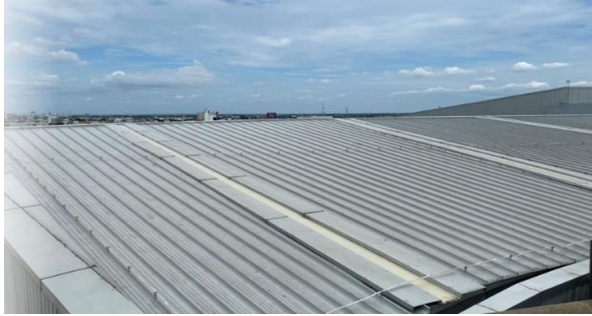
<ul style="list-style-type: none"> • Metal sheet with fiber glass

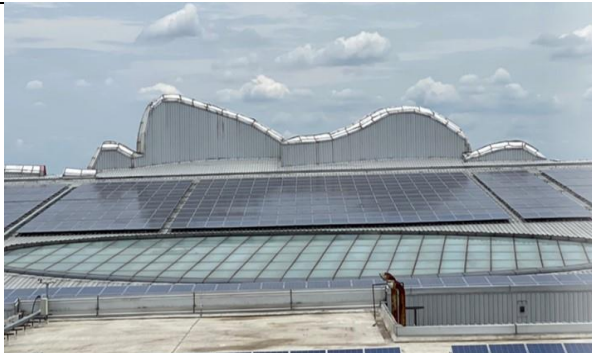
<ul style="list-style-type: none"> • Clear low-E glass 10 mm for natural lighting sky roof at hall area.

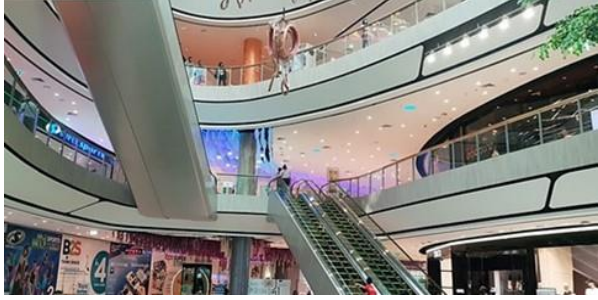
<p>Main shopping center and shops area showing:</p> <ul style="list-style-type: none"> • Air conditioned with large chiller water cooled system, and concealed cool air duct supply. • Concealed downlight LED lamps, 6 to 18 Watt. • Lighting system in the shopping center and the shops are 100% LED.

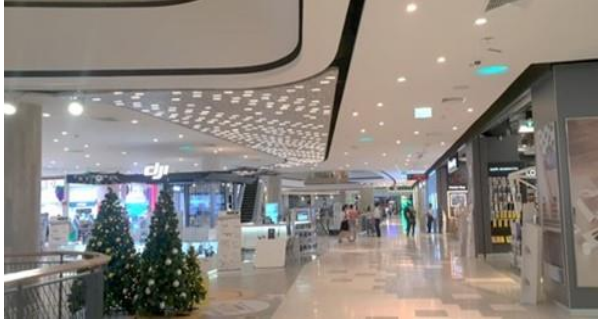
<p>Shopping center and rental shops:</p> <ul style="list-style-type: none"> • Concealed downlight LED lamps, 6 to 40 Watt for lighting. Installed lighting density for shopping area and shop is 1.81 W/m² • Lighting system in the shopping center and the shops (rental area) are 100% LED.
Cooling system

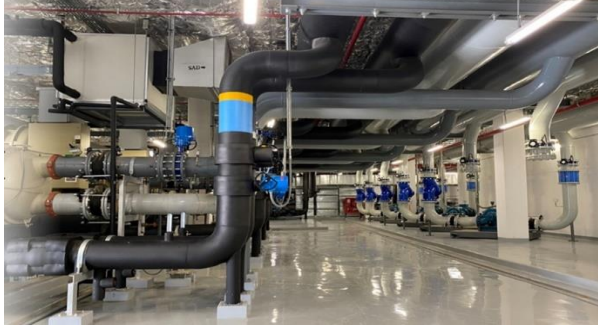
<p>Main chilled water supply for cooling system for whole building:</p> <ul style="list-style-type: none"> • The chiller was utilized only three units as maximum with one chiller stand-by for maintenance operation. • The chiller utilization level is about 50-60%. • The high efficiency chiller with VSD compressor is used to support the cooling load fluctuation.

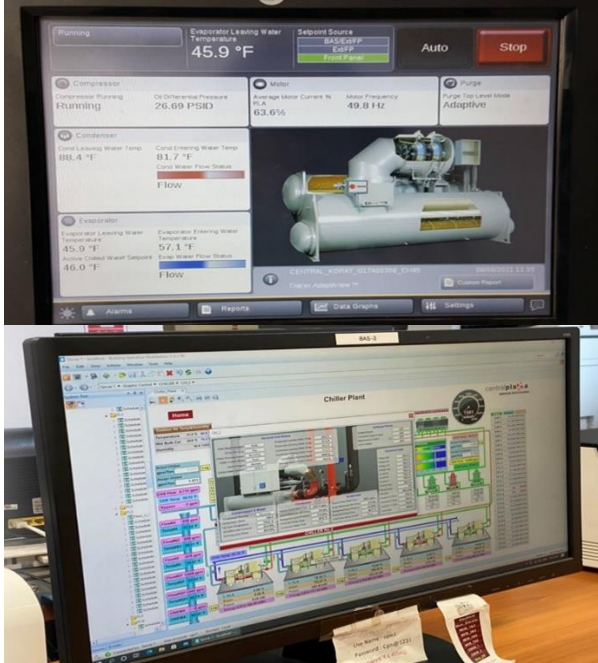
<p>Based on the designed, three units of chiller utilization are sufficient to cope with the maximum building cooling load demand in summer; one unit is back up as a stand-by chiller for sequential maintenance.</p> <ul style="list-style-type: none"> • Each individual chiller has chiller management control board, which linked and integrated the data to display in the overall chiller plant management system in the engineering division. • The overall chiller system is controlled with the chiller management system, and displayed in the monitoring system in the engineering room

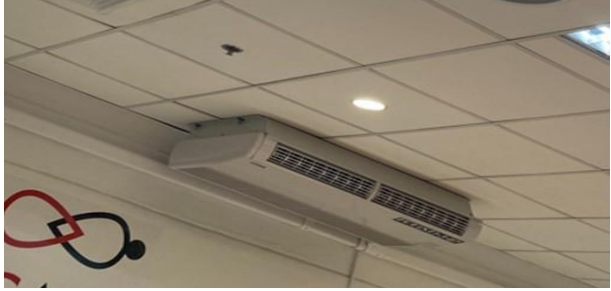
<p>Split-type air conditioners in the building office area and engineering zone will be used when the building is not in operation, and the shopping area is closed; the chiller system is not operated.</p>
<p>Electrical system</p>

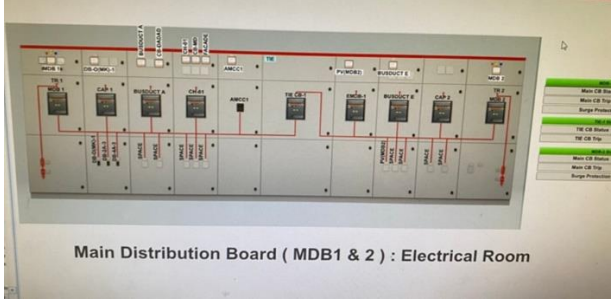
<p>Main Distribution Board (MDB1 & 2) : Electrical Room</p>	<p>Main distribution board for electricity distribution</p> <ul style="list-style-type: none"> • Metering cabinets installing electricity meters (analog kWh meters) for monitoring and recording of each major equipment, and integrated the data to display in the engineering division.
<p>Renewable utilization</p>

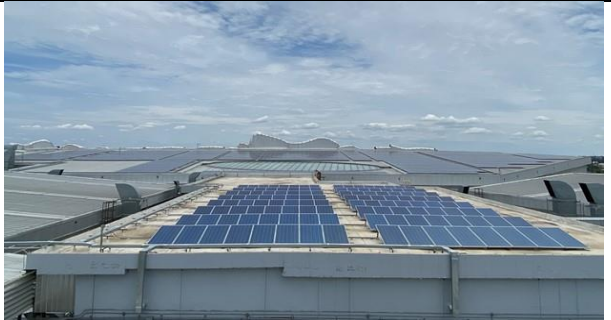
<p>Solar photovoltaic power generation system</p> <ul style="list-style-type: none"> • Off-grid solar PV system has an installation capacity of 1 MW, and start operated in June 2021, one year after the building operation.

It is noted that the solar photovoltaic generation system is not designed to comply with BEC compliance during the construction phase, the problem caused by the system design, and supplier selection in the bidding process. Therefore, the solar PV system is installed and operated one year later.

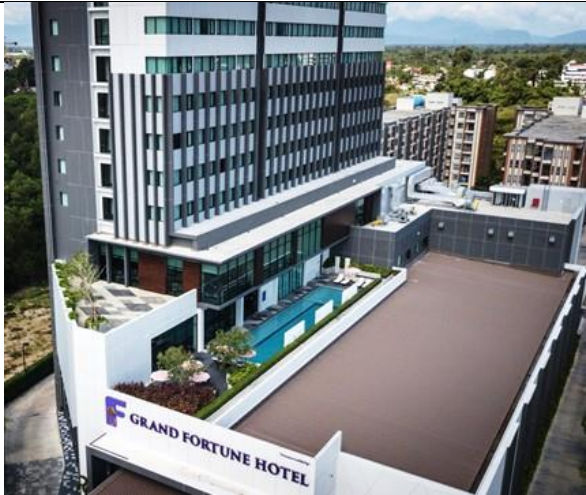
<p>Showing building envelope comprising:</p> <ul style="list-style-type: none"> • Opaque wall using light weight concrete with mixing of dark and light color. • Windows and transparent wall using double laminated tinted glass (green) 6 mm, 2 layers.

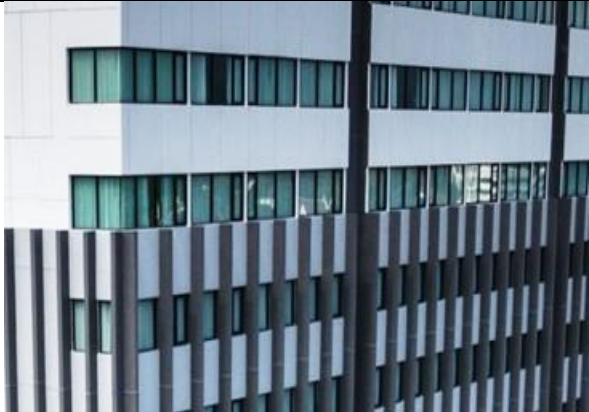
<ul style="list-style-type: none"> • Closer look of windows and transparent wall using double laminated tinted glass.

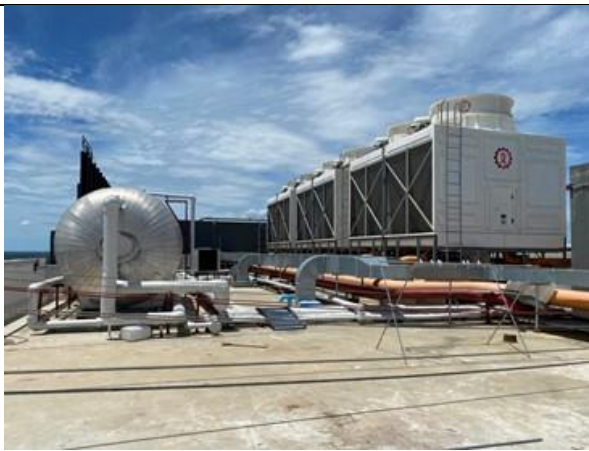
<ul style="list-style-type: none"> • Concrete roof and Insulation batts with fiber glass, no painted.
Building central service areas

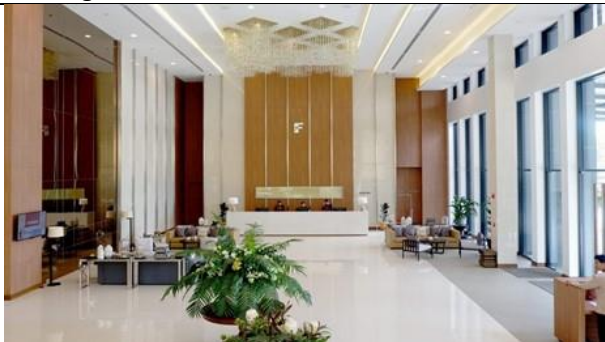
<p>Main lobby area showing:</p> <ul style="list-style-type: none"> • Air conditioned with large chiller water cooled system, and concealed cool air duct supply. • Concealed downlight LED lamps, 6 to 18 Watt. • Natural light from transparent wall and windows. •

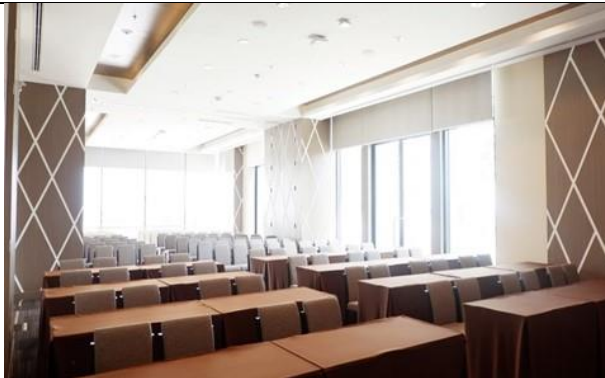
<p>Function room area:</p> <ul style="list-style-type: none"> • Opens from 0800 AM to 12.00 PM. Partially operated or fully operated depend on customer occupancy rate. • Air conditioned with large chiller water cooled system, and concealed cool air duct supply. • Normally the chilled water supply to the function area is not operated, if no events. • Concealed downlight LED lamps, 6 to 18 Watt for lighting. Installed lighting density for function room is 7.09 W/m²

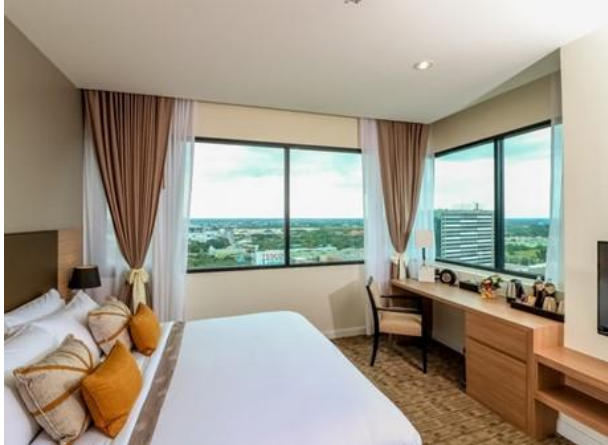
<p data-bbox="863 264 1409 322">Typical interior from the show room of the guest room units showing:</p> <ul data-bbox="863 331 1409 555" style="list-style-type: none"> • Concealed downlight LED lamps. • Split-type air conditioning units. • Electric appliances including refrigerator, TV, electric kettle. All electric appliances are energy efficiency No.5 label products. • Hot water supplies by air-source heat pump water heater system.

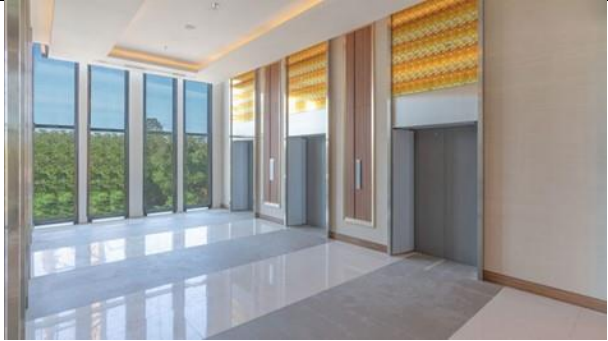
<p data-bbox="863 741 1409 770">Hall way and lift area to guest room in each floor:</p> <ul data-bbox="863 779 1409 1039" style="list-style-type: none"> • Hall way areas are non-air conditioned. • Concealed downlight LED lamps. • Utilize of natural light from transparent wall and windows. • Opens 24 hours on floors with guest occupancy, but turns off lighting and cooled air supplied in the floor that no guest occupies.

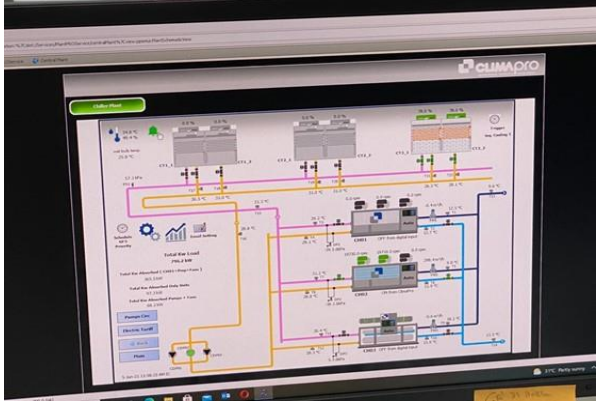
<p data-bbox="229 1120 400 1142">Cooling system</p>  	<p data-bbox="863 1149 1409 1207">Main chilled water supply for cooling system for whole building:</p> <ul data-bbox="863 1249 1409 1406" style="list-style-type: none"> • The chiller was utilized only two units as maximum with one chiller unit run in full-load operation, and one chiller runs in part load. • The chiller utilization level is about 50%-60%. as of less than 50% guest occupancy rate.

<p data-bbox="863 1583 1409 1675">The overall chiller system is controlled with the chiller management system (Climo Pro) with variable speed drive (VSD) pumps.</p>

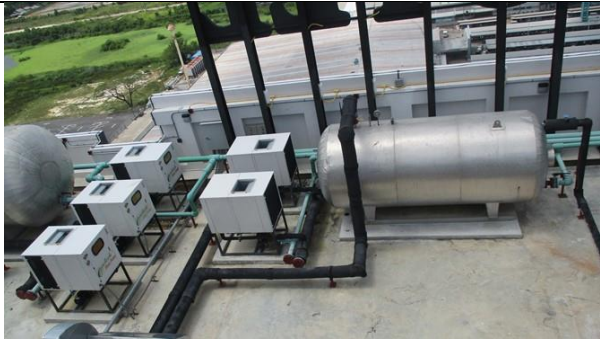
<p data-bbox="863 266 1342 293">Air-source heat pump water heater system:</p> <ul data-bbox="863 300 1401 651" style="list-style-type: none"> • Original designed 2 units of air source heat pump for swimming pool and hotel service area • Changed from electric water heater for guest rooms to air-source heat pump water heater during the construction phase, with heating capacity 36,000 watts and a cooling capacity 90,077 Btu/hr x 3 units • These additional 3 units of heat pump water heater supply hot water for all guest rooms (316 rooms)
<p data-bbox="229 658 416 685">Electrical system</p>

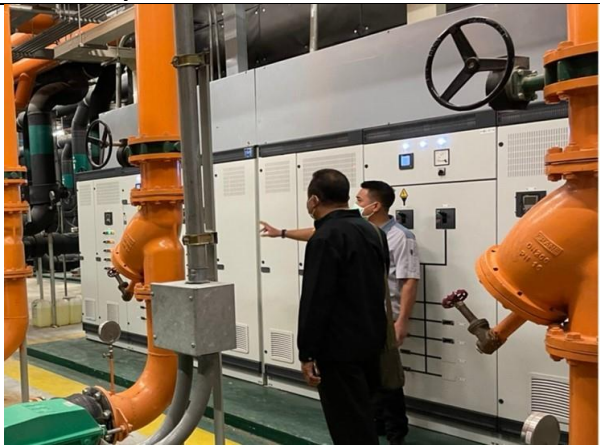
<p data-bbox="863 692 1406 719">Main distribution board for electricity distribution</p> <ul data-bbox="863 725 1406 882" style="list-style-type: none"> • Metering cabinets installing electricity meters (analog kWh meters) for recording and electricity billing of each major equipment and to main distribution board to each floor.

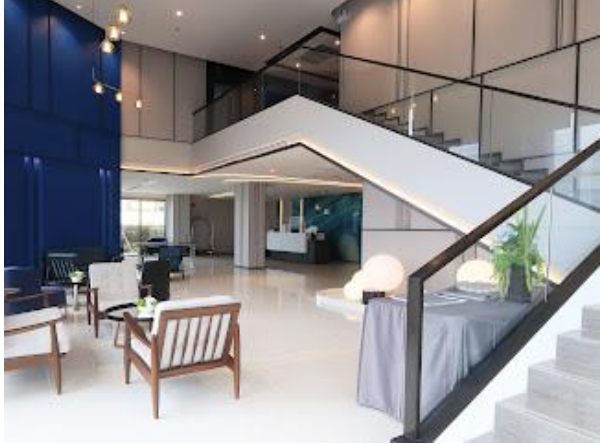
<ul style="list-style-type: none"> Main lobby with decorated LED lamps.

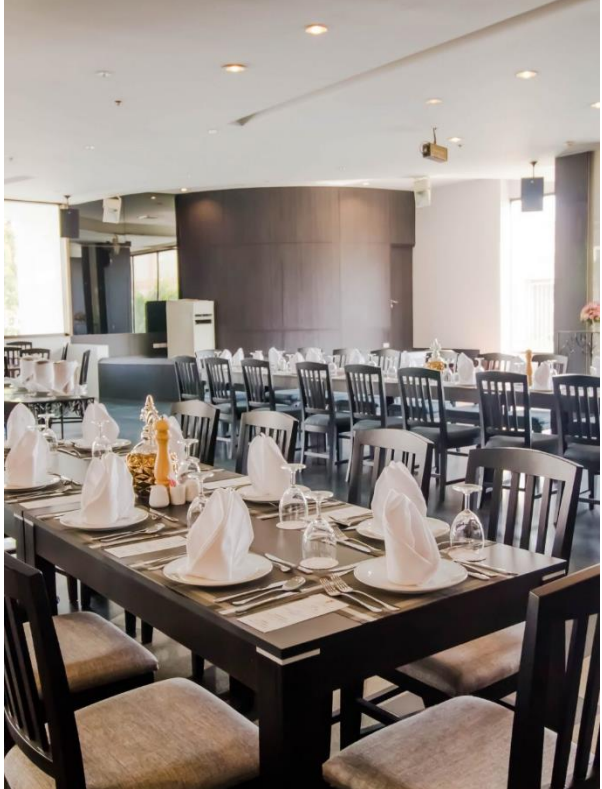
<ul style="list-style-type: none"> Dining room with concealed downlight LED lamps.

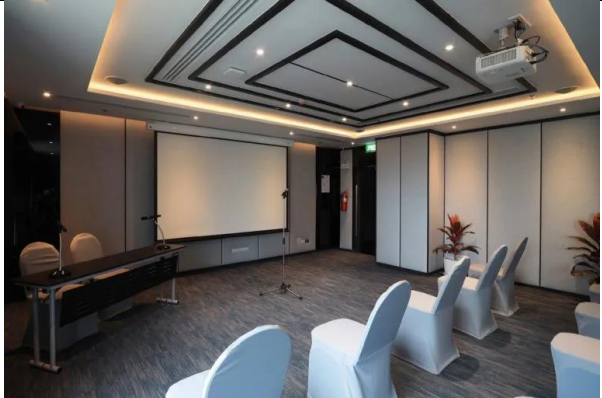
<ul style="list-style-type: none"> Meeting room with concealed downlight LED lamps and transparent wall with day lighting.

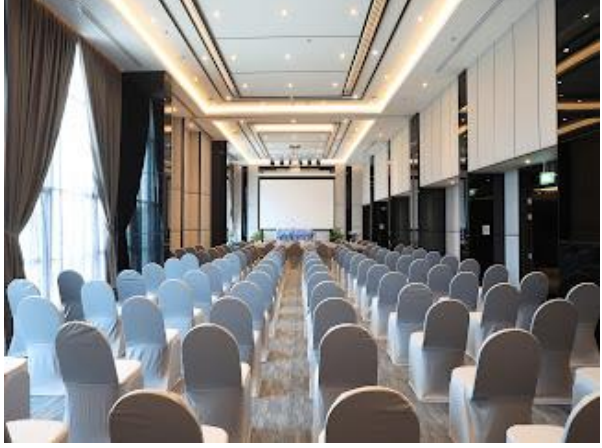
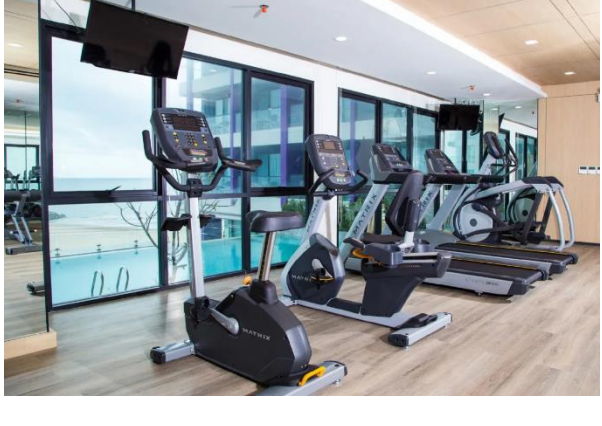
<ul style="list-style-type: none"> • Fitness center with concealed downlight LED lamps and transparent walls.

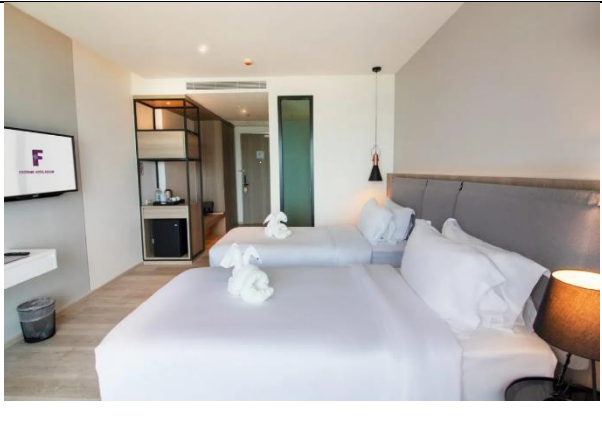
<p>Typical interior of guest rooms showing:</p> <ul style="list-style-type: none"> • Concealed downlight LED lamps. • Concealed fan coil of the VRF air conditioning system. • Electric appliances including LED TV and refrigerator.

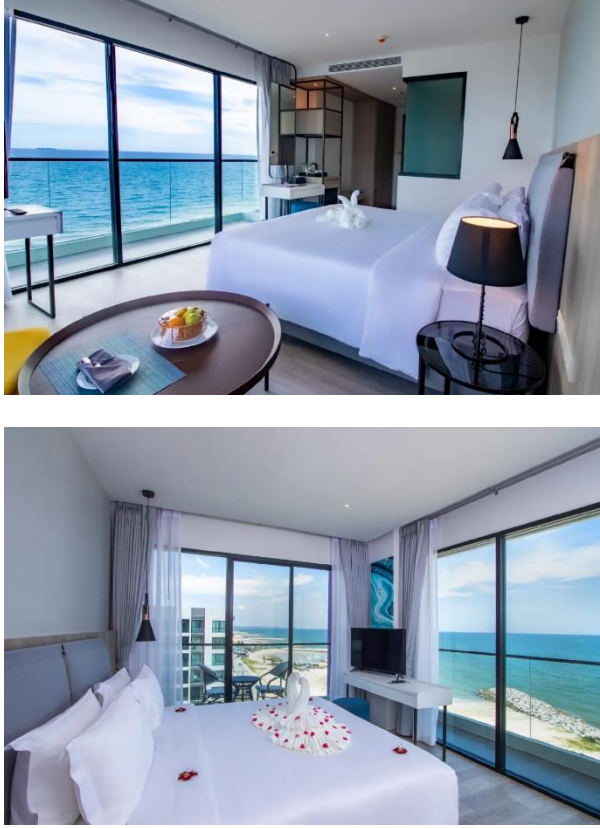
<ul style="list-style-type: none"> View from the luxury guest rooms with transparent walls for sea view and daylighting.
<p>Building Utilities Electrical system</p>

The BEC team recommends changing of glass on transparent walls from 8 mm laminated to 8 mm reflective glass to reduce air conditioning heat gain. From the web-based BEC calculation OTTV could be reduced from 55.01 W/ m² to 28.75 W/m².

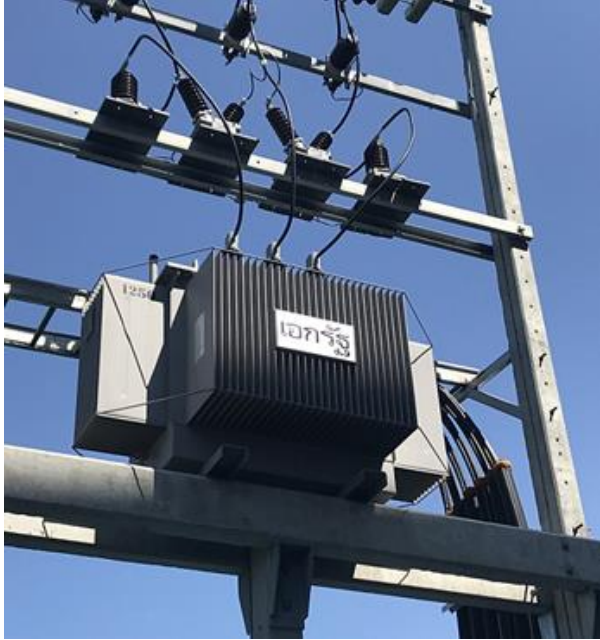
<ul style="list-style-type: none"> 1250 kVA PEA transformer for electricity supply to the building

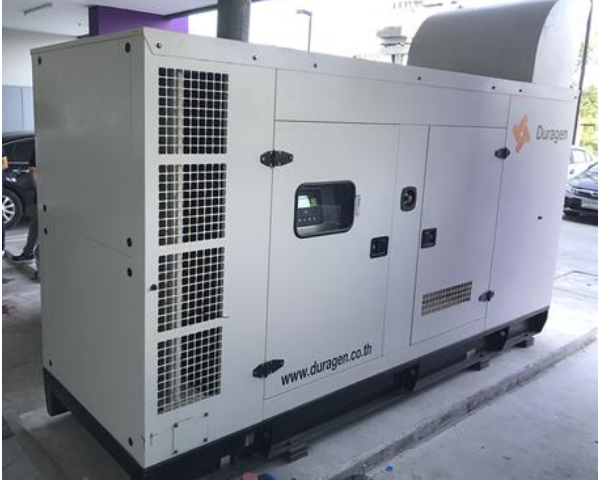
<ul style="list-style-type: none"> • 275 kVA backup diesel generator.
Air conditioning system

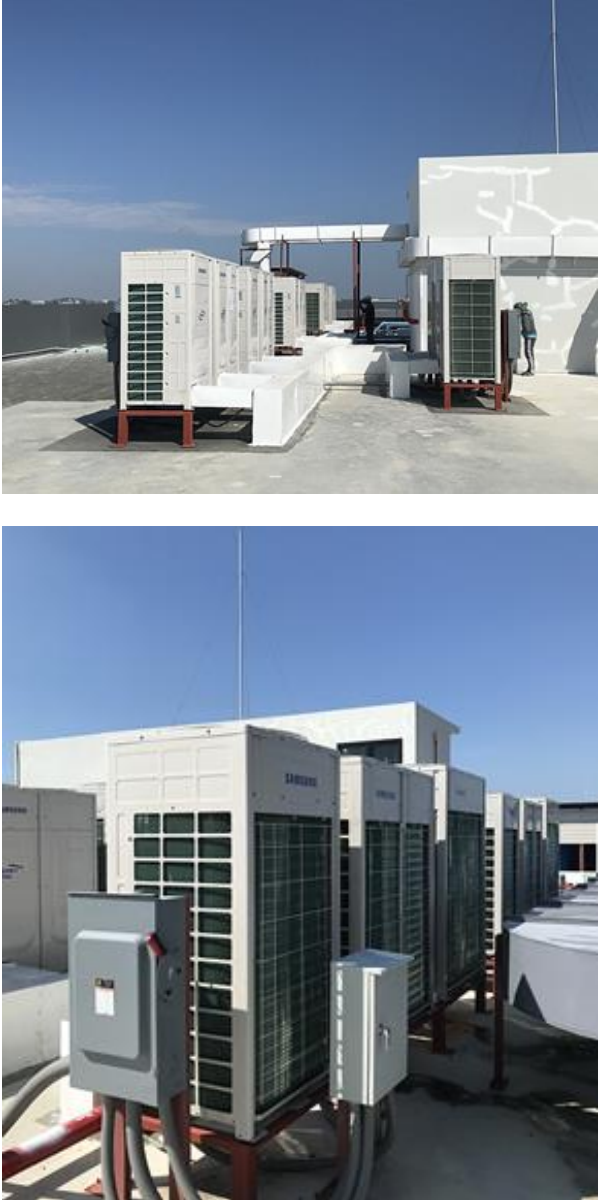
<ul style="list-style-type: none"> • Condensing units of the VRF air conditioning system for the whole building.
Hot water generation system

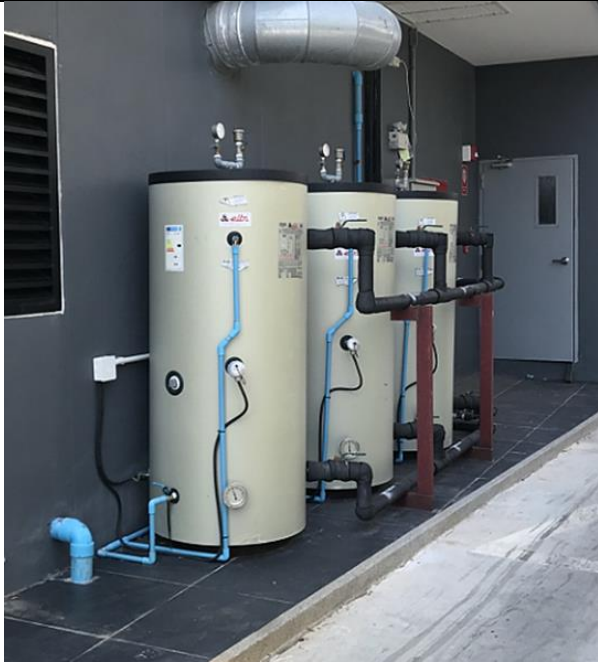
<ul style="list-style-type: none"> • 3 units of electric hot water heaters for central production of hot water.

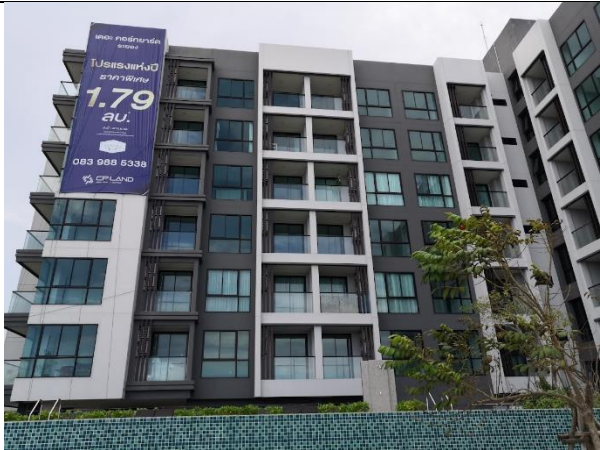
<p>Showing building envelope comprising:</p> <ul style="list-style-type: none"> • Opaque wall using light weight concrete with mixing of dark and light color. • Windows and transparent wall using ocean green tinted glass.

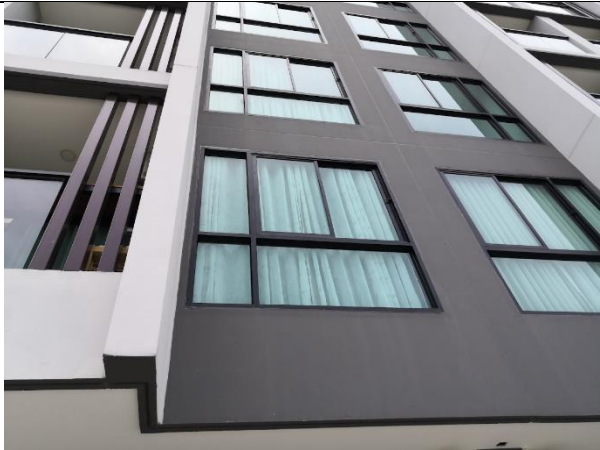
<ul style="list-style-type: none"> • Closer look of windows and transparent wall using ocean green tinted glass.

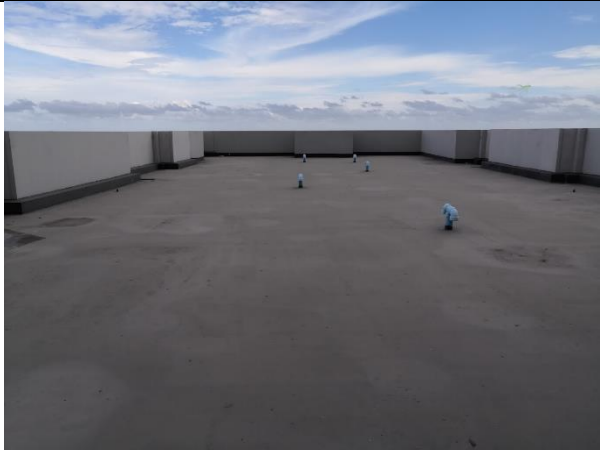
<ul style="list-style-type: none"> • Concrete roof with water prevention coating.
<p>Building central service areas</p>

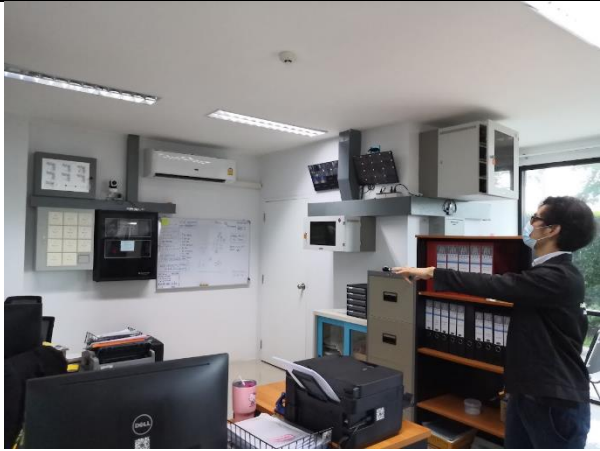
<p>Juris person office:</p> <ul style="list-style-type: none"> • Opens from 0800-1800 weekday • Partial opens 24 hours for stand-by maintenance duty. • Air conditioned with split type air conditioners. • Tubular LED lamps for lighting.
 	<p>Corridor to residence units in each floor:</p> <ul style="list-style-type: none"> • Corridors are non-air conditioned. • Concealed downlight LED lamps. • Opens 24 hours on floors with residence occupancy.
<p>Residence units</p>

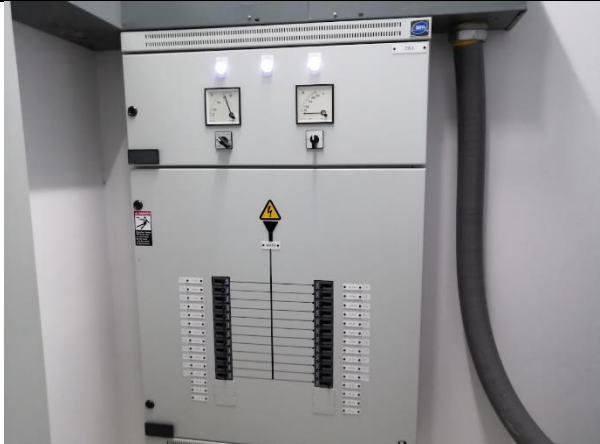
<ul style="list-style-type: none"> • Main distribution board for electricity distribution to residence units on each floor.

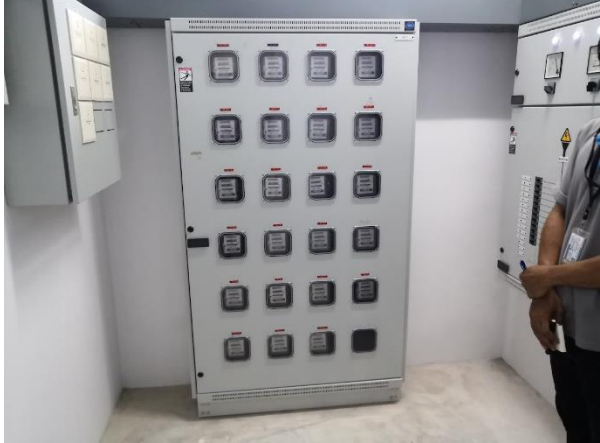
<ul style="list-style-type: none"> • Metering cabinets installing electricity meters (analog kWh meters) for recording and electricity billing of each residence unit.

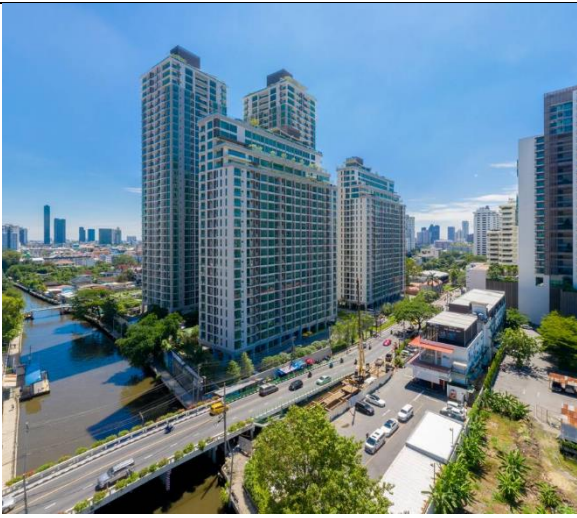
<p>Showing building envelope comprising:</p> <ul style="list-style-type: none"> • Opaque wall using precast concrete with light color. • Windows and transparent wall using mainly laminated tinted glass.

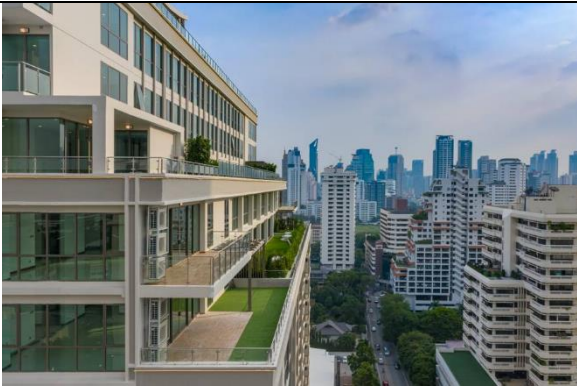
<ul style="list-style-type: none"> • Windows and transparent wall using ocean green laminated tinted glass. • Green roof with plantation over concrete roof for space utilization and heat protection.
Building central service areas

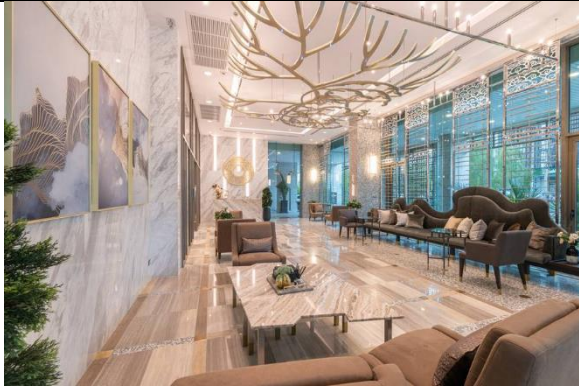
<p>Main lobby area showing:</p> <ul style="list-style-type: none"> • Concealed split type air conditioner. • Decorated and tubular LED lamps. • Transparent walls for natural light and external view.

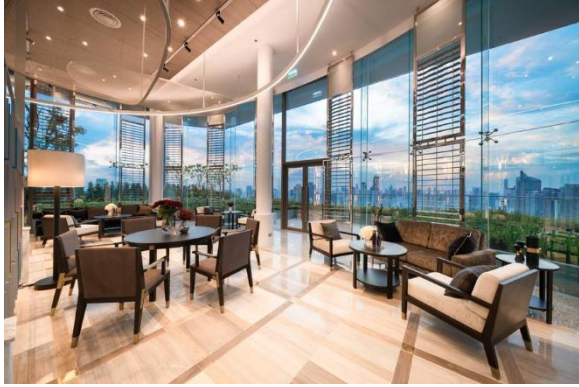
<p>Resting area showing:</p> <ul style="list-style-type: none"> • Decorated and concealed downlight LED lamps. • Transparent walls for natural light and external view.
Residence units

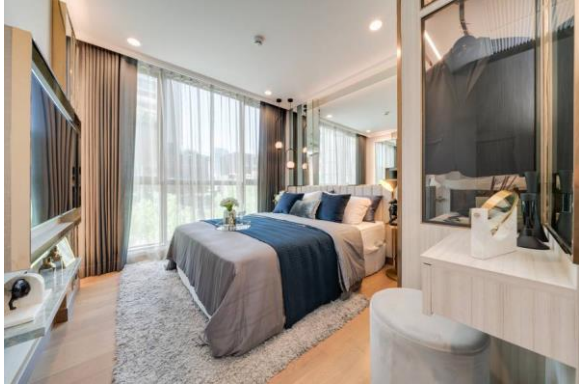
<p>Interior of the bedroom of the small sample residence unit showing:</p> <ul style="list-style-type: none"> • Transparent walls for natural lighting. • Concealed downlight LED lamps. • Split-type air conditioning units.

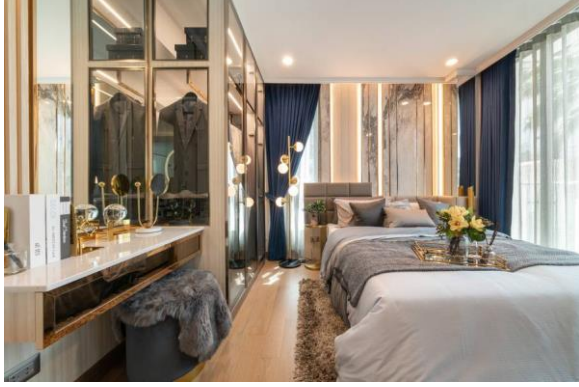
<p>Interior of the bedroom of the small sample residence unit showing:</p> <ul style="list-style-type: none"> • Transparent walls for natural lighting. • Concealed downlight LED lamps. • Split-type air conditioning units.

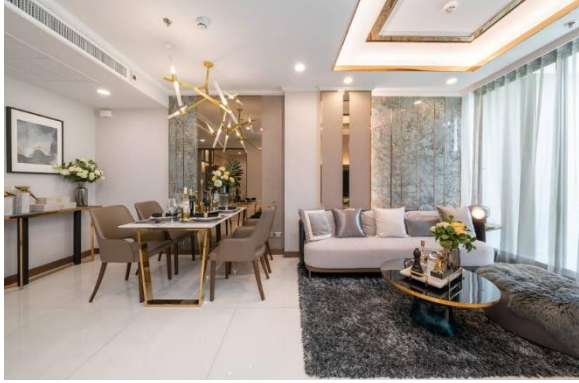
<p>Interior of the integrated dining and living room of the medium-sized sample residence unit showing:</p> <ul style="list-style-type: none"> • Transparent walls for natural lighting. • Concealed downlight LED lamps. • Split-type air conditioning units.

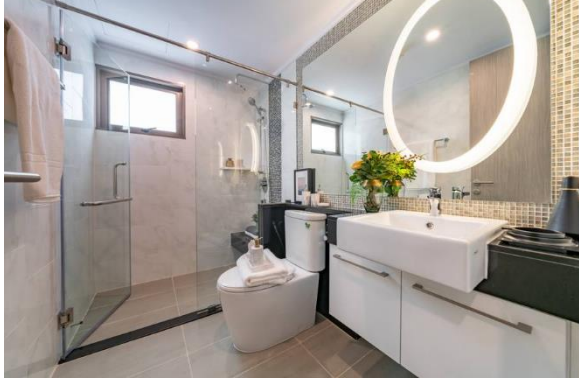
<ul style="list-style-type: none"> • Interior of the bathroom with downlight LED lamps and small window for ventilation.

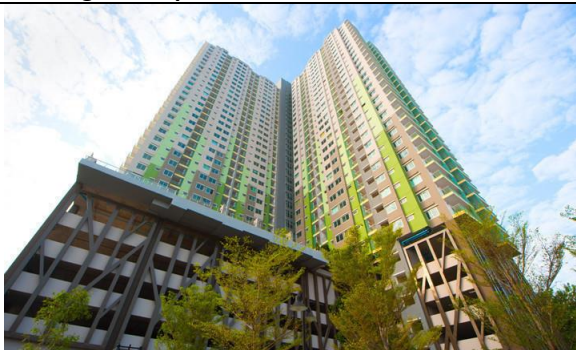
<p>Showing building envelope comprising:</p> <ul style="list-style-type: none"> • Opaque wall using light weight concrete and light brown and green colors. • Windows and transparent wall using mainly laminated tinted glass.
 	<ul style="list-style-type: none"> • Green roof with plantation over concrete roof for space utilization and heat protection.
Building central service areas	
 	<ul style="list-style-type: none"> • Main lobby area showing decorated and tubular LED lamps.

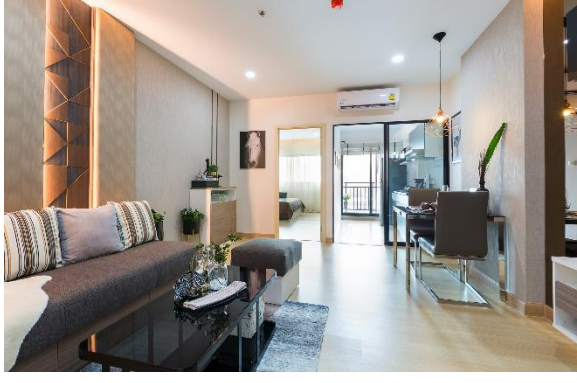
<p>Interior of the living room of the sample residence unit showing:</p> <ul style="list-style-type: none"> • Transparent walls for natural lighting. • Concealed downlight LED lamps. • Split-type air conditioning unit.

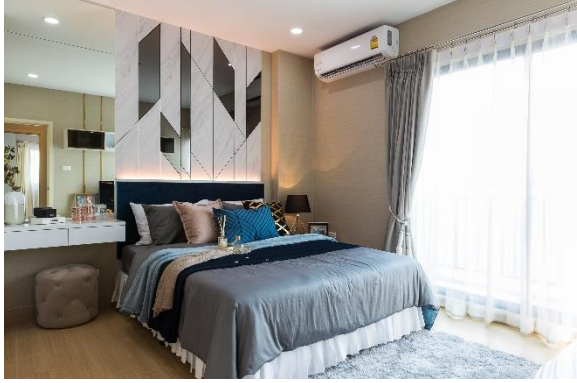
<p>Interior of the bedroom of the sample residence unit showing:</p> <ul style="list-style-type: none"> • Transparent walls for natural lighting. • Concealed downlight LED lamps. • Split-type air conditioning unit.

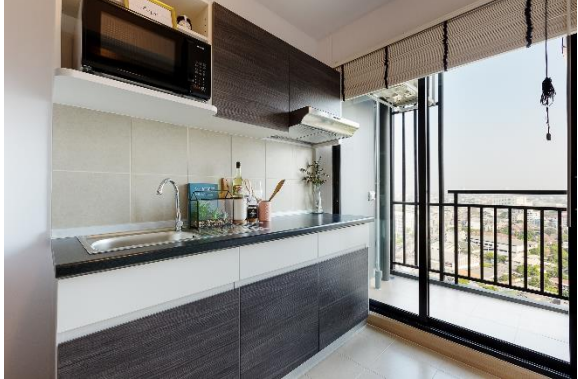
<p>Interior of the kitchen of the sample residence unit showing:</p> <ul style="list-style-type: none"> • Transparent wall for natural lighting. • Verandah for outdoor atmosphere and shading to the transparent wall.

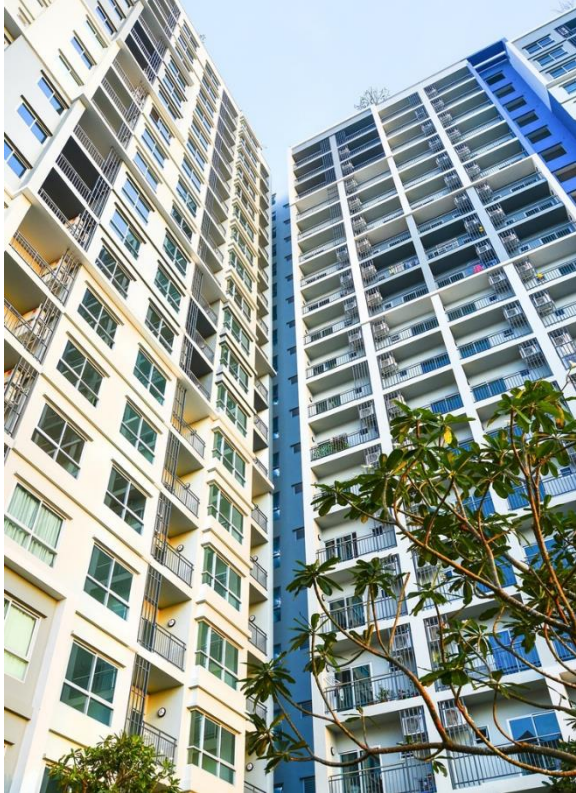
<p>Showing building envelope comprising:</p> <ul style="list-style-type: none"> • Opaque wall using light weight concrete and light colors. • Windows and transparent wall using laminated tinted glass.

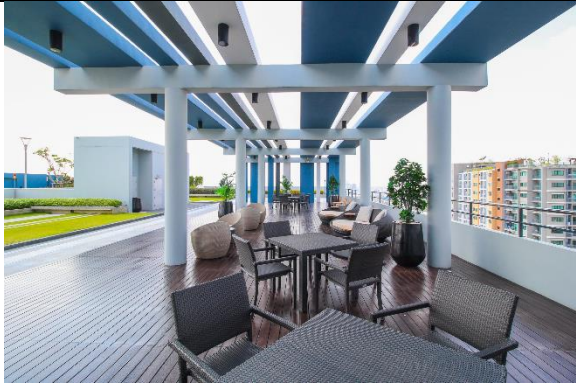
<ul style="list-style-type: none"> • Concrete roof being covered by garden and outdoor lounge.
Building central service areas

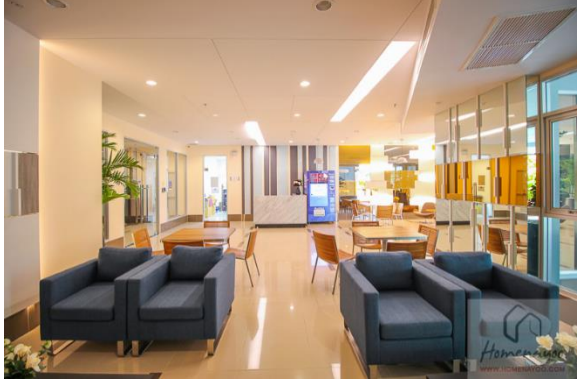
<p>Main lobby area showing:</p> <ul style="list-style-type: none"> • Tubular LED and concealed downlight LED lamps. • Concealed air conditioning unit.

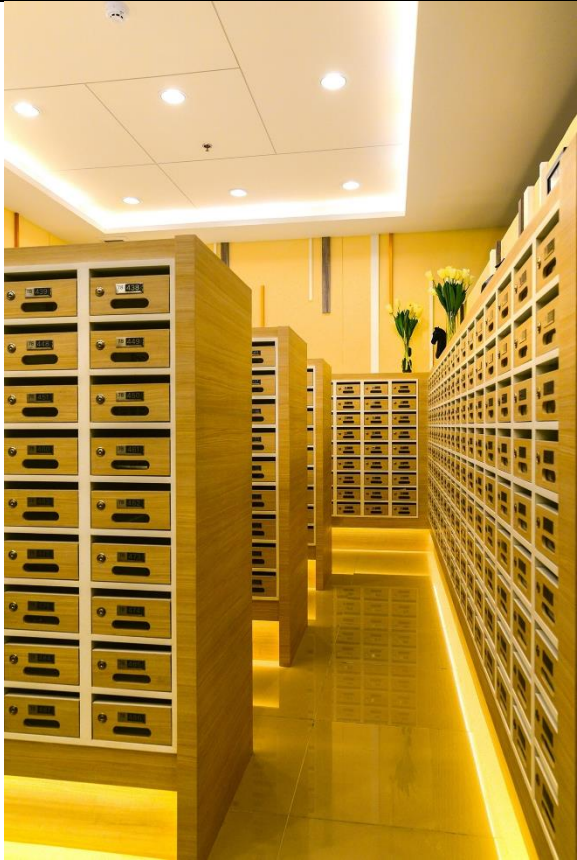
<ul style="list-style-type: none"> • Lift hall and mail box areas with concealed downlight and decorated LED lamps.

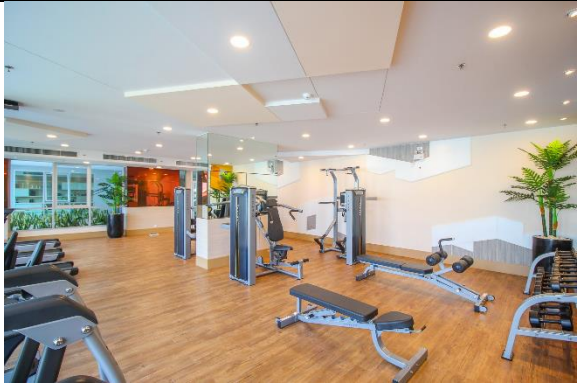
<p>Fitness room showing:</p> <ul style="list-style-type: none"> • Transparent walls for natural lighting. • Decorated and concealed downlight LED lamps. • Concealed air conditioning units.
<p>Residence units</p>

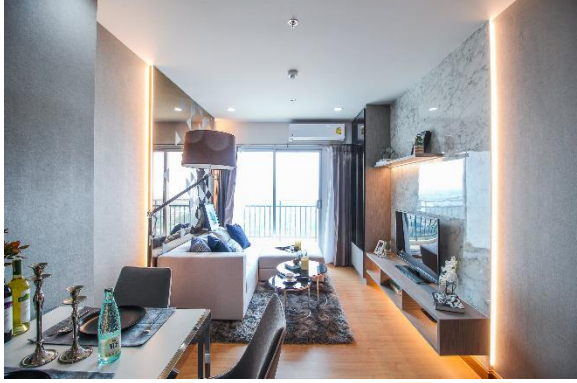
<p>Interior of the living room of the sample residence unit showing:</p> <ul style="list-style-type: none"> • Transparent walls for natural lighting. • Concealed downlight LED lamps. • Split-type air conditioning unit.

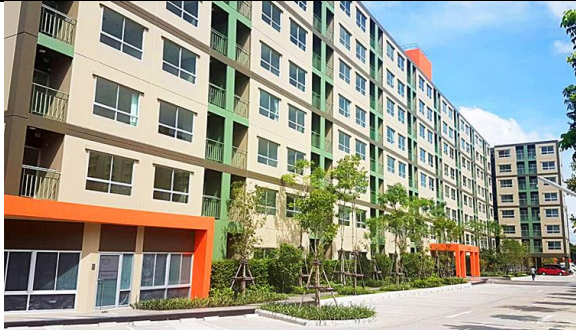
<p>Showing building envelope comprising:</p> <ul style="list-style-type: none"> • Opaque wall using precast concrete with light color. • Windows and transparent wall using tinted glass.

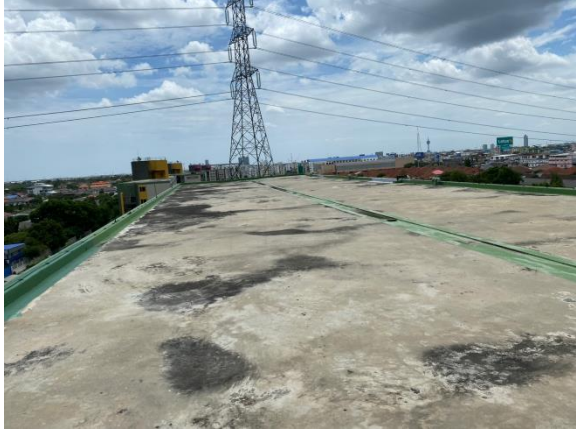
<ul style="list-style-type: none"> • Roof made of concrete slab.
Building central service areas

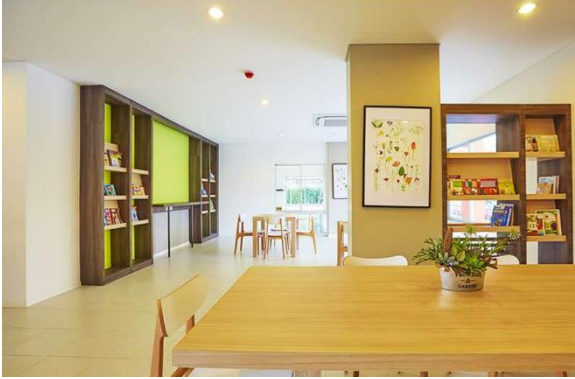
<p>Library room showing:</p> <ul style="list-style-type: none"> • Concealed split type air conditioner. • Concealed downlight LED lamps. • Transparent walls for natural lighting.
<p>Residence units</p>

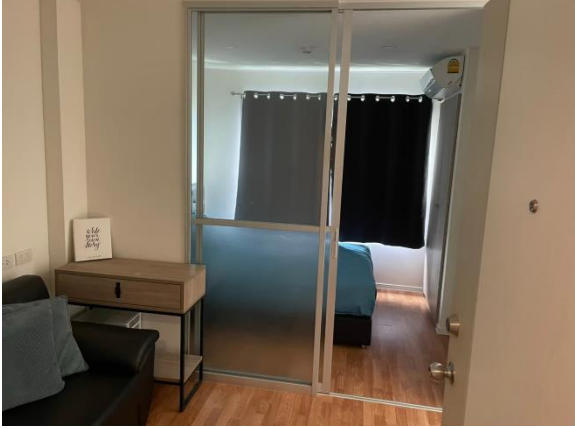
<p>Interior of the example bedroom in small residence units showing:</p> <ul style="list-style-type: none"> • Transparent walls for natural lighting. • Concealed downlight LED lamps. • Split-type air conditioning units.

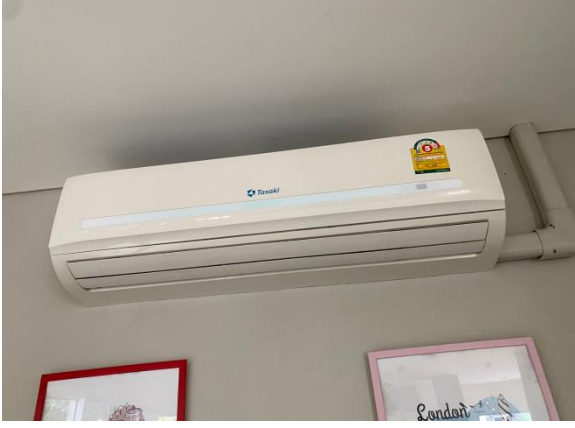
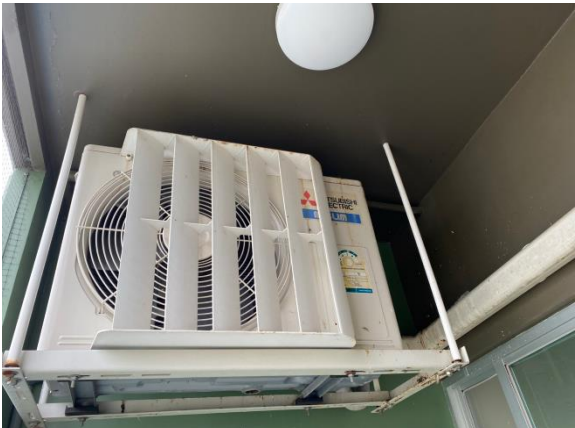
<ul style="list-style-type: none"> • Split-type air conditioner for the residence unit.

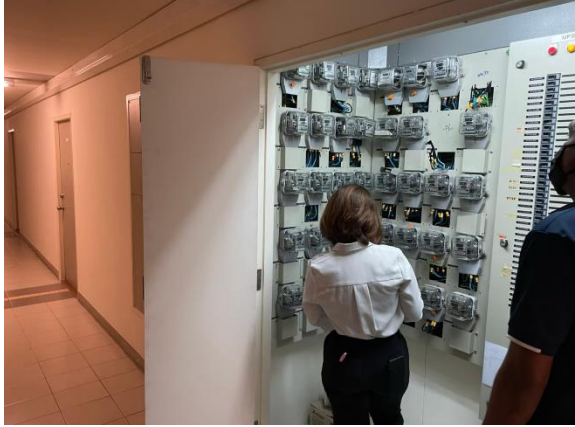
<ul style="list-style-type: none"> <li data-bbox="831 271 1398 360">• Floor power distribution board and analog electricity meters for measuring electricity consumption and billing of each residence unit.
