Provision of Services Related to Enabling Readiness for Up Scaling Investments in Building Energy Efficiency for Achieving NDC Goals in Thailand

PROGRESS REPORT 5: REPORT ON CONDUCT ENERGY AUDITS ON THE FIVE BUILDING TYPES (TASK 4)

INTERNATIONAL INSTITUTE FOR ENERGY CONSERVATION - ASIA

December 2021

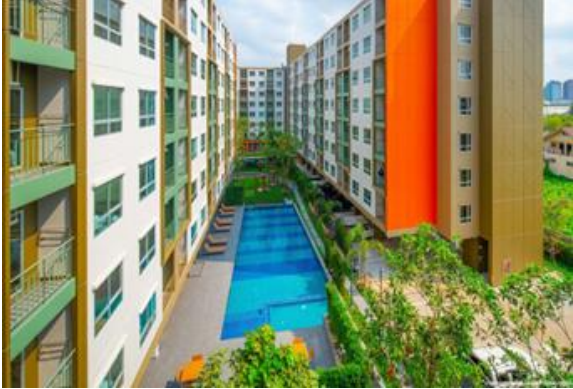
<p>Showing building envelope comprising:</p> <ul style="list-style-type: none"> • Opaque wall using precast concrete with mixing of light and bright colors. • Windows and transparent wall using tinted glass.

The BEC team has recommended to change the glass of the air conditioned areas from tinted glass to reflective glass to reduce heat gain through transparent walls and windows.

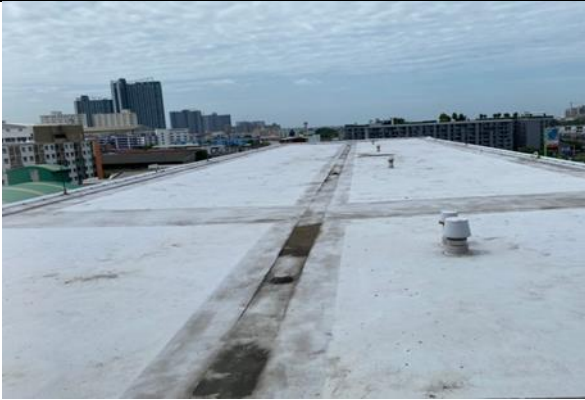
<ul style="list-style-type: none"> • Roof made of concrete slab.
Building central service areas

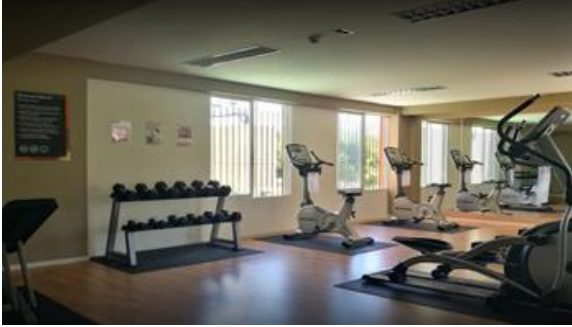
<p>Fitness room showing:</p> <ul style="list-style-type: none"> • Concealed tubular fluorescent lamps. • Transparent walls for natural lighting
Residence units	
 	<p>Interior of the bedroom of the sample residence unit showing:</p> <ul style="list-style-type: none"> • Transparent walls for natural lighting. • Concealed downlight LED lamps. • Split-type air conditioning units.
Electrical system

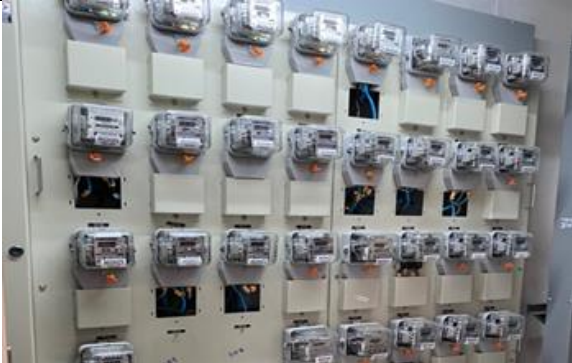
<ul style="list-style-type: none"> • Floor power distribution board and analog electricity meters for measuring electricity consumption and billing of each residence unit.

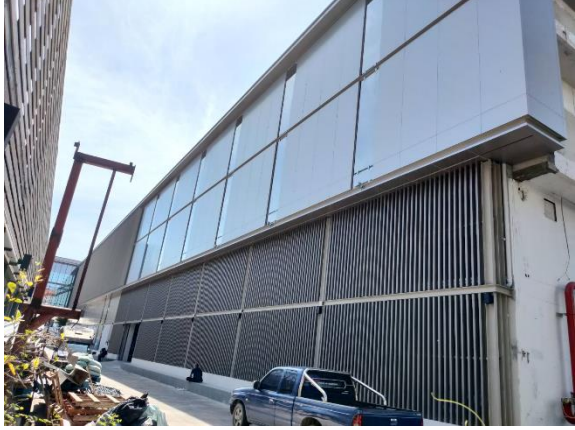
<ul style="list-style-type: none"> • Opaque wall with insulation and aluminium composite.

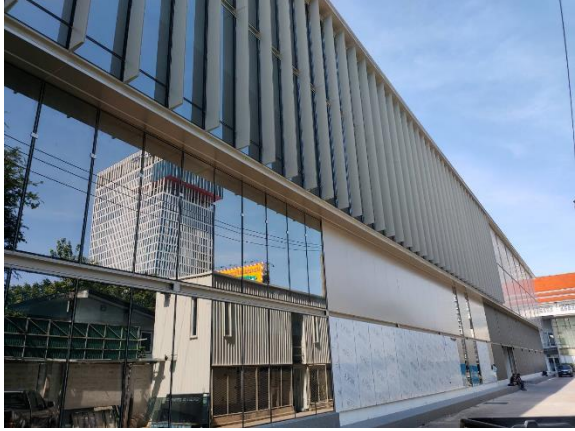
<ul style="list-style-type: none"> • Transparent walls with heat stop low-e insulating glass and vertical blinds for shading.

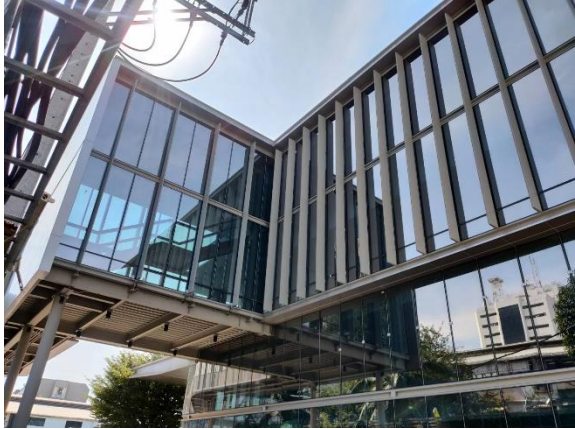
<ul style="list-style-type: none"> • Transparent walls providing high amount of natural light to the office areas and walk ways.
