# CTCN Sudan Case Studies

Combined Report (Field and NDVI Analysis)

## Executive Summary

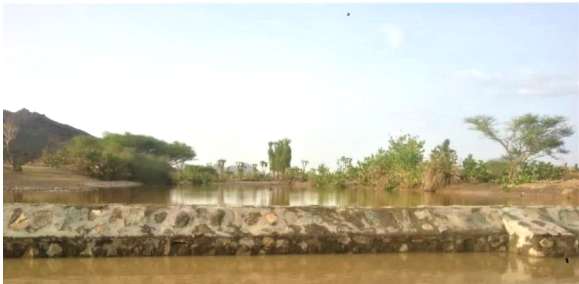
Figure 1, The Anikwan sand dam in Red Sea State shortly after the rainy season. The masonry structure spans the wadi channel, retaining runoff and coarse sediment to enhance infiltration and sustain groundwater recharge in the dry months.

The sand dam was designed with a 25-meter width and a 3.5-meter foundation depth, sufficient to act as a subsurface barrier that slows runoff and enhances infiltration into the wadi sand body. A settling basin was later added upstream to reduce sediment load and protect the wadi bed from scouring.

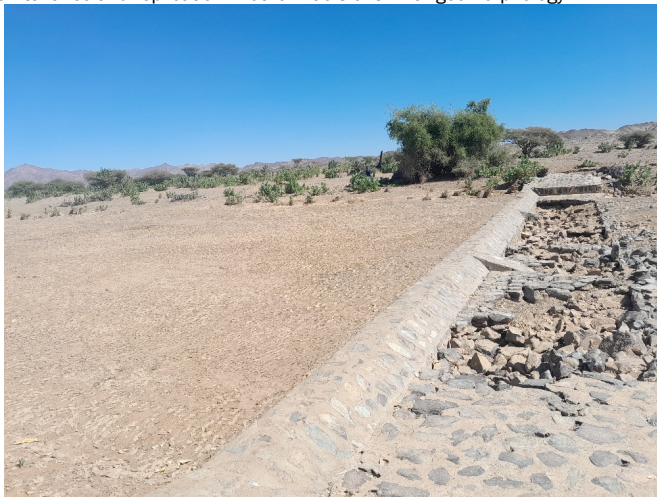
Figure 4 Anikwan dam in 2025. While the dam main body is in good condition, downstream energy dissipator requires urgent maintenance.

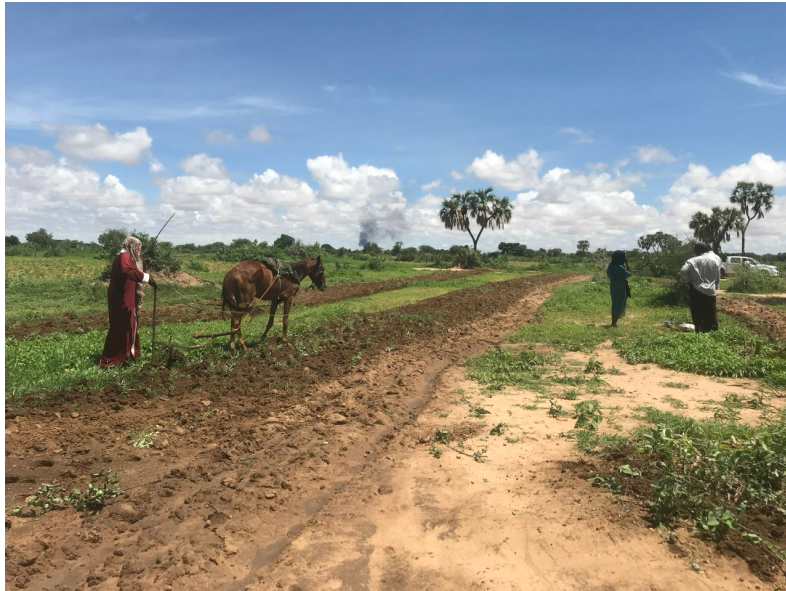
Figure 9 Local farmers utilizing the newly irrigated land by the diversion canal

- For the first time in more than 10 years, water once again flowed through the Baba irrigation canal.
- Over 40 gardens were irrigated directly by surface water.
- Approximately 120 farmers resumed winter irrigation, producing vegetables and fruits that had disappeared from the local diet.
- More than 35 open wells recorded increased static water levels, confirming improved shallow aquifer recharge through near-bank infiltration.
- The village water yard yield rose significantly as a result of higher groundwater levels.
- The weir stabilized the wadi channel and created a hydraulic jump that dissipated flood energy, reducing downstream bank erosion.

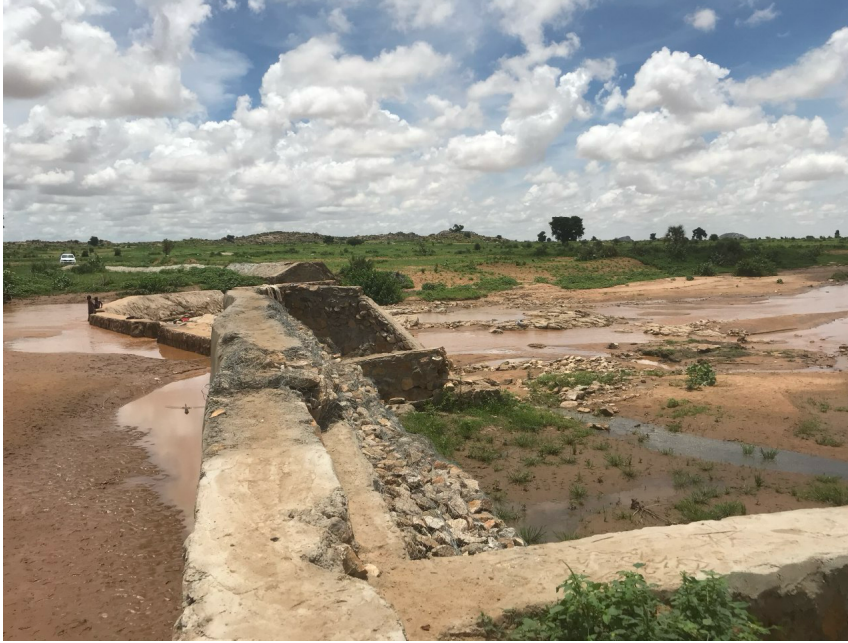
Figure 10 Baba dam after 2 seasons after construction. Source: ZOA International

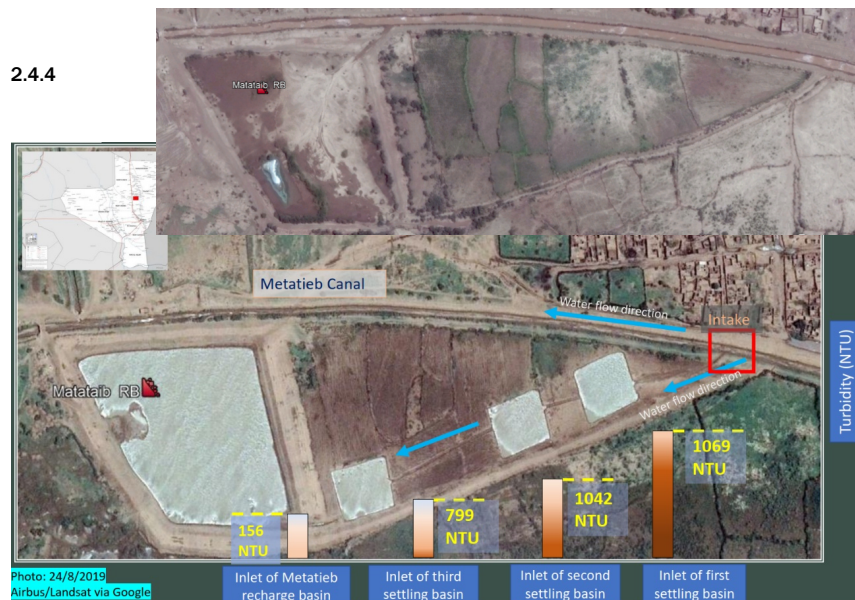
Figure 12. Aerial views of the Matateib artificial recharge system in North Delta, Kassala State. The upper image shows the Matateib recharge basin and nearby agricultural plots along the Gash irrigation canal. The lower annotated image illustrates the sediment pre-treatment system introduced under the project: an elongated diversion canal with three sequential stilling basins (each 50 × 50 m, 1 m deep) designed to slow flow and trap sediment before water reaches the recharge basin. Turbidity values measured at each stage (1069 → 1042 → 799 → 156 NTU) confirm an 80% reduction in suspended load, demonstrating the system's effectiveness in minimizing basin clogging and extending operational life.

These stilling basins act as a cascade of sediment traps, dissipating flow energy and allowing suspended solids to settle sequentially. As a result, only partially clarified water enters the main infiltration basin – substantially reducing surface clogging and improving infiltration performance.

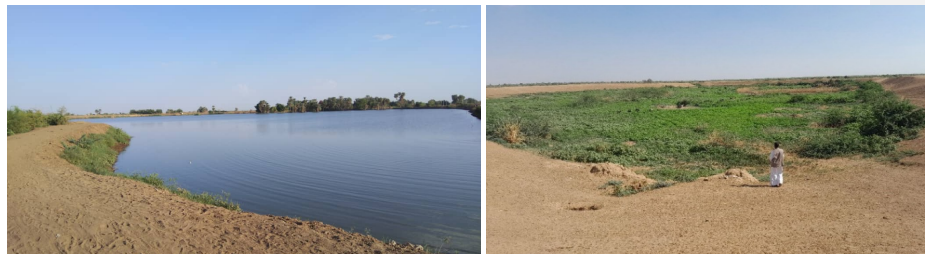
Figure 13. Left: The recharge basin during the wet season, showing full storage of diverted floodwater (Source: Plan International). Right: The same basin during the dry season, where vegetation growth indicates moisture retention and localized groundwater recharge (Source: field work 2024).
