Detailed Work Packages and Standard Structural Repair and Retrofit Drawings

Technical Assistance for Resilience to Climate Variability in the Building Sector of Antigua and Barbuda

Project No: 18106

Detailed Work Packages Consisting, Site Plans, Standard Retrofit Drawings and Engineering Cost Estimates for 34 Buildings

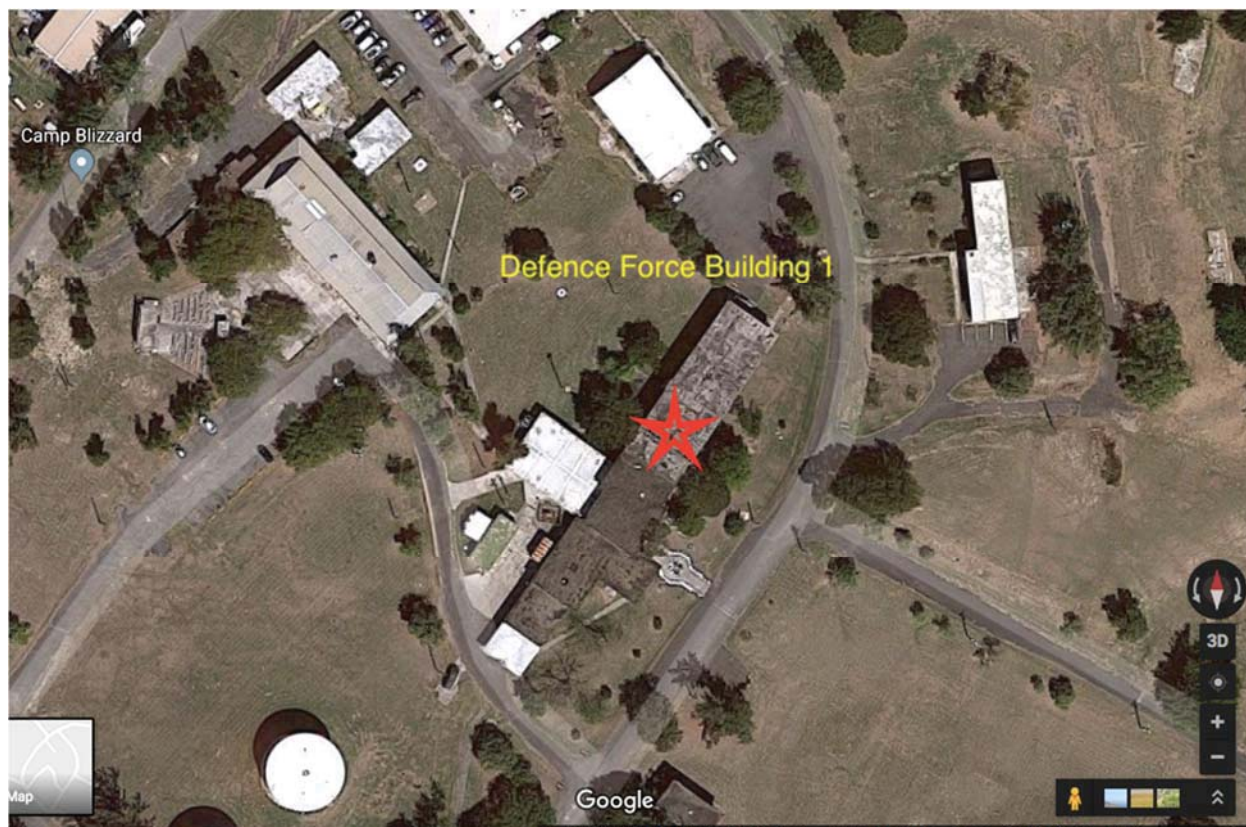
Facility Name:	Defence Force Building 1	Year built:	
Building Name:	Defence Force Building 1	Year(s) remodelled:	
Building Address:	Defence Force Building 1	Original Design Code:	Built By US army
Latitude:	17.1575905	Area (m2):	234
Longitude:	61.7950701	Length (m):	30.8
Use:	Military	Width (m):	7.6
Risk Category:	IV	No. of storeys:	2
Occupancy Group:	Group B	Storey height (m):	3.06
No. of occupants:	100	Total height (m):	6.1
Roof shape:	Flat	Walls	Concrete Blocks
Roofing:	Concrete	Structural system	Concrete Frame
Overall Condition	Low		
Comments	Building is in very poor condition and is in urgent need of repairs. The Risk Category also suggest that urgent action is required

Task No.	Interventions/Improvements	Unit	Quantity	Unit Rate (USD)	Total (USD)
DFB1-01	Condition of the building - as per Engineer's drawings and specifications				
	Introduce new columns so as to improve redundancy of structure	lm	20	495	9,900
	Stiffening of an existing floor and tying it into the walls	sum	1	5,000	5,000
	Increase capacity of columns	nr	10	300	3,000
	Increase capacity of beams	lm	20	300	6,000
	Introduce new collector beams to improve capacity of floor	lm	20	495	9,900
	Increasing flexural and shear strength by adding reinforcing bars and stirrups	sum	1	2,500	2,500
	Repair beams spalling and honeycombing as detailed	lm	20	150	3,000
	Repair slab soffits for spalling and honeycombing	m ²	75	320	24,000
DFB1-02	Safety of Foundations - as per Engineer's details and specifications				
	Reconstruct severely damaged foundation walls, strip and spread footings	lm	20	470	9,400
DFB1-03	Structural Integrity of Roofs

Installing and improving secondary underlayments	m ²	234	60	14,040
	Replace and retrofit entire ceiling	m ²	468	88	41,184
DFB1-04	Exterior Doors, Exits and Entrances				
	Protecting existing door with an impact-resistant covering	nr	4	1,000	4,000
	Install threshold to prevent ingress of water	nr	4	100	400
	Fasten door frames into concrete surrounds with bolts or screws	nr	4	30	120
DFB1-05	Windows and shutters				
	Replace existing windows with standard operable or fixed windows and install shutters with Miami Dade NOA	m ²	135	1,270	171,450
DFB1-06	Other Elements of the Building Envelope				
	Repair cracks > 6 mm using a welded mesh	sum	1	15,000	15,000
DFB1-07	Safety of roofing				
	Repair small cracks with epoxy grout	sum	1	3,500	3,500
DFB1-08	Parapets and other outside Elements (railings, ornaments)				
	Repair cracks > 6 mm using a welded mesh	sum	1	5,000	5,000
DFB1-09	Internal walls - concrete masonry units finishd with mortar plastering

Replace entire existing masonry wall with the inclusion of a ring beam	m ²	72	475	34,200
DFB1-10	False or Suspended Ceilings				
	Replace and retrofit entire ceiling	m ²	468	31	14,508
DFB1-11	Safety of stairways and Ramps				
	Reconstruct up to 50% of the staircase	sum	1	3,750	3,750
DFB1-12	Condition and safety of floor coverings				
	Allow for repairs to defective areas of the floor finish - allow for 100% of floor area	m ²	468	88	41,184
	To Collection				421,036

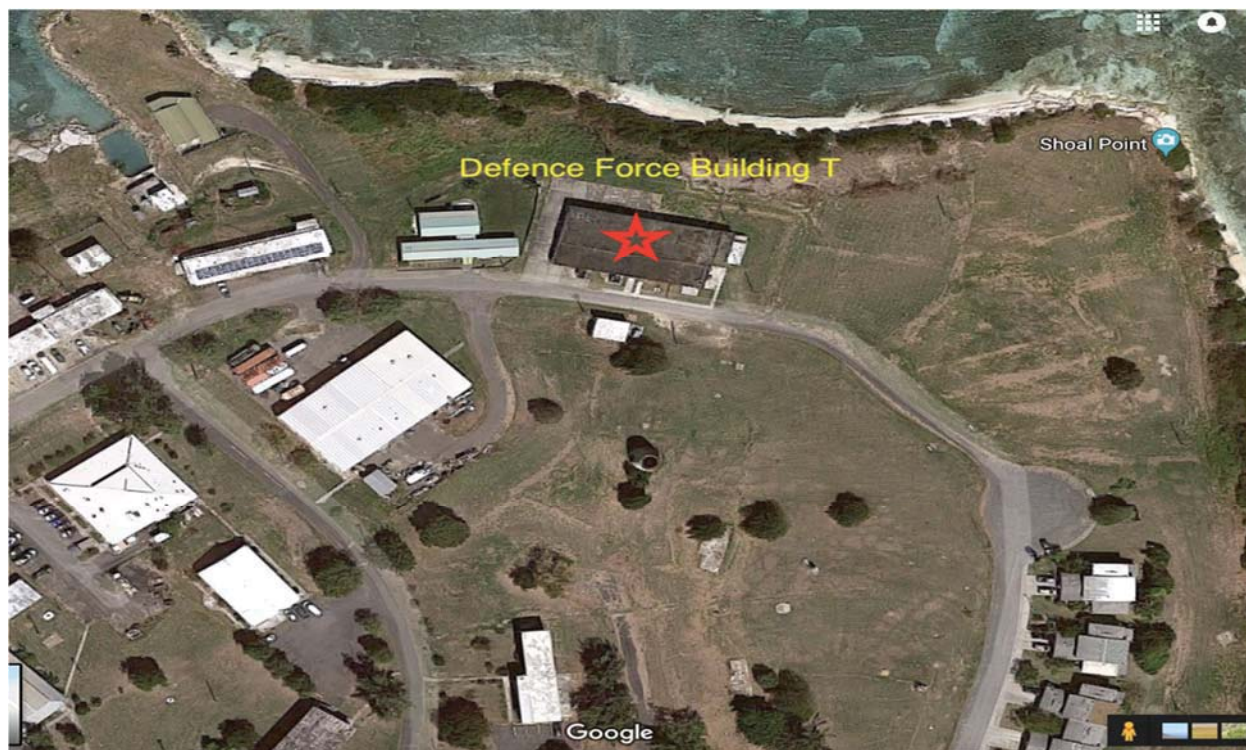
Facility Name:	Defence Force Building T	Year built:	
Building Name:	Defence Force Building T	Year(s) remodelled:	
Building Address:	Building T	Original Design Code:	Built By US Army
Latitude:	17.1575905	Area (m2):	609
Longitude:	61.7950701	Length (m):	30.8
Use:	Military	Width (m):	19.6
Risk Category:	IV	No. of storeys:	1
Occupancy Group:	Group B	Storey height (m):	3.06
No. of occupants:	50	Total height (m):	4.6
Roof shape:	Flat	Walls	Concrete Blocks
Roofing:	Concrete	Structural system	Concrete Frame
Overall Condition	Low		
Comments	In an extremely poor condition and the exposure to the sea warrants works being undertaken in the immediate term. The Risk Category also suggest that urgent action is required

Task No.	Interventions/Improvements	Unit	Quantity	Unit Rate (USD)	Total (USD)
DFTB-01	Condition of the building - as per Engineer's drawings and specifications				
	Introduce new columns so as to improve redundancy of structure	lm	20	495	9,900
	Stiffening of an existing floor and tying it into the walls	sum	1	5,000	5,000
	Increase capacity of columns	nr	10	300	3,000
	Increase capacity of beams	lm	20	300	6,000
	Introduce new collector beams to improve capacity of floor	lm	20	495	9,900
	Increasing flexural and shear strength by adding reinforcing bars and stirrups	sum	1	2,500	2,500
	Repair beams spalling and honeycombing as detailed	lm	20	150	3,000
	Repair slab soffits for spalling and honeycombing	m ²	75	320	24,000
DFTB-02	Safety of Foundations - as per Engineer's details and specifications				
	Reconstruction of severely damaged foundation walls, strip and spread footings	lm	40	470	18,800
DFTB-03	Structural Integrity of Roofs

Repair small cracks with epoxy grout	lm	100	5	500
DFTB-04	Exterior Doors, Exits and Entrances				
	Protecting existing door with an impact-resistant covering	nr	4	1,000	4,000
	Install threshold to prevent ingress of water	nr	4	100	400
	Fasten door frames into concrete surrounds with bolts or screws	nr	4	30	120
DFTB-05	Windows and shutters				
	Replace existing windows with standard operable or fixed windows and install shutters with Miami Dade NOA	m ²	135	1,270	171,450
DFTB-06	Other Elements of the Building Envelope				
	Repair cracks > 6 mm using a welded mesh	sum	1	10,000	10,000
DFTB-07	Safety of roofing				
	Installing and improving new built-up roofing with proper underlayments	m ²	609	60	36,540
DFTB-08	Internal walls - concrete masonry units finishd with mortar plastering				
	Replace entire existing masonry wall with the inclusion of a ring beam	m ²	175	475	83,125
DFTB-09	False or Suspended Ceilings

Replace and retrofit entire ceiling	m ²	609	31	18,879
DFTB-10	Condition and safety of floor coverings				
	Allow for repairs to defective areas of the floor finish - allow for 100% of floor area	m ²	609	91	55,419
	To Collection				462,533

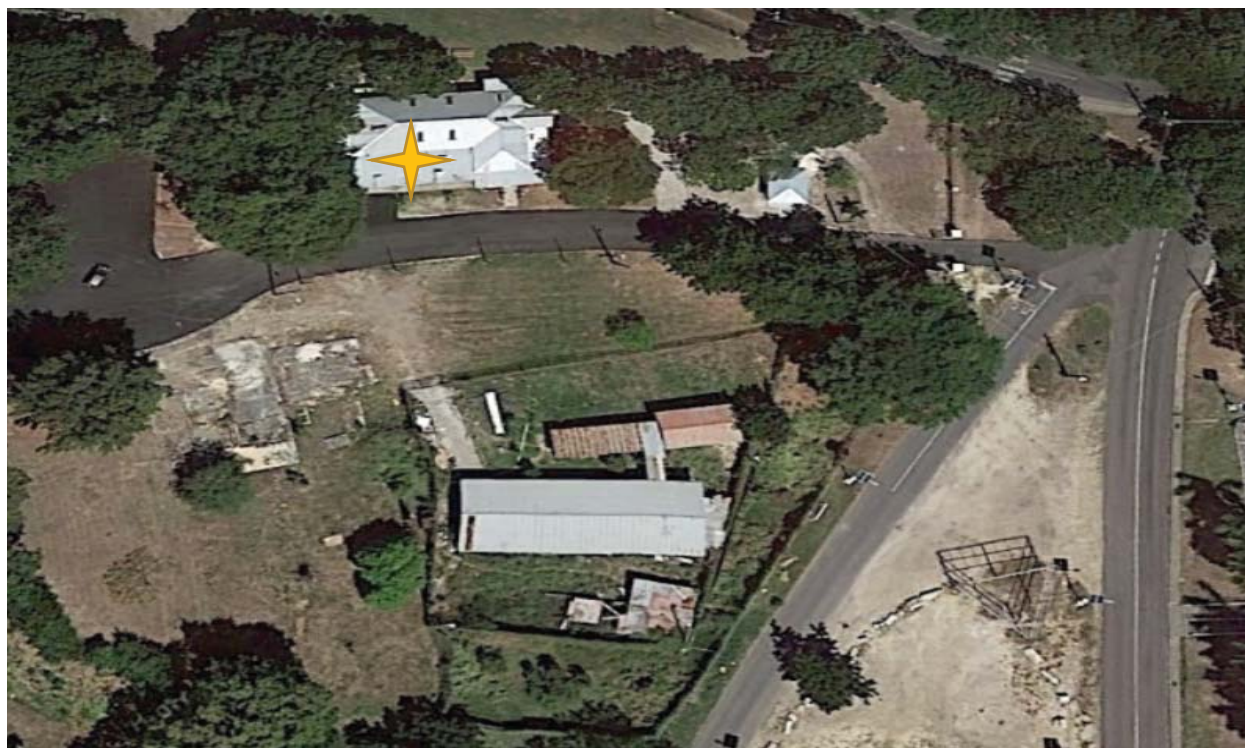
Department of the Environment 1

Facility Name:	Department of Environment 1	Year built:	1981
Building Name:	DOE Main Building	Year(s) remodeled:	
Building Address:	Factory Road	Original Design Code:	
Latitude:	17.1208782	Area (m2):	330
Longitude:	61.836505	Length (m):	22
Use:	Government	Width (m):	15
Risk Category:	II	No. of storeys:	1
Occupancy Group:	Group D	Storey height (m):	3
No. of occupants:	50	Total height (m):	5
Roof shape:	Hip and Valley	Walls	Concrete Blocks
Roofing:	Metal Sheeting	Structural system	Concrete Frame
Overall Condition	High		
Comments	The Risk Category and the overall condition suggest works could be considered in the short term

Task No.	Interventions/Improvements	Unit	Quantity	Unit Rate (USD)	Total (USD)
DOE-01	Windows and shutters Replace existing windows with standard operable or fixed windows and install shutters with Miami Dade NOA	m ²	20	750	15,000
DOE-02	Condition and safety of floor coverings Allow for repairs to defective areas of the floor finish - allow for 20% of floor area	m ²	132	88	11,616
DOE-03	Water Reserves Install potable water storage tanks to accommodate a 5-day supply Installation of pump or upgrade of existing	Litres nr	22,500 1	0.75 5,000	16,875 5,000
DOE-04	Alternate water supply to regular water supply Install rainwater tanks with capacity equivalent to 30% of building consumption - include potable water backup connection Re-plumbing of building to facilitate dual water use - potable and non-potable	Litres sum	6,750 1	0.75 5,000	5,063 5,000
DOE-05	Water Distribution System Supply and install 80 Gall solar water heaters on roof Source, repair chronic pipe leaks and retrofit plumbing Install low volume water fixtures	nr sum nr	2 1 6	2,500 5,000 800	5,000 5,000 4,800

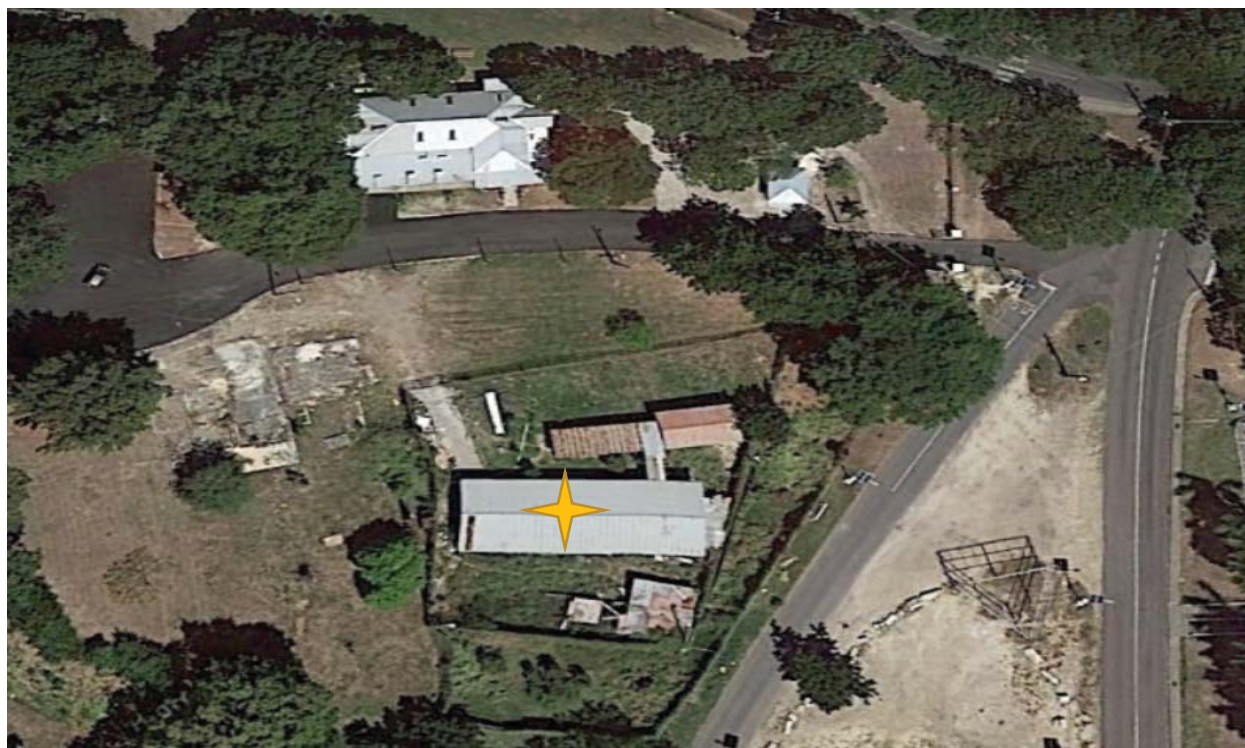
Department of the Environment 2

Facility Name:	Department of Environment 2	Year built:	1981
Building Name:	DOE Conference Room	Year(s) remodeled:	2018
Building Address:	Factory Road	Original Design Code:	
Latitude:	17.120325	Area (m2):	240
Longitude:	61.836387	Length (m): 24	24
Use:	Government	Width (m): 10	10
Risk Category:	II	No. of storeys:	1
Occupancy Group:	Group D	Storey height (m):	3
No. of occupants:	(1-80)	Total height (m):	5
Roof shape:	Gable	Walls	Concrete Block
Roofing:	Metal Sheeting	Structural system	Concrete Frame
Overall Condition	High		
Comments	The Risk Category and the overall condition suggest works could be considered in the short term

Task No.	Interventions/Improvements	Unit	Quantity	Unit Rate (USD)	Total (USD)
DOE2-01	Windows and shutters Replace existing windows with standard operable or fixed windows and install shutters with Miami Dade NOA	m ²	15	750	11,250
DOE2-02	Safety of roofing Replace entire roof with trusses and roof angle of 25 degrees	m ²	240	125	30,000
DOE2-03	Internal walls - concrete masonry units finishd with mortar plastering Replace entire wall with new ring beam on both floors	m ²	24	203	4,865
DOE2-04	False or Suspended Ceilings Replace and retrofit entire ceiling	m ²	240	31	7,440
DOE2-05	Condition and safety of floor coverings Allow for repairs to defective areas of the floor finish - allow for 20% of floor area	m ²	96	88	8,448
DOE2-06	Water Reserves Install potable water storage tanks to accommodate a 5-day supply Installation of pump or upgrade of existing	Litres nr	36,000 1	0.75 5,000	27,000 5,000
DOE2-07	Alternate water supply to regular water supply Install rainwater tanks with capacity equivalent to 30% of building consumption - include potable water backup connection Re-plumbing of building to facilitate dual water use - potable and non-potable	Litres sum	10,800 1	0.75 5,000	8,100 5,000

DOE2-08	Water Distribution System Supply and install 80 Gall solar water heaters on roof Source, repair chronic pipe leaks and retrofit plumbing Install low volume water fixtures	nr sum nr	2 1 6	2,500 2,500 800	5,000 2,500 4,800
DOE2-09	Storm Drainage System - site Improve stormwater drainage on the compound	lm	102	110	11,220
DOE2-10	Storm Drainage System - roof and gutters Install guttering to new roof structure inclusive of down pipes	lm	68	50	3,400
DOE2-11	Alternate Sources of Electricity 200 KVA generator plus automatic transfer switch Allow for 500-litre fuel tank and accessories Install roof mounted solar photovoltaic system as per legal statutes - 15 KW tied to the national grid	sum sum KW	1 1 15	70,000 6,000 3,500	70,000 6,000 52,500
DOE2-12	Safety of Electrical Equipment Undertake up to 50% rewiring of the building as required Re-inspection and certification of building as required	m ² sum	120 1	120 2,500	14,400 2,500

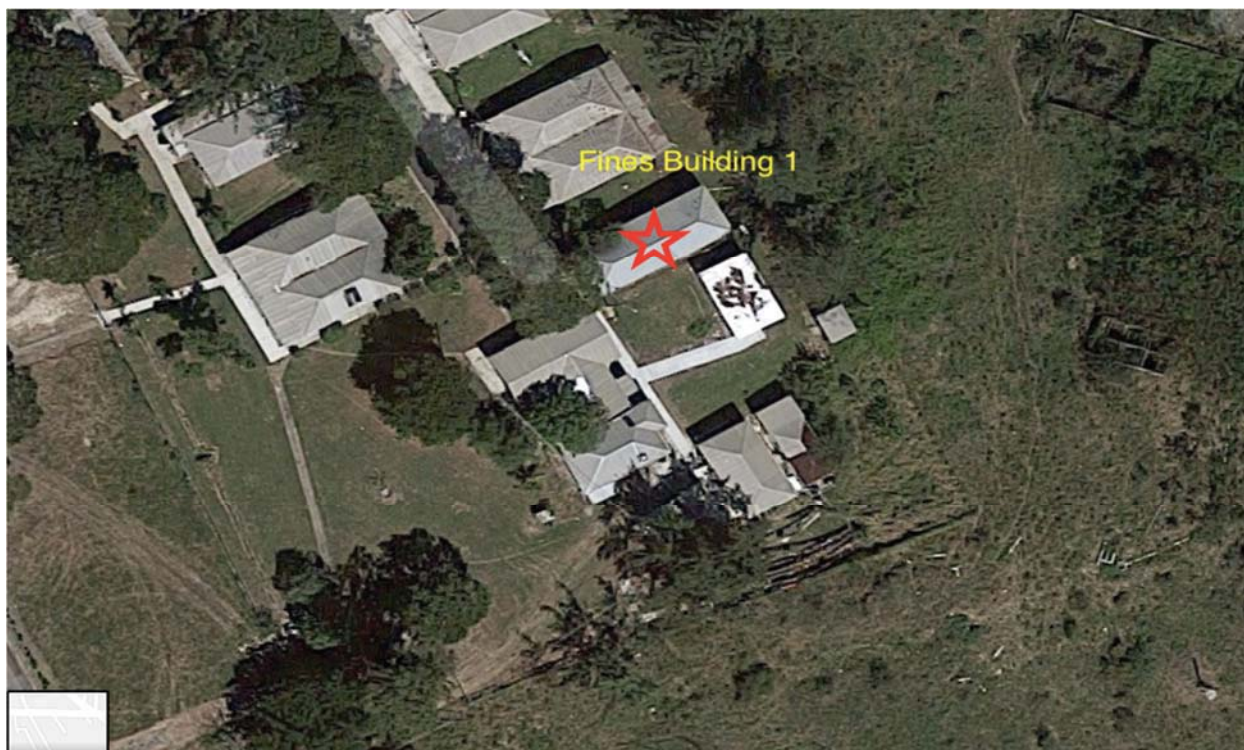
Facility Name:	Fines Building 1	Year built:	
Building Name:	Governor Building	Year(s) remodeled:	
Building Address:	Queen Elizabeth Highway	Original Design Code:	
Latitude:	17.1172478	Area (m2): 126	126
Longitude:	61.8314605	Length (m): 18	18
Use:	Government	Width (m): 7	7
Risk Category:	5	No. of storeys:	1
Occupancy Group:	Group B	Storey height (m):	4
No. of occupants:	30	Total height (m):	4
Roof shape:	Hip	Walls	Concrete Block
Roofing:	Metal Sheetting	Structural system	Concrete Frame
Overall Condition	Average		
Comments	Works likely necessary in the short term

Task No.	Interventions/Improvements	Unit	Quantity	Unit Rate (USD)	Total (USD)
F-01	Structural Integrity of Roofs Replace entire roof with trusses and roof angle of 25 degrees	m ²	126	200	25,200
F-02	Exterior Doors, Exits and Entrances Protecting existing door with an impact-resistant covering Install threshold to prevent ingress of water	nr nr	3 3	1,000 100	3,000 300
F-03	Windows and shutters Replace existing windows with standard operable or fixed windows and install shutters with Miami Dade NOA	m ²	13	1,270	16,510
F-04	Other Elements of the Building Envelope Repair small cracks with epoxy grout Repair cracks > 6 mm using a welded mesh	sum sum	1 1	2,500 3,500	2,500 3,500
F-05	False or Suspended Ceilings Replace and retrofit up to 50% of the ceilings	m ²	63	31	1,953
F-06	Condition and safety of floor coverings Allow for repairs to defective areas of the floor finish - allow for 20% of floor area	m ²	25	88	2,218

F-07	Water Reserves Install potable water storage tanks to accommodate a 5-day supply Supply and install 80 Gall solar water heaters on roof Installation of pump or upgrade of existing	Litres nr nr	13,500 1 1	0.75 2,500 2,500	10,125 2,500 2,500
F-08	Alternate water supply to regular water supply Install rainwater tanks with capacity equivalent to 30% of building consumption - include potable water backup connection Re-plumbing of building to facilitate dual water use - potable and non-potable	Litres sum	4,050 1	0.75 5,000	3,038 5,000
F-09	Water Distribution System Source, repair chronic pipe leaks and retrofit plumbing Install low volume water fixtures	sum nr	1 6	5,000 800	5,000 4,800
F-10	Wastewater System Construct new septic tank system to maximum size of 15 m ³	m ³	15	250	3,750
F-11	Storm Drainage System - site Improve stormwater drainage on the compound	lm	75	110	8,250
F-12	Storm Drainage System - roof and gutters Install guttering to roof structure inclusive of down pipes	lm	50	60	3,000

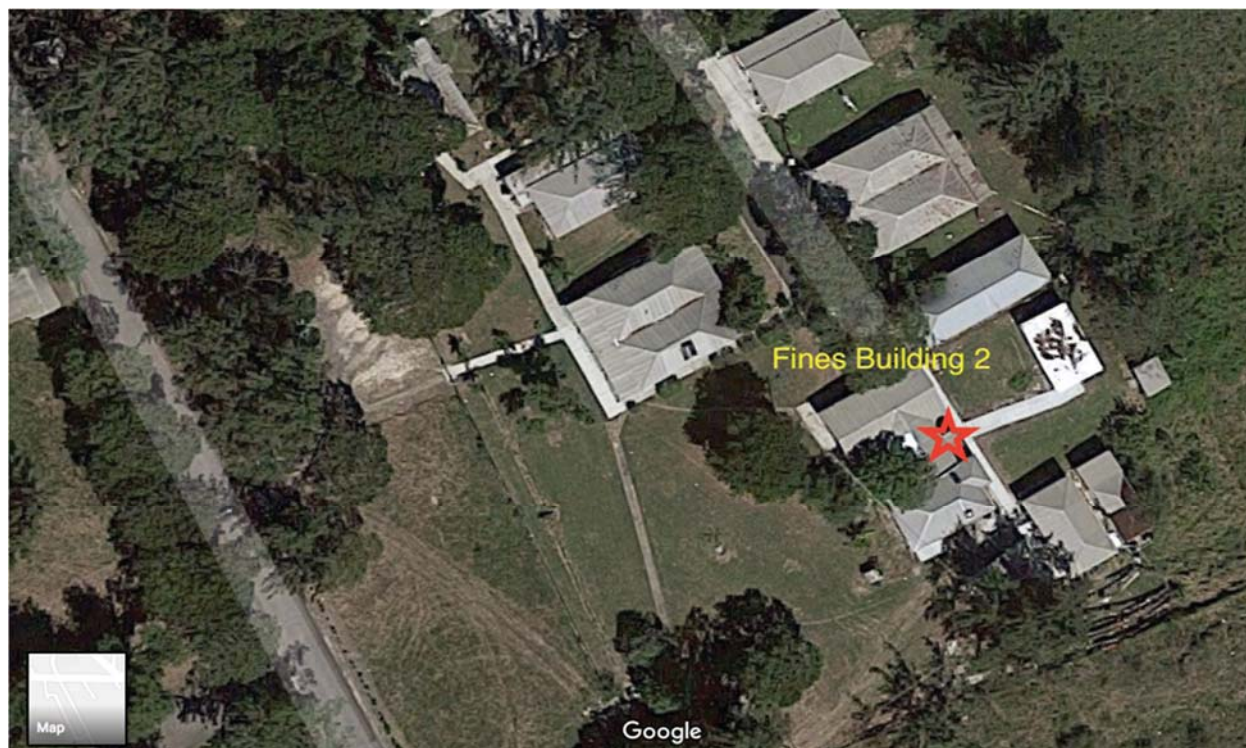
Fines Building 2

Facility Name:	'Fines Institute	Year built:	
Building Name:	Kitchen – Fines Building	Year(s) remodeled:	
Building Address:	Queen Elizabeth Highway	Original Design Code:	
Latitude:	17.117248	Area (m2): 294	294
Longitude:	61.8314529	Length (m): 21	21
Use:	Government	Width (m): 14	14
Risk Category:	5	No. of storeys:	1
Occupancy Group:	Group B	Storey height (m):	4
No. of occupants:	30	Total height (m):	4
Roof shape:	Hip	Walls	Concrete Blocks
Roofing:	Metal Sheetting	Structural system	Concrete Frame
Overall Condition	Average		
Comments	Condition is a high average rating of 64%. Retrofit works likely required in the short term

Task No.	Interventions/Improvements	Unit	Quantity	Unit Rate (USD)	Total (USD)
F2-01	Structural Integrity of Roofs Replace entire roof with trusses and roof angle of 25 degrees	m ²	294	200	58,800
F2-02	Exterior Doors, Exits and Entrances Protecting existing door with an impact-resistant covering	nr	6	1,000	6,000
	Install threshold to prevent ingress of water	nr	6	100	600
F2-03	Windows and shutters Replace existing windows with standard operable or fixed windows and install shutters with Miami Dade NOA	m ²	20	1,270	25,400
F2-04	Condition and safety of floor coverings Allow for repairs to defective areas of the floor finish - allow for 20% of floor area	m ²	25	88	2,218
F2-05	Water Reserves Install potable water storage tanks to accommodate a 5-day supply	Litres	13,500	0.75	10,125
	Supply and install 80 Gall solar water heaters on roof	nr	1	2,500	2,500
	Installation of pump or upgrade of existing	nr	1	2,500	2,500

F2-06	Alternate water supply to regular water supply Install rainwater tanks with capacity equivalent to 30% of building consumption - include potable water backup connection	Litres	4,050	0.75	3,038
	Re-plumbing of building to facilitate dual water use - potable and non-potable	sum	1	5,000	5,000
F2-07	Water Distribution System Source, repair chronic pipe leaks and retrofit plumbing	sum	1	5,000	5,000
	Install low volume water fixtures	nr	6	800	4,800
F2-08	Wastewater System Construct new septic tank system to maximum size of 15 m ³	m ³	15	250	3,750
F2-09	Storm Drainage System - site Improve stormwater drainage on the compound	lm	75	110	8,250
F2-10	Storm Drainage System - roof and gutters Replace roof guttering	lm	50	60	3,000
F2-11	Alternate Sources of Electricity Install roof mounted solar photovoltaic system as per legal statutes - 25 KW tied to the national grid	KW	15	3,500	52,500

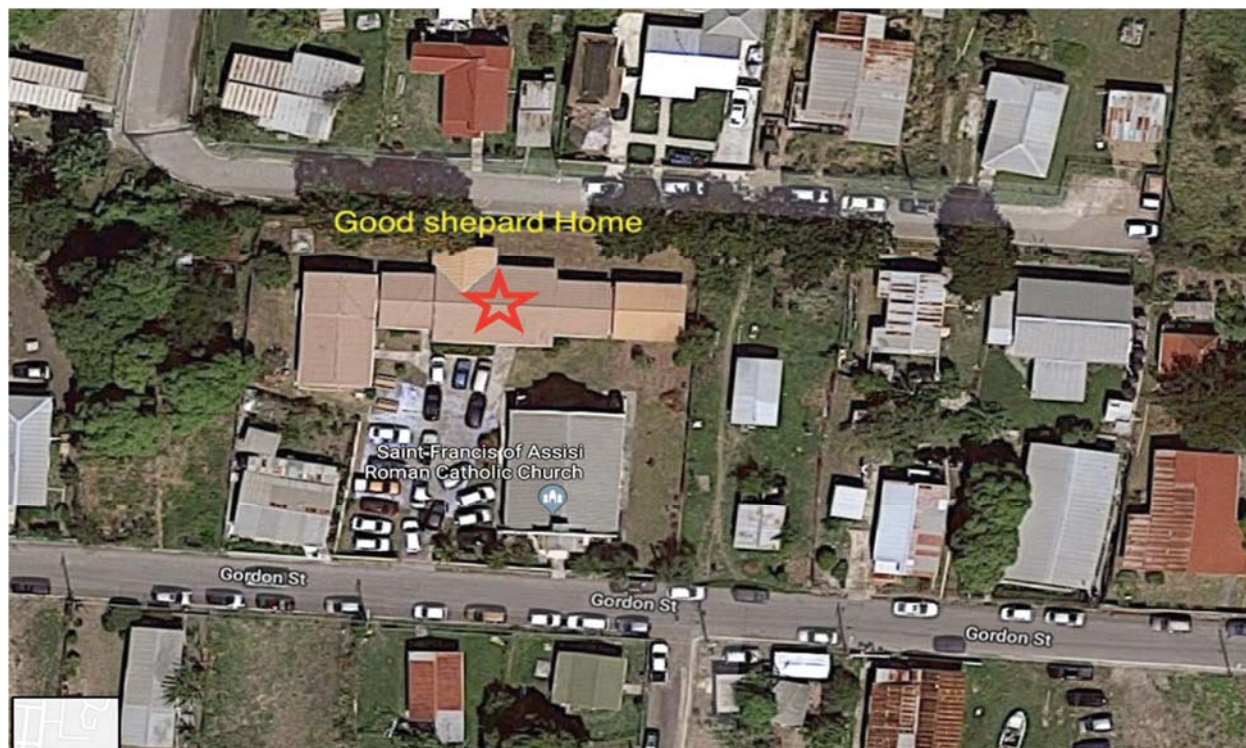
Facility Name:	Good Shepherd Home	Year built:	
Building Name:	Good Shepherd Home	Year(s) remodeled:	
Building Address:	Gordon St, Villa Area	Original Design Code:	
Latitude:	17.1323759	Area (m2):	283
Longitude:	61.84654	Length (m):	41.7
Use:	Medical	Width (m):	15.8
Risk Category:	IV	No. of storeys:	1
Occupancy Group:	Group B	Storey height (m):	3.06
No. of occupants:	10-20	Total height (m):	4.6
Roof shape:	Hip	Walls	Hard Plastic
Roofing:	Plastic Shingles	Structural system	Hard Plastic
Overall Condition	Average		
Comments	The high Risk Category and the Average rating suggest that work should be undertaken in the immediate to short term

Task No.	Interventions/Improvements	Unit	Quantity	Unit Rate (USD)	Total (USD)
GS-01	Exterior Doors, Exits and Entrances Protecting existing door with an impact-resistant covering Install threshold to prevent ingress of water	nr	3	1,000	3,000
		nr	3	100	300
GS-02	Windows and shutters Replace existing windows with standard operable or fixed windows and install shutters with Miami Dade NOA	m ²	62	750	46,701
GS-03	Safety of roofing Replace entire roof with trusses and roof angle of 25 degrees	m ²	283	200	56,600
GS-04	Condition and safety of floor coverings Allow for repairs to defective areas of the floor finish - allow for 20% of floor area	m ²	57	88	4,981
GS-05	Water Reserves Installation of pump or upgrade of existing Install potable water storage tanks to accommodate a 5-day supply	nr	1	2,000	2,000
		Litres	9,000	0.75	6,750
GS-06	Alternate water supply to regular water supply Install rainwater tanks with capacity equivalent to 30% of building consumption - include potable water backup connection Re-plumbing of building to facilitate dual water use - potable and non-potable	Litres	3,000	0.75	2,250

sum	1	5,000	5,000
GS-07	Water Distribution System Source, repair chronic pipe leaks and retrofit plumbing Supply and install 80 Gall solar water heaters on roof Install low volume water fixtures	sum	1	3,500	3,500
		nr	1	2,500	2,500
		nr	4	800	3,200
GS-08	Wastewater System Empty and improve site septic units and filtration systems	sum	1	2,500	2,500
GS-09	Storm Drainage System - site Improve stormwater drainage on the compound	lm	174	55	9,570
GS-10	Storm Drainage System - roof and gutters Install guttering to roof structure inclusive of down pipes	lm	116	50	5,800
GS-11	Alternate Sources of Electricity 16.5 KVA generator plus automatic transfer switch Allow for 500-litre fuel tank and accessories Install roof mounted solar photovoltaic system as per legal statutes - 15 KW tied to the national grid	sum	1	25,000	25,000
		sum	1	6,000	6,000
		KW	15	3,500	52,500
GS-12	Safety of Electrical Equipment Re-inspection and certification of building as required Undertake complete rewiring of the building as required Improve electrical panels with the change to residual-current devices	sum	1	3,500	3,500

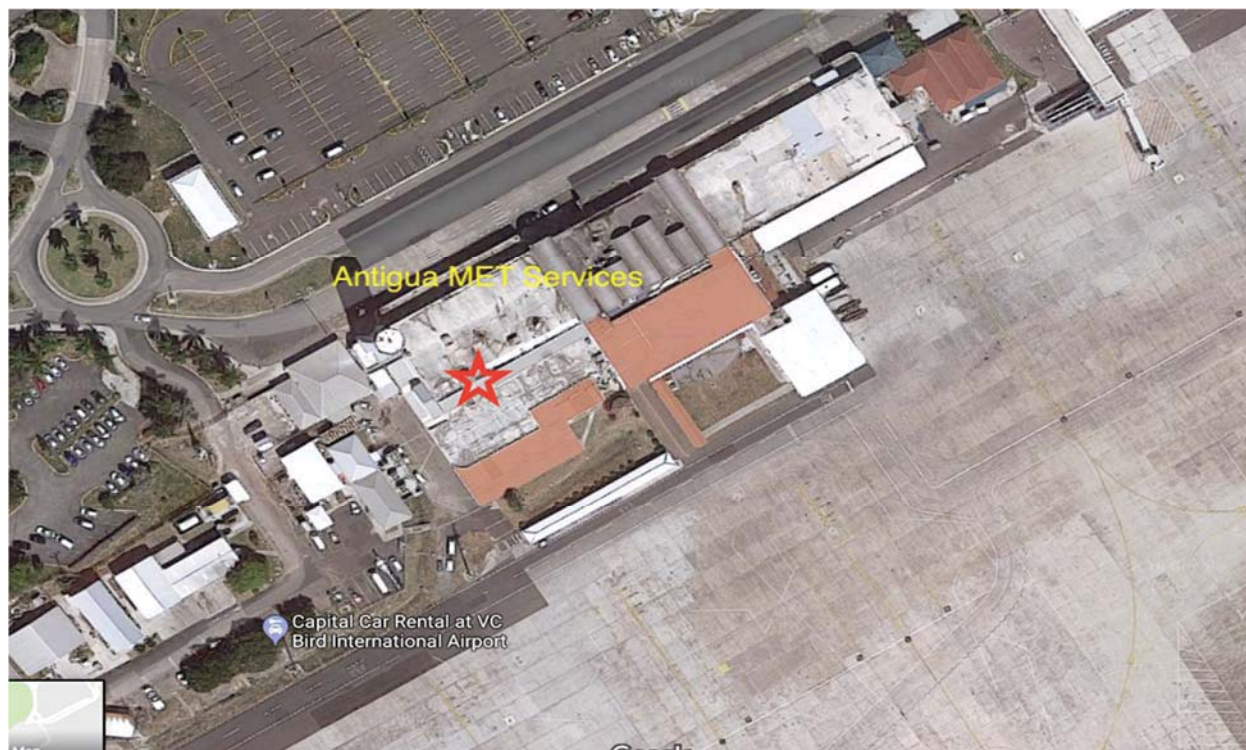
MET Office

Facility Name:	Antigua MET Services	Year built:	
Building Name:	Airport Terminal	Year(s) remodeled:	
Building Address:	VC Bird International Airport	Original Design Code:	
Latitude:	17.13997	Area (m2):	234
Longitude:	61.792704	Length (m):	30.8
Use:	Government	Width (m):	7.6
Risk Category:	IV	No. of storeys:	1
Occupancy Group:	Group D	Storey height (m):	3.05
No. of occupants:	20	Total height (m):	6.1
Roof shape:	Flat	Walls	Concrete Bricks
Roofing:	Concrete	Structural system	Concrete Frame
Overall Condition	Average		
Comments	Although structural retrofit is not required, the Average condition rating and the Risk Category of IV, suggest that works need to be in the immediate term

Task No.	Interventions/Improvements	Unit	Quantity	Unit Rate (USD)	Total (USD)
MO-01	Structural Redundancy - as per typical detail and specifications Introduce new columns so as to improve redundancy of structure - location and design to be provided by Engineer	sum	1	5,000	5,000
MO-02	Safety of Foundations - as per Engineer's details and specifications Allowance for foundation retrofit	sum	1	5,000	5,000
MO-03	Structural Integrity of Roofs Complete Sealing of the concrete roof. The roof has major leaks. Replace and retrofit up to 50% of the ceilings	m ² m ²	234 117	135 50	31,590 5,850
MO-04	Exterior Doors, Exits and Entrances Protecting existing door with an impact-resistant covering Install threshold to prevent ingress of water Fasten door frames into concrete surrounds with bolts or screws	nr nr nr	4 4 4	593 93 50	2,370 370 200
MO-05	Windows and shutters Replace existing windows with standard operable or fixed windows and install shutters with Miami Dade NOA	m ²	50	99	4,944

MO-06	Safety of roofing Undertake repairs to roof protection - built-up roofing felt	m ²	234	60	14,040
MO-07	Internal walls - concrete masonry units finishd with mortar plastering Undertake retrofit of walls	sum	1	1,500	1,500
MO-08	False or Suspended Ceilings Replace and retrofit entire ceiling	m ²	234	31	7,254
MO-09	Water Reserves Install solar hot water units Source, repair chronic pipe leaks and retrofit plumbing Install low volume water fixtures Re-plumbing of building to facilitate dual water use - potable and non-potable	sum m ² nr m ²	1 234 6 234	2,222 20 741 60	2,222 4,616 4,444 13,988
MO-10	Location of water storage tanks Improve stormwater drainage on the compound Installation of pump or upgrade of existing	lm sum	117 1	75 1,500	8,775 1,500
MO-11	Alternate water supply to regular water supply Install rainwater tanks with capacity equivalent to 30% of building consumption - include potable water backup connection	litres	4,500	0.75	3,375

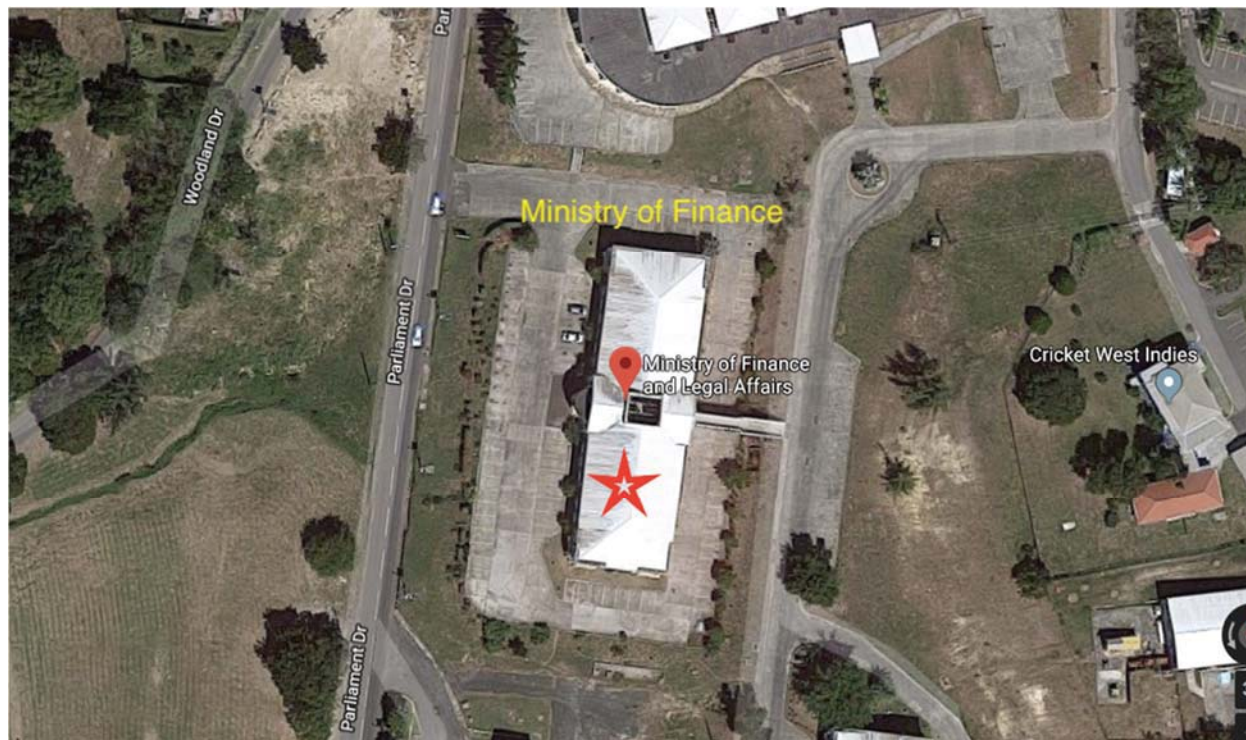
Facility Name:	Government Complex	Year built:	1995
Building Name:	Ministry of Finance	Year(s) remodeled:	
Building Address:	Parliament Drive	Original Design Code:	OECS Building Code
Latitude:	17.1194999	Area (m2):	2558
Longitude:	61.8357685	Length (m):	67
Use:	Government	Width (m):	22
Risk Category:	II	No. of storeys:	2
Occupancy Group:	Group D	Storey height (m):	10'
No. of occupants:	300	Total height (m):	28'
Roof shape:	Hip and Valley	Walls	Concrete Block
Roofing:	Metal Sheeting	Structural system	Concrete frame
Overall Condition	Average		
Comments	Risk Category II and high Average condition suggest that a short term repair horizon would be adequate

Task No.	Interventions/Improvements	Unit	Quantity	Unit Rate (USD)	Total (USD)
MoF-01	Condition of construction materials - repair as detailed in drawings				
	Repair small cracks with a high strength epoxy grout	sum	1	5,000	5,000
	Repair cracks > 6 mm using a welded mesh	sum	1	3,500	3,500
MoF-02	Structural Integrity of Roofs				
	Install horizontal bracing to existing trusses	sum	1	5,000	5,000
	Decreasing spacing of fasteners, particularly at eaves, hips, ridge & edges of gable roofs	sum	1	2,500	2,500
	Fixing roof sheathing with minimum 75 mm screws into rafters and ridges	sum	1	5,000	5,000
	Replace all fasteners and comply with OECS-BC 7th Edition	sum	1	5,000	5,000
MoF-03	Windows and shutters				
	Replace existing windows with standard operable or fixed windows and install shutters with Miami Dade NOA	m ²	390	750	292,500
MoF-04	False or Suspended Ceilings				
	Replace and retrofit up to 50% of the ceilings	m ²	1,279	31	39,649

MoF-05	Water Reserves				
	Supply and install 80 Gall solar water heaters on roof	nr	1	2,500	5,000
	Source, repair chronic pipe leaks and retrofit plumbing	sum	1	5,000	16,000
	Install low volume water fixtures	nr	20	800	16,000
	Installation of pump or upgrade of existing	nr	1	2,500	2,500
MoF-06	Alternate water supply to regular water supply				
	Install potable water storage tanks to accommodate a 5-day supply	Litres	135,000	0.75	101,250
	Install rainwater tanks with capacity equivalent to 30% of building consumption - include potable water backup connection	Litres	40,500	0.75	30,375
	Re-plumbing of building to facilitate dual water use - potable and non-potable	sum	1	10,000	10,000
MoF-07	Water Distribution System				
	Supply and install 80 Gall solar water heaters on roof	nr	1	2,500	2,500
	Source, repair chronic pipe leaks and retrofit plumbing	sum	1	2,000	2,000
	Install low volume water fixtures	nr	20	800	16,000

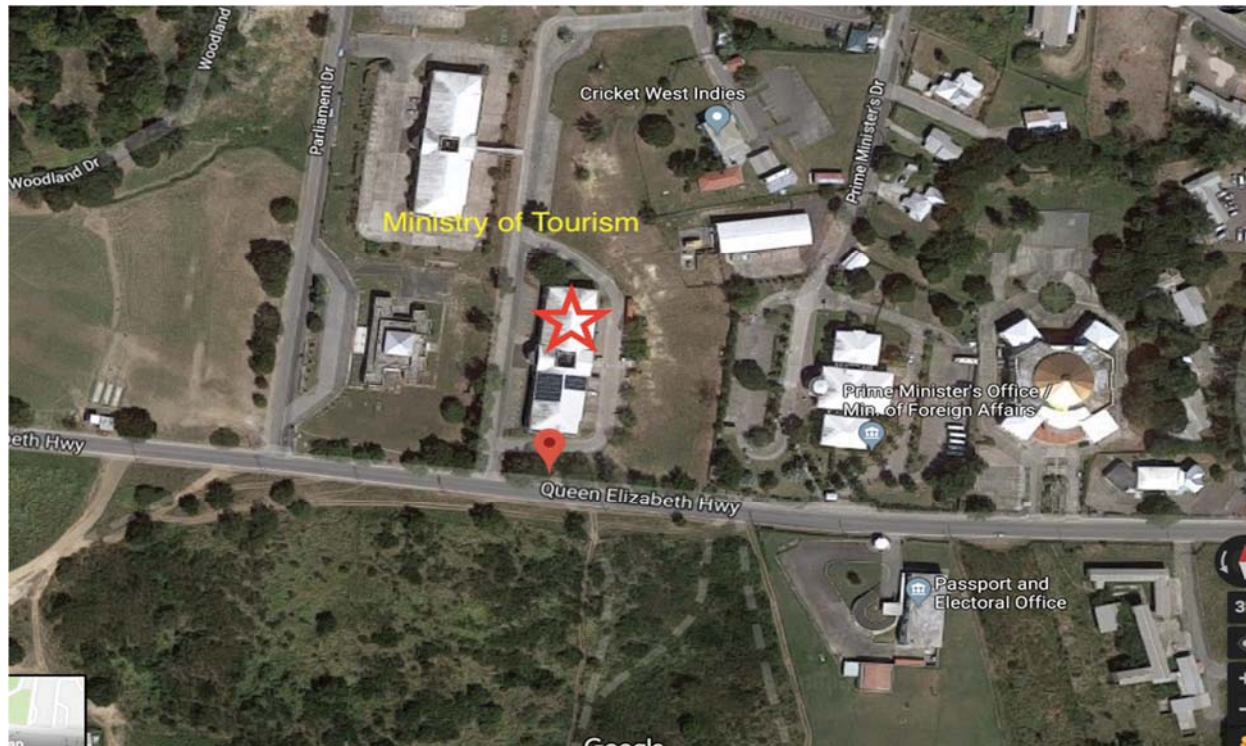
Facility Name:	Government Complex	Year built:	1995
Building Name:	Ministry of Tourism	Year(s) remodeled:	
Building Address:	Queen Elizabeth Highway	Original Design Code:	OECS Building Code
Latitude:	17.11864	Area (m2):	2060
Longitude:	61.835004	Length (m):	48
Use:	Government	Width (m):	25
Risk Category:	II	No. of storeys:	2
Occupancy Group:	Group D	Storey height (m):	10'
No. of occupants:	338	Total height (m):	28'
Roof shape:	Pitched	Walls	Concrete Blocks
Roofing:	Metal Sheeting	Structural system	Concrete Frame
Overall Condition	High		
Comments	Risk Category II and High condition suggest that a short term repair horizon would be adequate

Task No.	Interventions/Improvements	Unit	Quantity	Unit Rate (USD)	Total (USD)
MoT-01	Condition of the building - as per Engineer's drawings and specifications				
	Repair small cracks with epoxy grout	sum	1	5,000	5,000
	Repair cracks > 6 mm using a welded mesh	sum	1	3,500	3,500
MoT-02	Structural Integrity of Roofs				
	Install horizontal bracing to existing trusses	sum	1	2,500	2,500
	Decreasing spacing of fasteners, particularly at eaves, hips, ridge & edges of gable roofs	sum	1	2,500	2,500
MoT-03	Windows and shutters				
	Replace existing windows with standard operable or fixed windows and install shutters with Miami Dade NOA	m ²	245	750	183,750
MoT-04	Other Elements of the Building Envelope				
	Repair cracks > 6 mm using a welded mesh	sum	1	2,500	2,500
	Replace entire existing masonry wall with the inclusion of a ring beam	m ²	40	202	8,080
MoT-05	Safety of roofing				
	Inspect roof and then Install hurricane straps at the eaves/ring beams and ridge to rafter connections	nr	210	5	1,050

Fixing roof sheathing with minimum 75 mm screws into rafters and ridges	nr	600	1	600
	Decreasing spacing of fasteners, particularly at eaves, hips, ridge & edges of gable roofs	nr	420	1	420
MoT-06	False or Suspended Ceilings				
	Replace and retrofit 50% of ceiling	m ²	1,030	31	31,930
MoT-07	Condition and safety of floor coverings				
	Allow for repairs to defective areas of the floor finish - allow for 20% of floor area	m ²	412	88	36,256
MoT-08	Water Reserves				
	Install potable water storage tanks to accommodate a 5-day supply	Litres	152,100	0.75	114,075
	Installation of pump or upgrade of existing	nr	1	2,500	2,500
MoT-09	Alternate water supply to regular water supply				
	Install rainwater tanks with capacity equivalent to 30% of building consumption - include potable water backup connection	Litres	45,630	0.75	34,223
	Re-plumbing of building to facilitate dual water use - potable and non-potable	sum	1	10,000	10,000

MoT-10	Water Distribution System				
	Supply and install 80 Gall solar water heaters on roof	nr	1	2,500	2,500
	Source, repair chronic pipe leaks and retrofit plumbing	sum	1	5,000	5,000
	Install low volume water fixtures	nr	20	800	16,000
MoT-11	Wastewater System				
	Empty and improve site septic units and filtration systems	sum	1	2,500	2,500
	To Collection				464,884

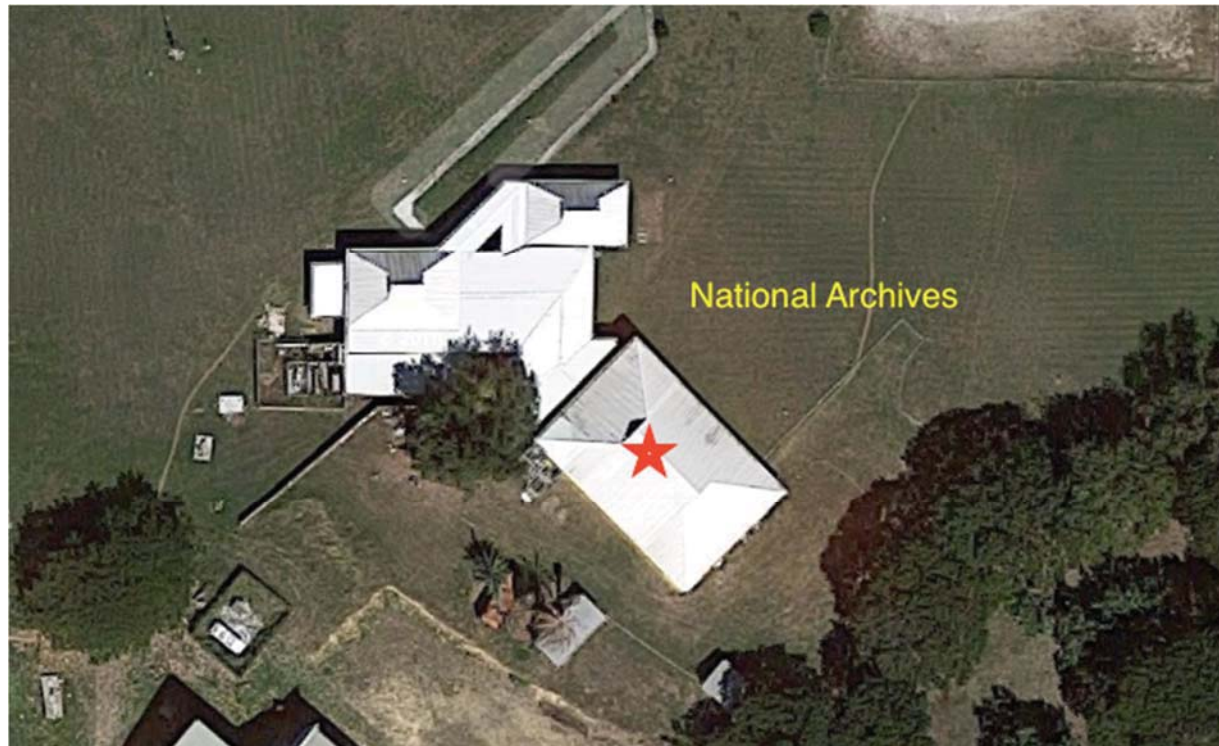
Facility Name:	National Archives	Year built:	1981
Building Name:	National Archives	Year(s) remodeled:	
Building Address:	Factory Road	Original Design Code:	
Latitude:	17.1214369	Area (m2):	855
Longitude:	61.8386363	Length (m):	26
Use:	Government	Width (m):	15
Risk Category:	II	No. of storeys:	2
Occupancy Group:	Group C	Storey height (m):	2.4
No. of occupants:	28	Total height (m):	7.3
Roof shape:	Hip	Walls	Concrete Blocks
Roofing:	Metal Sheetting	Structural system	Concrete Frame
Overall Condition	Average		
Comments	Risk Category II and Average condition suggest that a short term repair horizon would be adequate

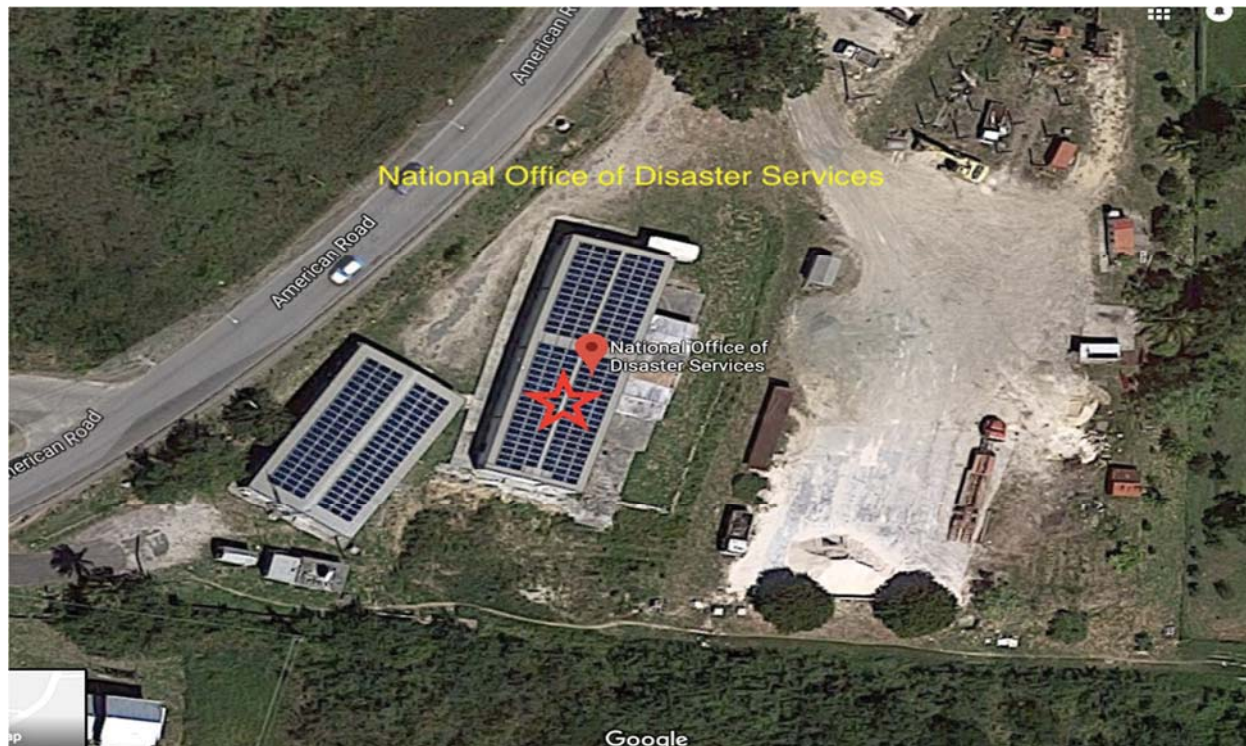
Facility Name:	National Office of Disaster Services	Year built:	
Building Name:	National Office of Disaster Services	Year(s) remodeled:	2018
Building Address:	St John's, American road	Original Design Code:	OECS Building Code
Latitude:	17.1118254	Area (m2):	294
Longitude:	61.8318272	Length (m):	20.2
Use:	Government	Width (m):	14.6
Risk Category:	IV	No. of storeys:	1
Occupancy Group:	Group D	Storey height (m):	4.5
No. of occupants:	15	Total height (m):	4.6
Roof shape:	Gable	Walls	Concrete Blocks
Roofing:	Metal Sheeting	Structural system	Steel Frame
Overall Condition	High		
Comments	Despite the Risk Category IV, the High condition rating suggest that a short term repair horizon would be adequate

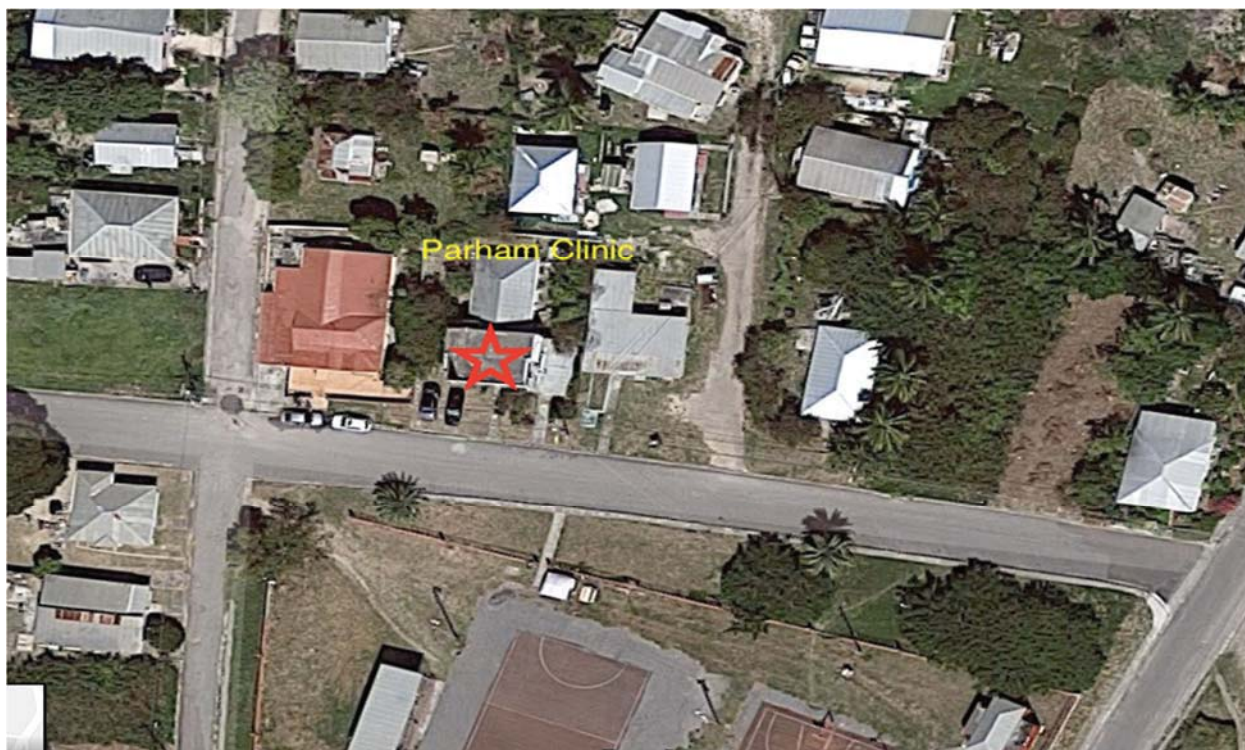
Facility Name:	Parahm Clinic	Year built:	
Building Name:	Parahm Clinic	Year(s) remodeled:	
Building Address:	Parahm Village	Original Design Code:	OECSBuilding Code
Latitude:	17.107832	Area (m ²):	107.8
Longitude:	61.7667422	Length (m):	13.65
Use:	Clinic	Width (m):	11.3
Risk Category:	IV	No. of storeys:	Single
Occupancy Group:	1	Storey height (m):	3.35
No. of occupants:	30	Total height (m):	4
Roof shape:	Flat	Walls	Concrete Blocks
Roofing:	Metal sheeting	Structural system	Concrete Frame
Overall Condition	Average		
Comments	Risk Category II and Average condition suggest that an immediate to short term repair horizon would be adequate

Task No.	Interventions/Improvements	Unit	Quantity	Unit Rate (USD)	Total (USD)
PC-16	Safety of Electrical Equipment				
	Re-inspection and certification of building as required	sum	1	1,500	1,500
	Undertake 50% rewiring of the building as required	m ²	108	120	12,960
PC-17	Lighting System				
	Improve lighting using LED tubes and light fixtures	m ²	108	40	4,320
PC-18	Safety of HVAC Components				
	Install AC system	m ²	108	175	18,900
	Total Collection				37,680
	Collection	Page 1			202,838
		Page 2			37,680
	Base Cost				240,518
	Allowance for Demolition of works to be repaired - 3% of Base Cost	Sum			7,216
	Allowance for preliminaries - 7.5% of Base Cost	Sum			18,039
	Sub-total				265,772
	Allow 20% contingencies due to the nature of repairs and retrofit works	Sum			53,154
	Total				318,927
	Value Added Tax - 15% of Total				47,839
	Total Construction cost of repairs and retrofit works - Parahm Clinic				366,766

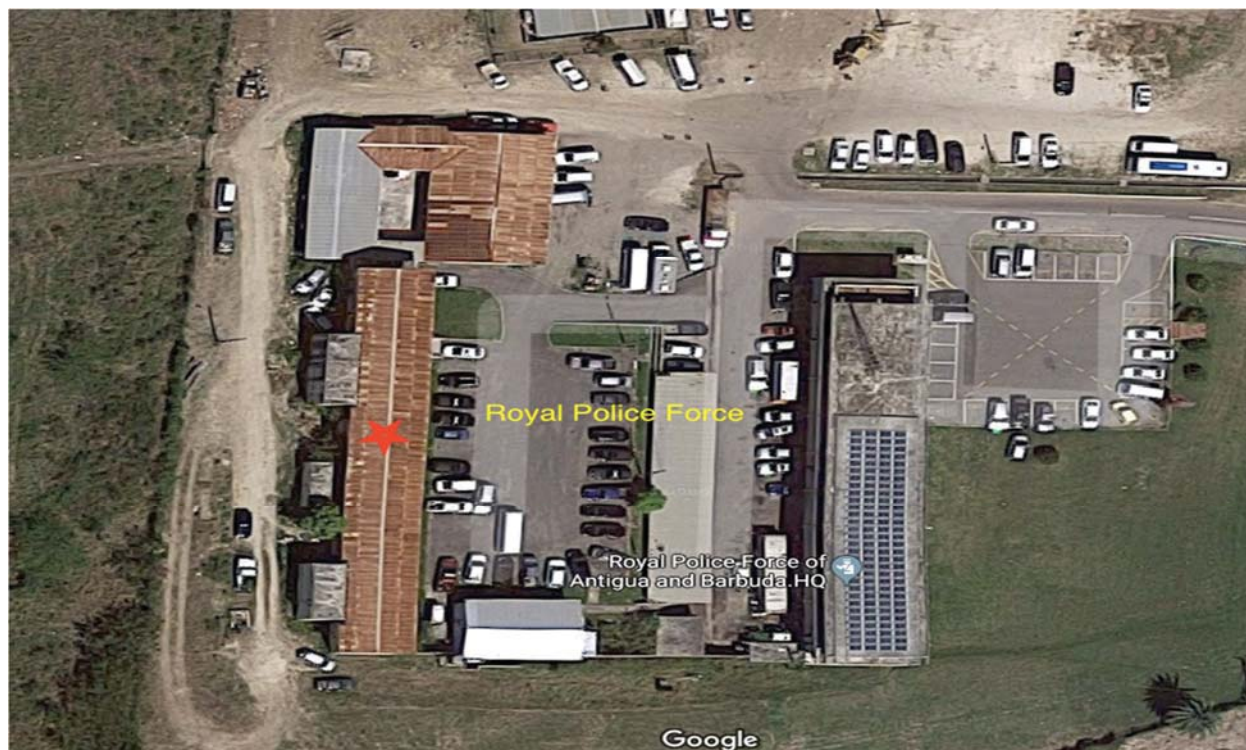
Police Headquarters

Facility Name:	Royal Police Force of Antigua and Barbuda Headquarters	Year built:	
Building Name:	Constable Quarters	Year(s) remodelled:	
Building Address:	St John's, American road	Original Design Code:	
Latitude:	17.1148965	Area (m2):	668
Longitude:	61.8314998	Length (m):	27.4
Use:	Military	Width (m):	12.2
Risk Category:	IV	No. of storeys:	2
Occupancy Group:	Group B	Storey height (m):	3.06
No. of occupants:	80	Total height (m):	4.6
Roof shape:	Gable	Walls	Concrete Blocks
Roofing:	Metal Sheeting	Structural system	Concrete Frame
Overall Condition	Low		
Comments	Risk Category IV and Low condition rating suggest that an immediate term repair horizon would be required.

PH2-09	Condition and safety of floor coverings				
	Allow for repairs to defective areas of the floor finish - allow for 100% of floor area	m ²	668	88	58,784
	To Collection				588,061
