Detailed Work Packages and Standard Structural Repair and Retrofit Drawings

Technical Assistance for Resilience to Climate Variability in the Building Sector of Antigua and Barbuda

Project No: 18106

Detailed Work Packages Consisting, Site Plans, Standard Retrofit Drawings and Engineering Cost Estimates for 34 Buildings

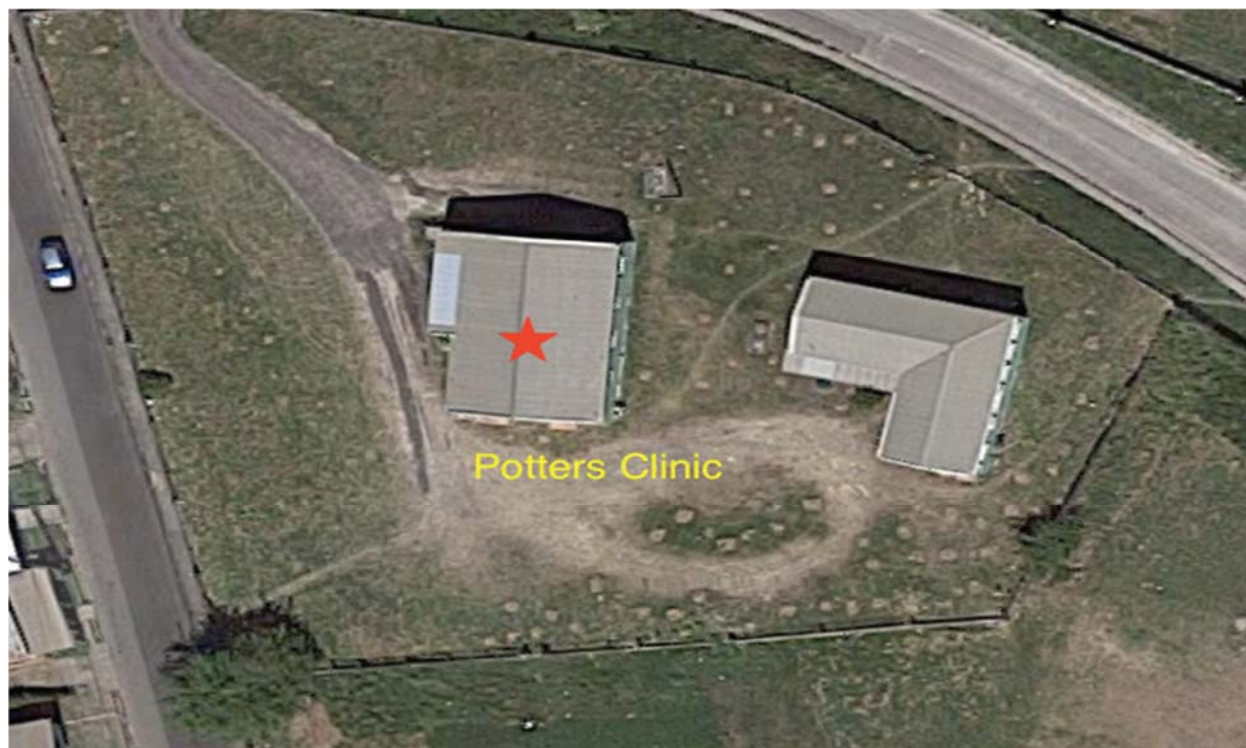
Facility Name:	Potters Clinic	Year built:	
Building Name:	Potters Clinic	Year(s) remodeled:	
Building Address:	Potters Main Road	Original Design Code:	OECS Building Code
Latitude:	17.1118307	Area (m2):	220
Longitude:	61.8190544	Length (m):	16.6
Use:	Medical	Width (m):	13.4
Risk Category:	IV	No. of storeys:	1
Occupancy Group:	Group B	Storey height (m):	3
No. of occupants:	35	Total height (m):	4.5
Roof shape:	Gable	Walls	Concrete Blocks
Roofing:	Metal Sheetting	Structural system	Concrete Frame
Overall Condition	Average		
Comments	Risk Category IV and Average condition suggest that a short term repair horizon would be adequate.
