## Technical Assistance for Increasing Resilience of the Education System to Climate Change in Saint Lucia and Antigua & Barbuda

### Technical Assessment and Technology Options Report

Submitted to

Climate Technology Centre and Network  
United Nations Industrial Development Organization

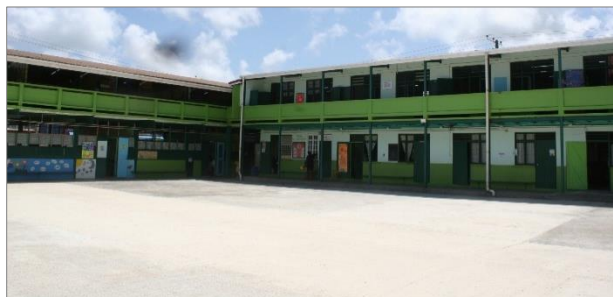
**Photo. 1** – Ave Maria Infant School

Both of these schools are located within one fenced compound in the central business district of Castries about three city blocks away from the Central Fire Station. Photographs 1 and 2 show the Infant and Primary schools respectively.

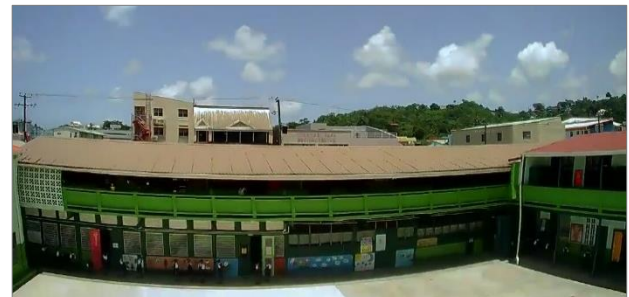
**Photo. 2** – Ave Maria Primary School

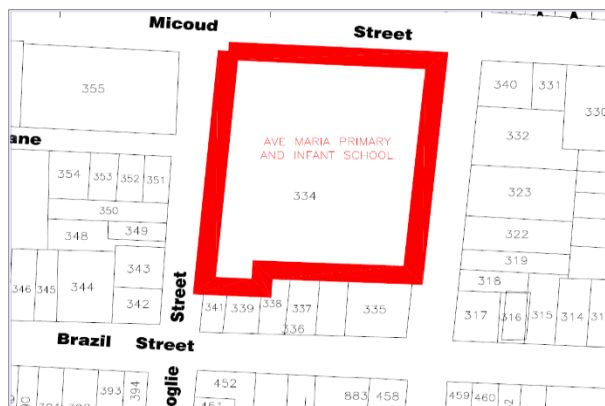
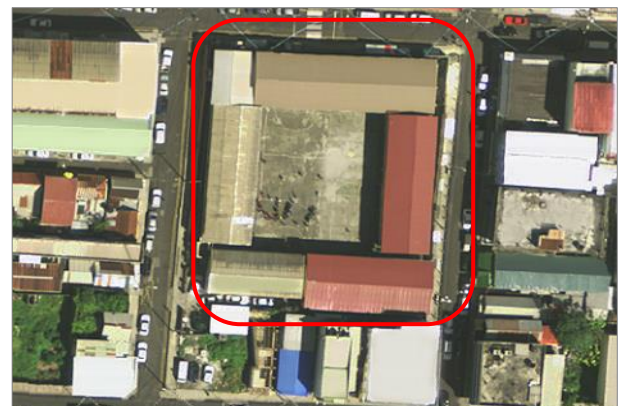
**Figure 2** – Location Plan and Aerial Photo of Ave Maria Infant and Primary Schools

The site is flat and occupies the major portion of a city block, on 3,000 m<sup>2</sup> of land. The location plan and aerial view of the school are presented in Figure 2. The compound comprises six school buildings enclosing a playground, void of any vegetation. The property has exits on all the three streets which are contiguous to the northern, eastern, and western boundaries. Both schools are identified as emergency shelters and are two of five schools which are considered as being located in the centre of Castries. The total population of the two Schools is 498 students.

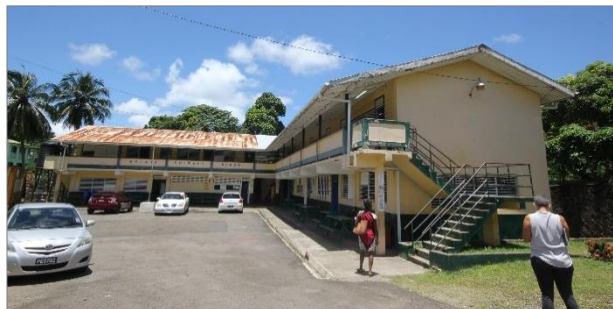
**Photo. 3 – Balata Combined School**

The school (shown in Photograph 3) is nestled within the Balata community, which is in the district of Castries and in the central north of Saint Lucia. The location plan and aerial view of the school are presented in Figure 3.

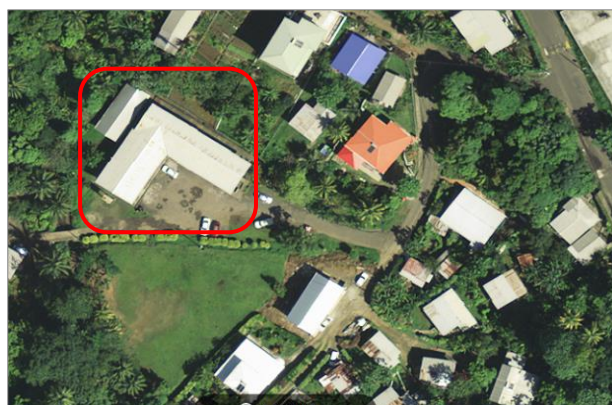
**Figure 3 – Location Plan and Aerial Photo of Balata Combined School**

The compound is at the end of an ill-defined cul-de-sac, accessed by a narrow road with inadequate geometric design. The road reduces to a community footpath after passing the school, and there are no other vehicular accesses to the site. There is minimal space available for vehicular turning. A ravine flows to the western side of the school and is in close proximity to the school's north-western boundary. The compound is flat and school operations accommodated within an "L" shaped building with access to a playground on the opposite side of the access road. The school compound occupies about 1,880 m<sup>2</sup>. It is used as an emergency shelter and has a population of 378 students.

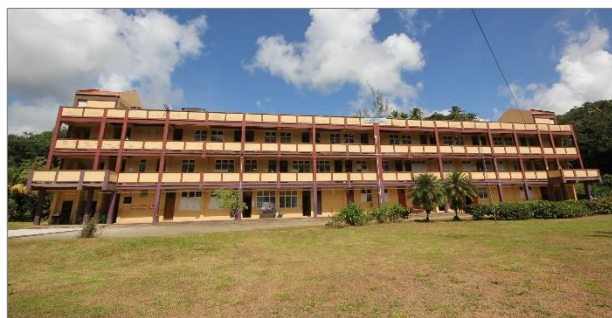
**Photo. 4 – Bexon Primary School**

This school is located in the centre of the Island. It is considered to be between the Cul De Sac and Mabouya Valleys and sits within a low lying plain which is known to flood. Photograph 4 shows the Bexon Primary School. Vehicular access is off an extended track which does not facilitate easy manoeuvrability of emergency and other vehicles. The location plan and aerial view of the school are presented in Figure 4.

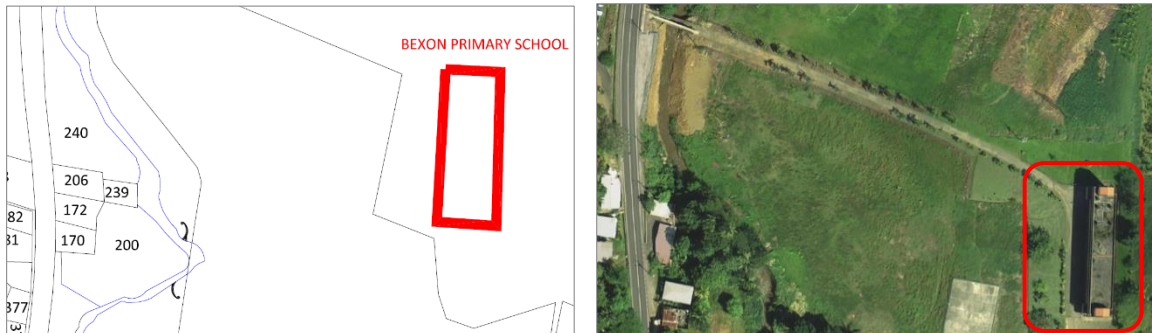
Figure 4 – Location Plan and Aerial Photo of Bexon Primary School

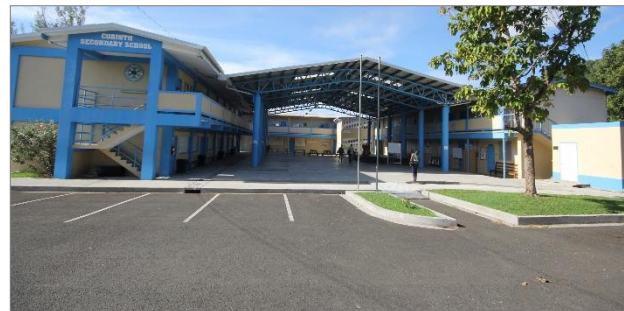
Photo. 5 – Corinth Secondary School

This school (shown in Photograph 5) is located in the northern section of the Island and is accessed off a major secondary road which runs in an easterly direction from the Grand Riviere Junction off the Castries-Gros Islet Highway. The location plan and aerial view of the school are presented in Figure 6. It is within a densely populated residential area, which is quickly becoming sub-urban. It is one of the largest schools in the Gros-Islet area and the compound occupies 8,130 m<sup>2</sup> of land adjacent to a community playground. The La Brelotte River flows near its north-eastern boundary and the school site is known to have experienced issues with drainage and flooding of the northern side of the compound. Emergency services (police and fire) are available about 8 km to the north and the school is designated as an emergency shelter. It has a population of 706 students.

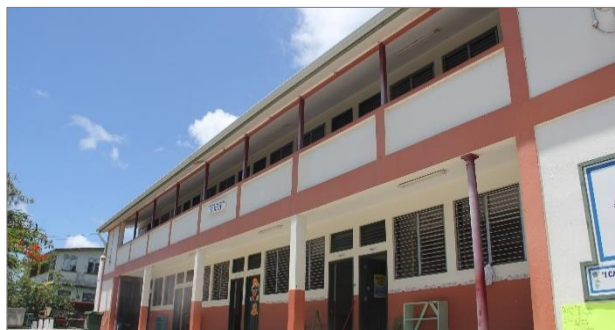
**Photo. 6 – Desruisseaux Combined**

The Desruisseaux Combined school is located in the south of the island in the Quarter of Micoud. The location plan and aerial view of the school are presented in Figure 7. It is accessed directly off the Desruisseaux main road. The Church and the playground are on the eastern boundary of the school. The site is generally gently sloping from south to north, at a high elevation of 133 m above sea level. It has a population of 230 pupils.

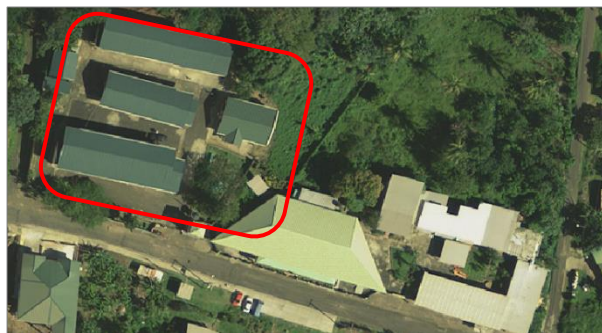
**Figure 6 – Location Plan and Aerial Photo of Desruisseaux Combined School**

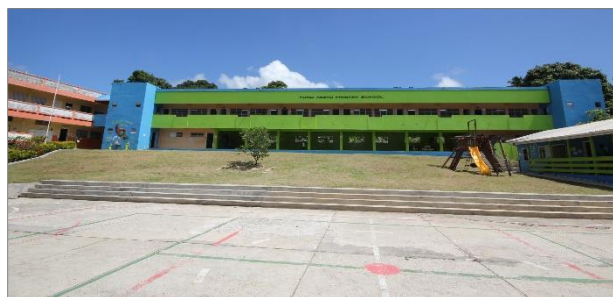
**Photo. 7 – Fond Assau Combined School**

The school is located in Babonneau, a community in the northeast of Saint Lucia. The location plan and aerial view of the school are presented in Figure 8. The school is accessed off the main Fond Assau road and is about 2 km downhill from the Babonneau main road. It is a sloping site which has been benched to build three school blocks, one of which was recently constructed. The entire compound measures about 3,932 m<sup>2</sup>. The school's population is 130 pupils.

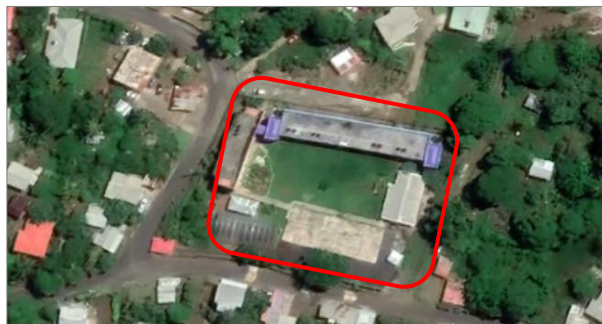
**Figure 7 – Location Plan and Aerial Photo of Fond Assau Combined School**

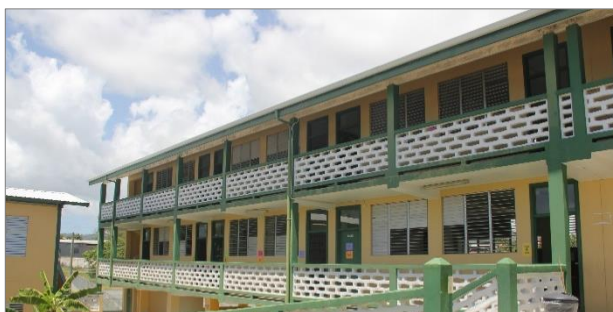
**Photo. 8** – Micoud Primary School

Micoud Primary School is located on the southeast of Saint Lucia and is accessed off the Castries-Vieux Fort Highway. The location plan and aerial view of the school are presented in Figure 9. The main access to the school is narrow and below standard. There are four buildings within the compound, one of which was recently constructed. The compound is gently sloping from north to south and measures about 5,090 m<sup>2</sup>. It has 385 students.

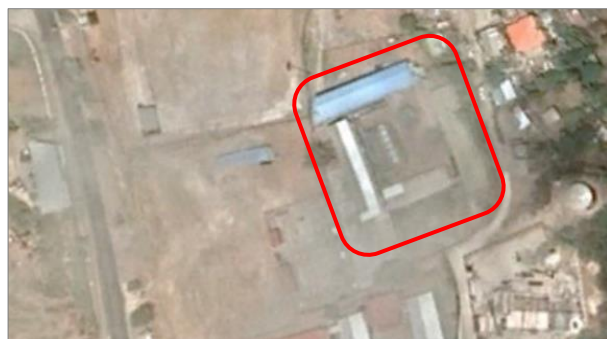
**Figure 8** – Location Plan and Aerial Photo of Micoud Primary School

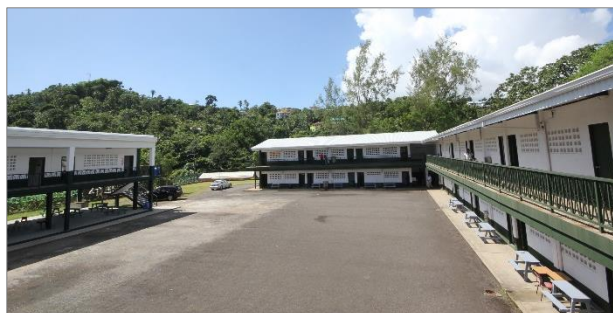
**Photo. 9** – Patience Combined School

This school is located in the district of Praslin, north of Micoud. The location plan and aerial view of the school are presented in Figure 9. It is east of the Castries-Vieux Fort Highway and has a view of the Atlantic coastline. It is accessed off a paved secondary road and comprises four buildings, one of which was built recently. The compound measures 5,250 m<sup>2</sup>. The school has 253 pupils and is a designated emergency shelter.

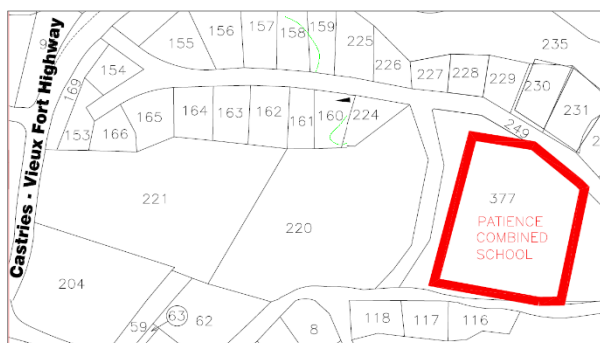
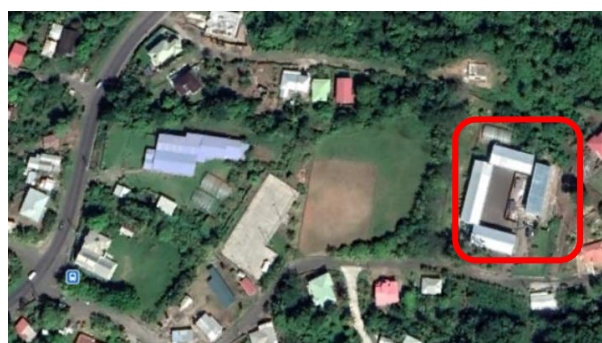
**Figure 9** – Location plan and aerial photo of Patience Combined School

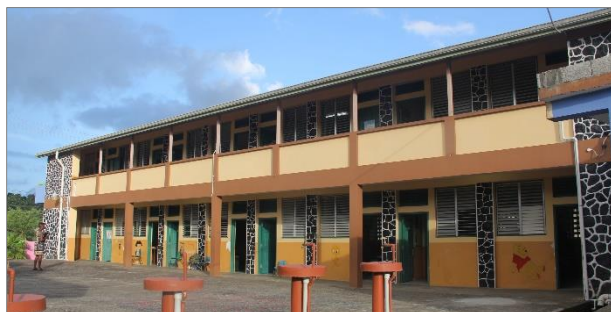
**Photo. 10** – Saltibus Combined School

The Saltibus Combined School is at an elevation of 282 m above sea level. It is located along an extended spur, which is about 10 - 12 km off the Laborie-Choiseul Highway. The location plan and aerial view of the school are presented in Figure 11. The School appears to straddle the Laborie - Choiseul boundary. The immediate area is characterized by steep terrain and the only available access road to the school runs along the spur, where it ends some 12 - 13 km inland. The property area is 2,188 m<sup>2</sup> and is adjacent to a community playground. It is identified as an emergency shelter and has a student population of 106.

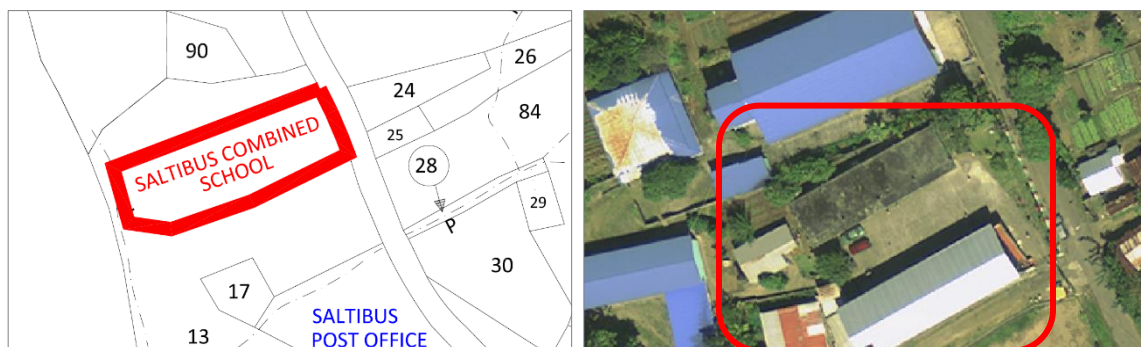
**Figure 10** – Location Plan and Aerial Photo of Saltibus Combined School

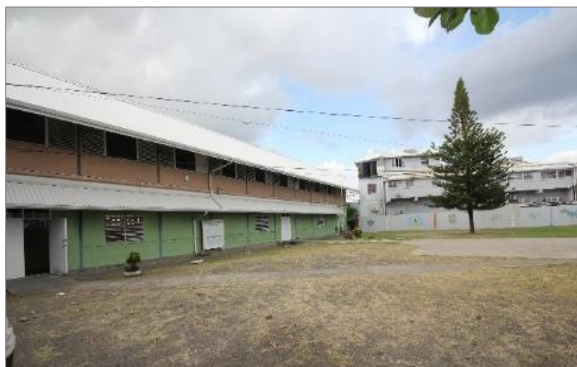
**Photo. 11** – Vieux Fort Infant

These two schools are located in the suburban locality of the town of Vieux Fort. The location plan and aerial views of the schools are presented in Figure 12. The Infant School is accessed directly off Clarke Street which is the main road into the town centre. The Primary School is further east, where the town's urbanization appears to be expanding. Photographs 11 and 12 show the infant and primary schools respectively.

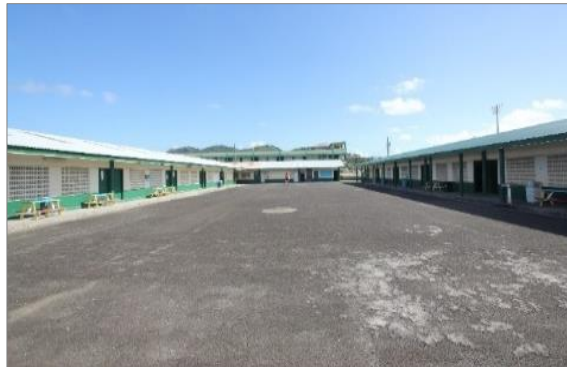
**Photo. 12** – Vieux Fort Primary

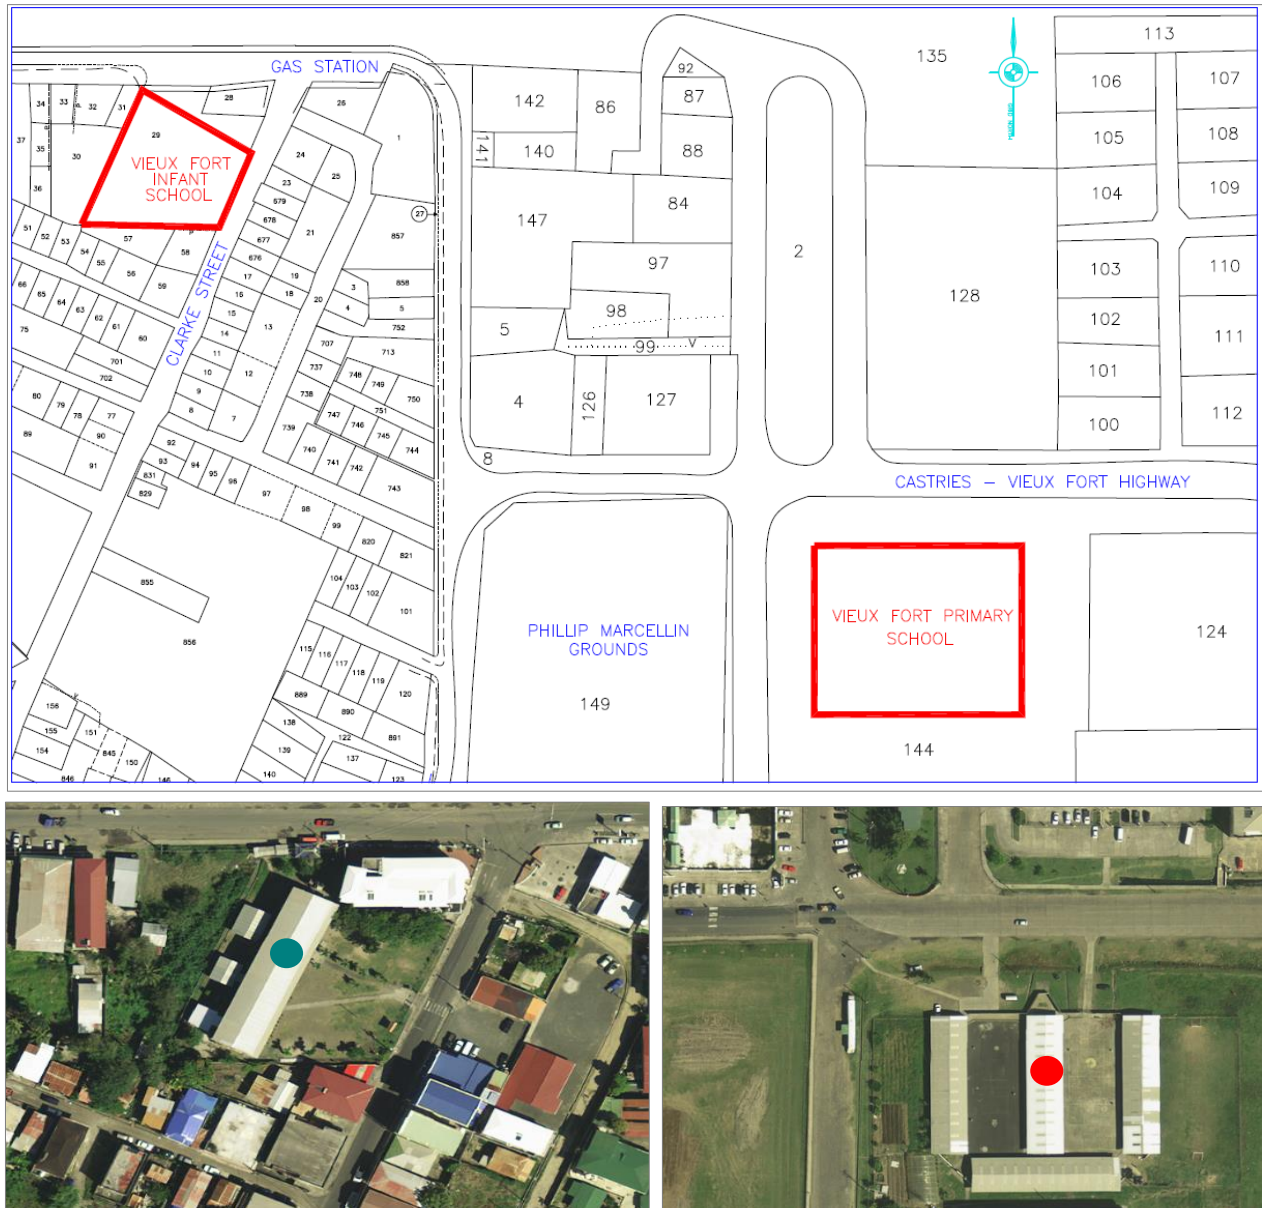
Figure 11 – Location Plan and Aerial Photos of Vieux Fort Infant and Primary schools

Both schools are on extremely flat grounds but the primary school is much more exposed to the trade winds and coastal inundation. The Infant School occupies 2,922 m<sup>2</sup> of land while the primary school is 7,120 m<sup>2</sup>. The Infant School has a population of 167 students, and the primary school, 205 students.

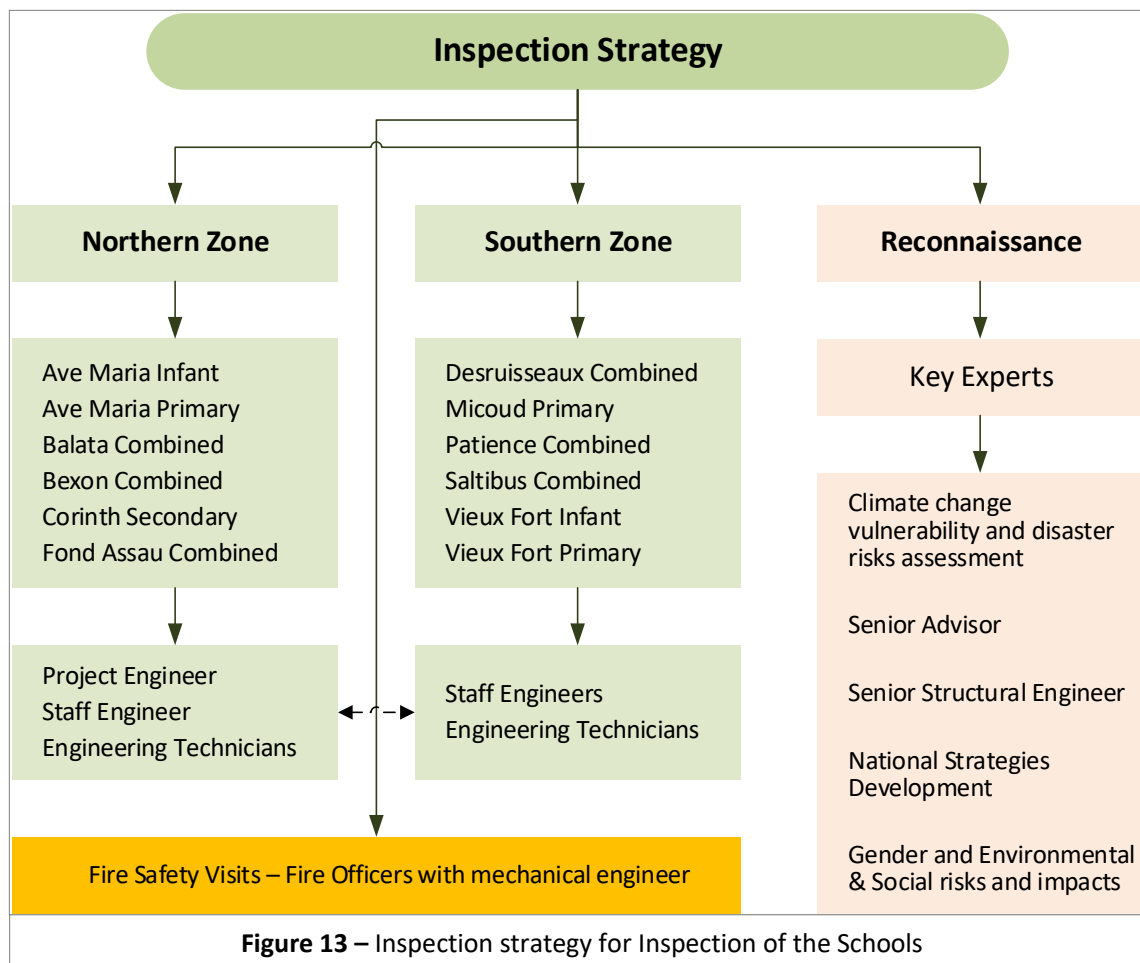
Figure 13 – Inspection strategy for Inspection of the Schools

To facilitate an efficient and optimal process, the inspection strategy involved dividing the Island into two zones; north and south as explained in Figure 13. The inspection team for each zone comprised two engineers and two technicians; however, for expediency purposes and due to the allotted time offered by the principal, the Corinth Secondary school was inspected by a larger team.

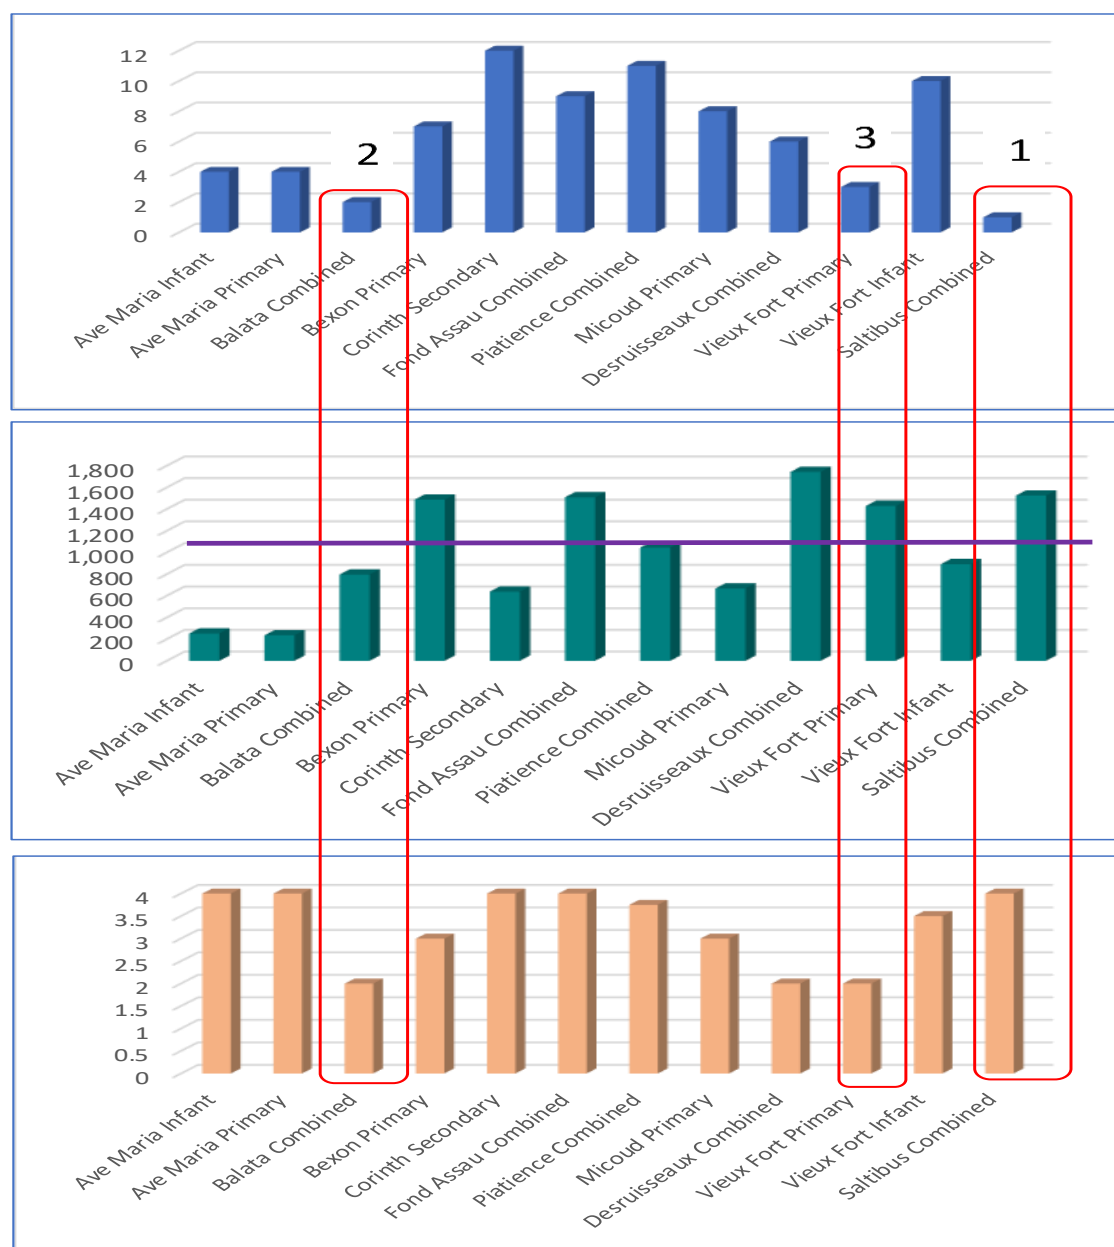
Figure 14Top – Combination of Ranking Metrics  
Overall ranking of schools; Middle – Cost-effectiveness; Bottom – Condition rating

The three graphs in Figure 14 provides a broad analysis of the cost-effectiveness of the interventions in relation to the building's condition and overall ranking. Balata Combined, the school ranked second in requiring retrofitting, has a low condition rating and a cost-effectiveness below the average for the twelve schools. However, the Vieux Fort Primary as the third-ranked school has a low condition rating but a cost-effectiveness which is above the average. Interestingly, Saltibus Combined which is ranked first has a high condition rating and an above-average cost-effectiveness. Thus, if the cost-effectiveness metric is included in the ranking of the schools, Balata Combined, is the most deserving of immediate resiliency upgrading.

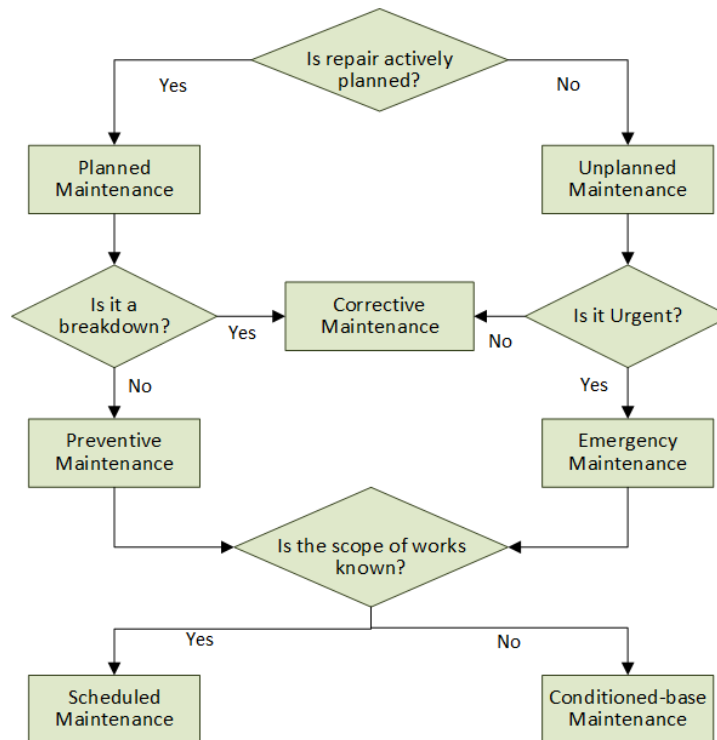
Figure 15 – Decision-Based Type of Maintenance

relative importance of the building element to the structure, facility or equipment must be first considered. In this regard, Figure 15 illustrates a decision-based type of maintenance.

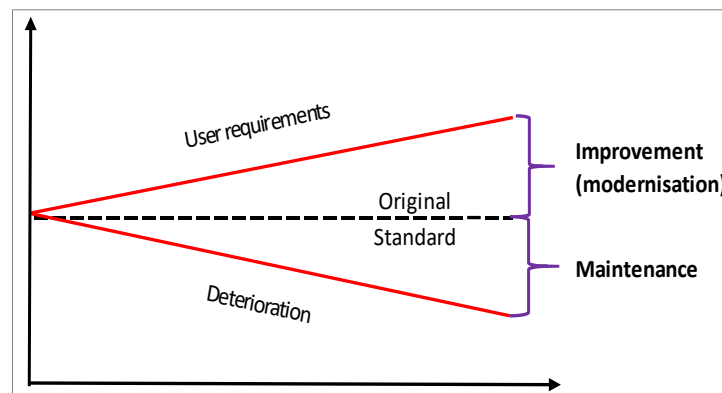
Figure 16 – Relation of Time to Maintenance Requirements

Even more important insofar as changing standards is concerned, is a widening gap between the standards demanded by current building codes and that produced at the design stage. This scenario was clearly evident in some of the schools inspected. Therefore, the applicable intervention, as is being proposed for some of the schools, is considered retrofitting for improvement or modernising and is depicted in Figure 16.
